COA Application - 415 E Edenton St - Tree Removal

Tree Removal Project Description

The proposed project involves the removal of four trees located on the property at **415 East Edenton Street, Raleigh, NC**, as recommended in the certified arborist report dated **March 4, 2026**, and the replacement of the 18" DBH Elm. The removal is necessary due to documented structural risks, property damage, and public safety concerns associated with the existing trees.

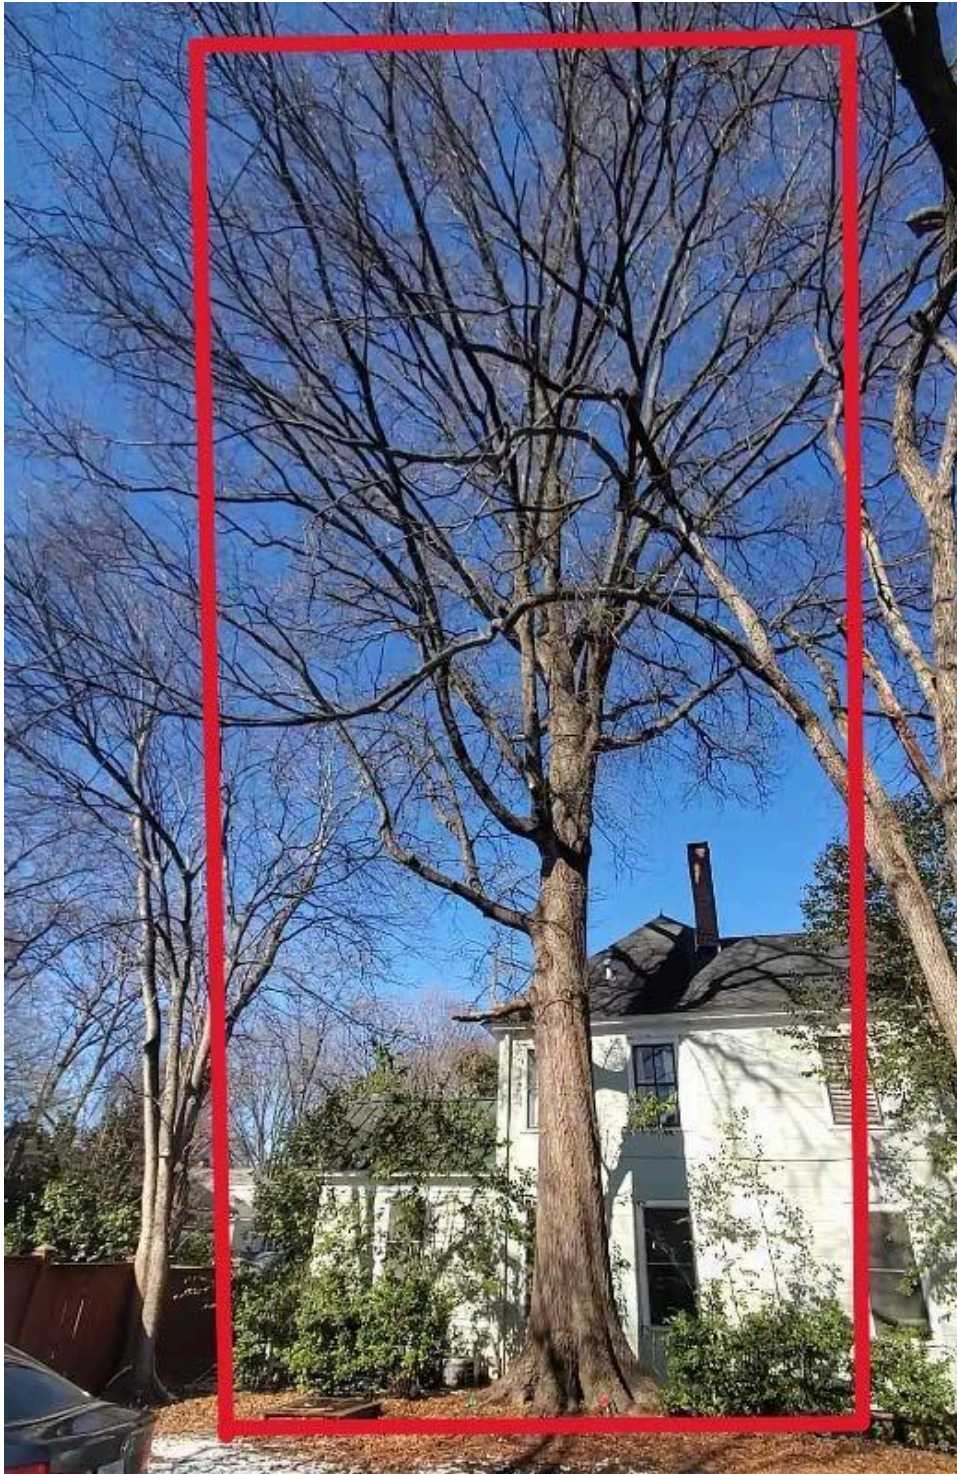
A mature willow oak located on the property has developed a root system that is actively encroaching into the building foundation. According to the arborist assessment, the majority of the tree's root system exists beneath the tree's drip line and extends into the foundation area. Removal of the invasive roots without damaging the stability or health of the tree is not feasible. Continued growth of the root system presents a risk of **ongoing structural damage to the building foundation** and could also impact adjacent structures, including the neighboring property at **103 East Street**, due to the size and spread of the root system. 103 East St is also located directly underneath the tree now and poses more safety risks. Based on these conditions, the arborist recommends full removal of the tree to prevent further structural damage.

1. Willow Oak 48 inch DBH x 95 feet tall: The roots from this tree trunk are growing into the foundation and compromising the building. Typically 70% of the roots of this tree are primarily under the drip line of the tree. There is no way to remove these roots without damaging the stability or the health of this tree. A good 40% of the tree is also directly above the neighboring house causing risk for damages. Therefore, it is my recommendation to remove this tree

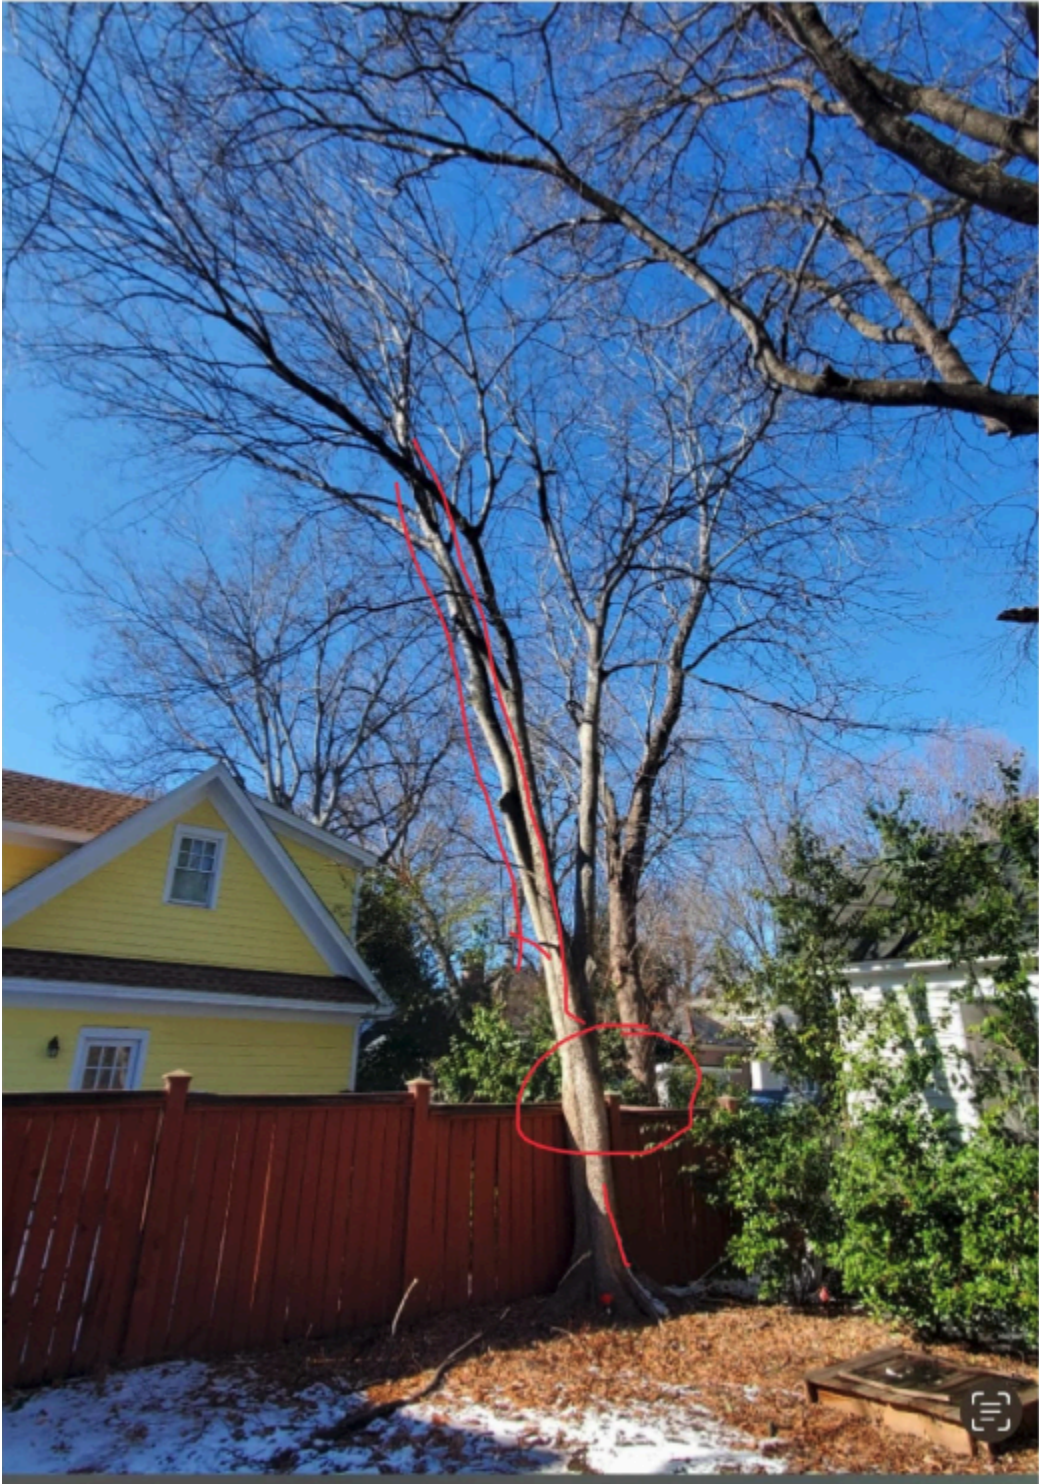
The hackberry tree is growing directly into a wooden fence located on the property line. The fence cannot be relocated due to boundary constraints, and continued growth of the tree is causing progressive structural damage to the fencing. Removal is recommended to prevent further deterioration of the fence and avoid potential property disputes or repair costs.

2. Hackberry tree 16 inch DBH x 35 feet tall: This tree is growing at an angle and into and damaging the wooden fence. This fence is on the property line and can not be moved. It is my recommendation to remove

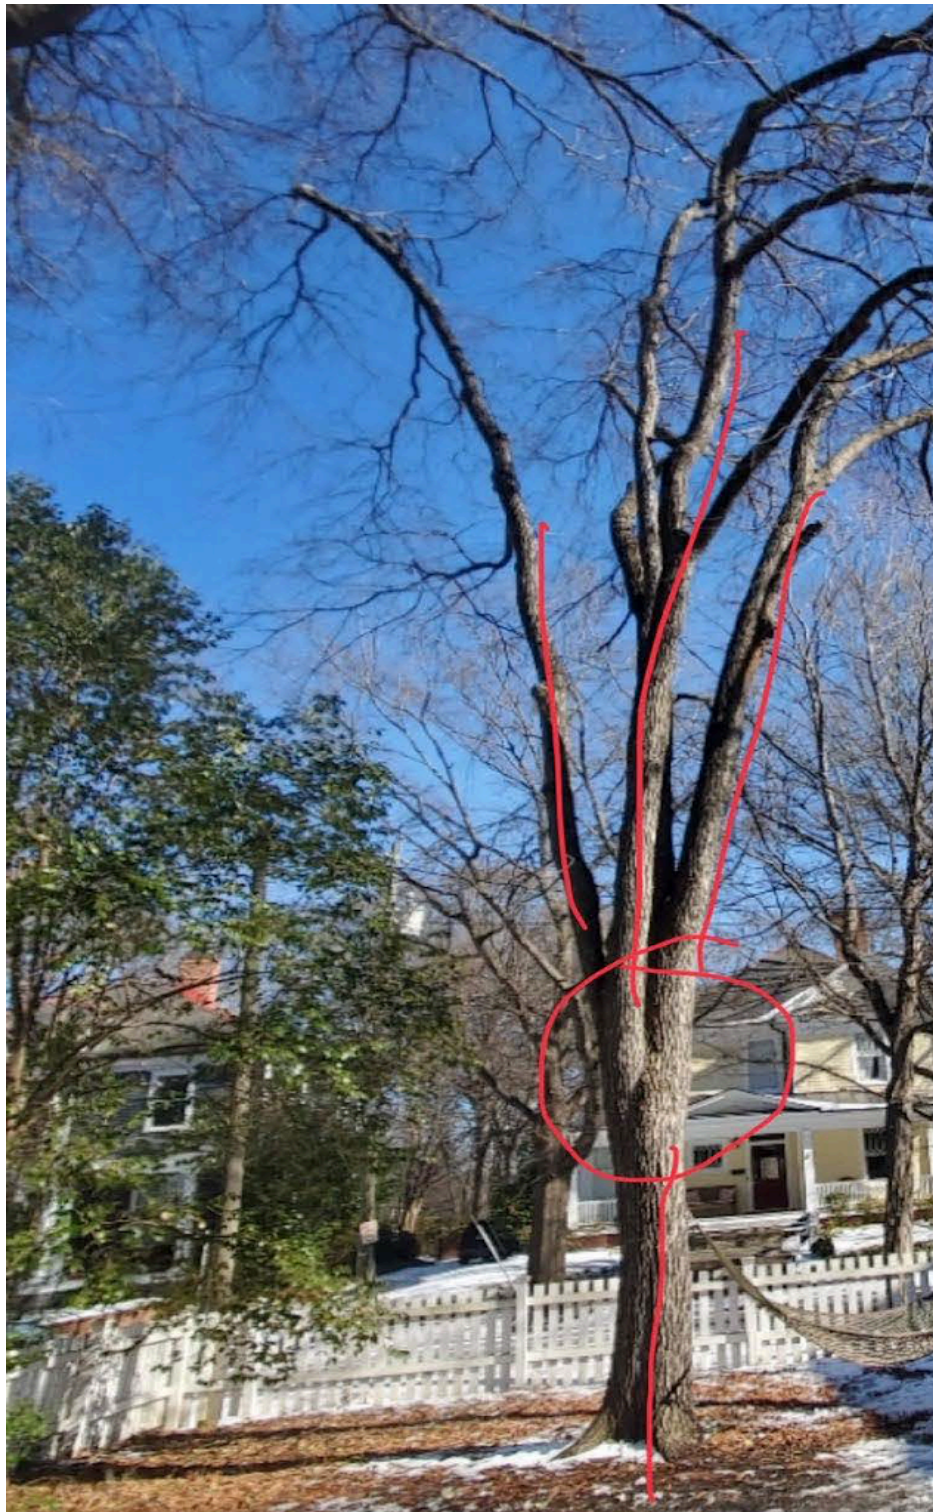
This elm tree exhibits **included bark**, a structural defect that significantly increases the likelihood of trunk splitting or major limb failure. The tree also shows evidence of broken branches in the upper canopy. Remediation through pruning is not feasible because approximately **50% of the canopy would need to be removed**, which would compromise the survival of the tree. Due to the high risk of structural failure and falling limbs, the tree presents a safety hazard to nearby structures, pedestrians, and **vehicles parked on adjacent streets and properties**. This tree is to be replaced in the corner of the lot - see site plan for more information.

3. Elm tree 18 inch DBH x 45 feet tall: This tree has included bark, which means it runs the risk of splitting apart. It also shows signs of broken branches in the top of the tree. It is not possible to remove these branches and have the tree survive because 50% of this tree would need to be removed. It is my recommendation that this tree be removed.

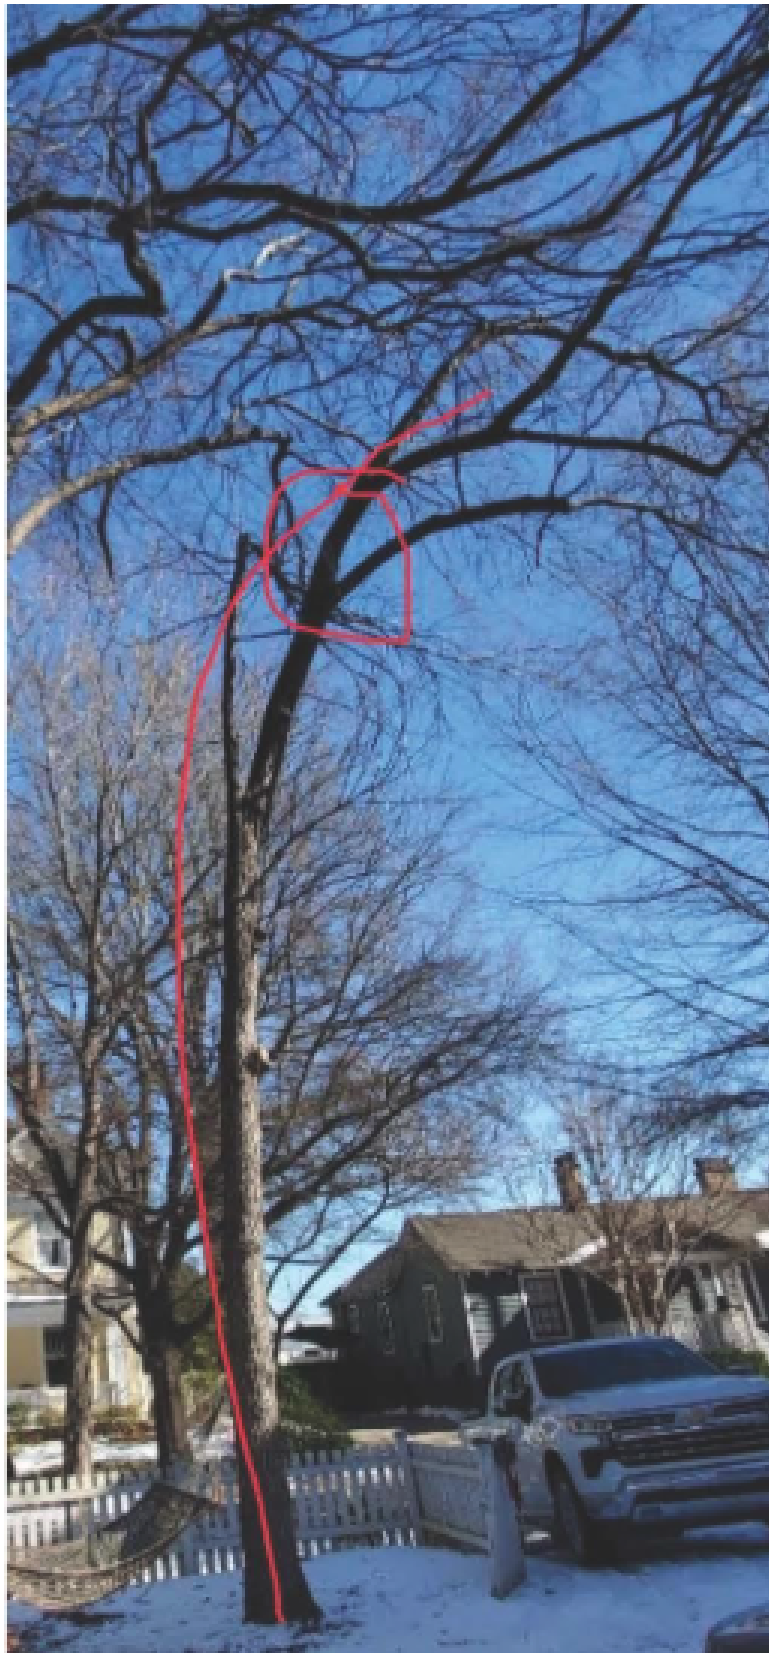
This understory elm has experienced **severe phototropic growth**, resulting in a lean exceeding 20 feet as it bends toward available sunlight. This excessive lean places the tree at risk of **uprooting or catastrophic failure**, particularly during storms or high wind events. If failure occurs, the tree could cause **significant damage to nearby vehicles, structures, or individuals in the immediate vicinity**. The lean is in the direction of our house on 415 E Edenton St.

4. Elm tree 15 inch DBH x 38 feet tall: This tree is an “understory tree” and is bending out toward the sun (Phototropism) and has over 20 feet of lean. This tree at risk of uprooting and causing serious damage to persons or vehicles. It is my recommendation that this tree be removed
