Thursday, April 23, 2026

RHDC - Certificate of Appropriateness Committee
05:00 PM

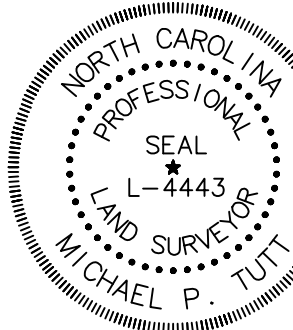
I, MICHAEL PRESTON TUTT, CERTIFY THAT THIS MAP WAS DRAWN UNDER MY SUPERVISION FROM AN ACTUAL SURVEY AND FROM REFERENCES NOTED; THAT THE RATIO OF PRECISION BEFORE ADJUSTMENTS WAS 1:10,000 WITNESS MY ORIGINAL SIGNATURE, 5TH OF FEBRUARY, 2026.

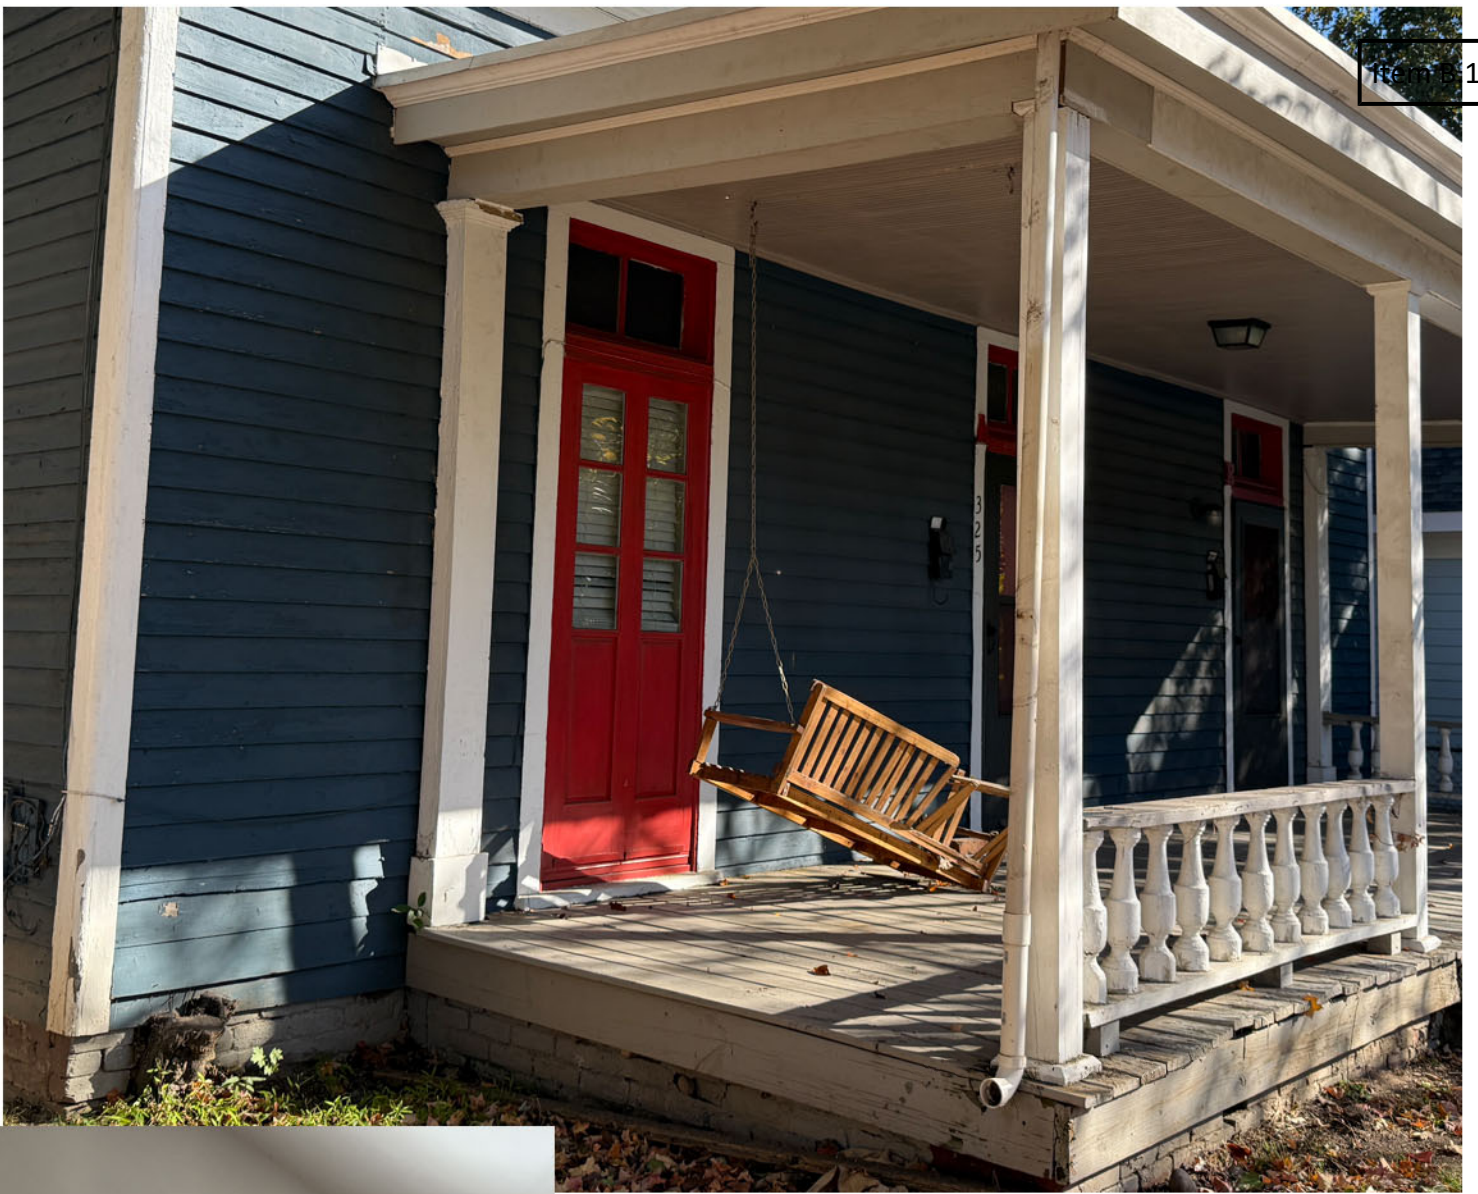
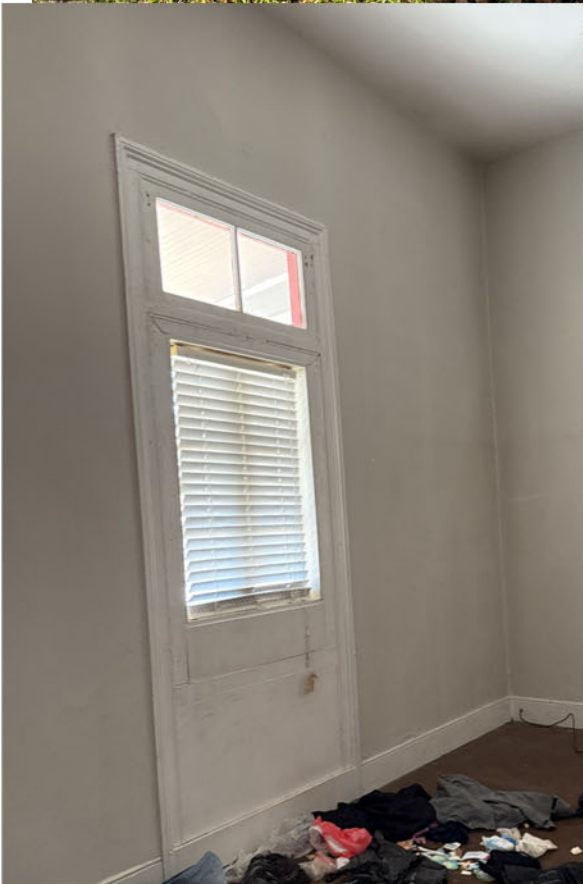
Exterior image of modified pair of doors as well as the existing porch columns. Both proposed to be replaced with new.

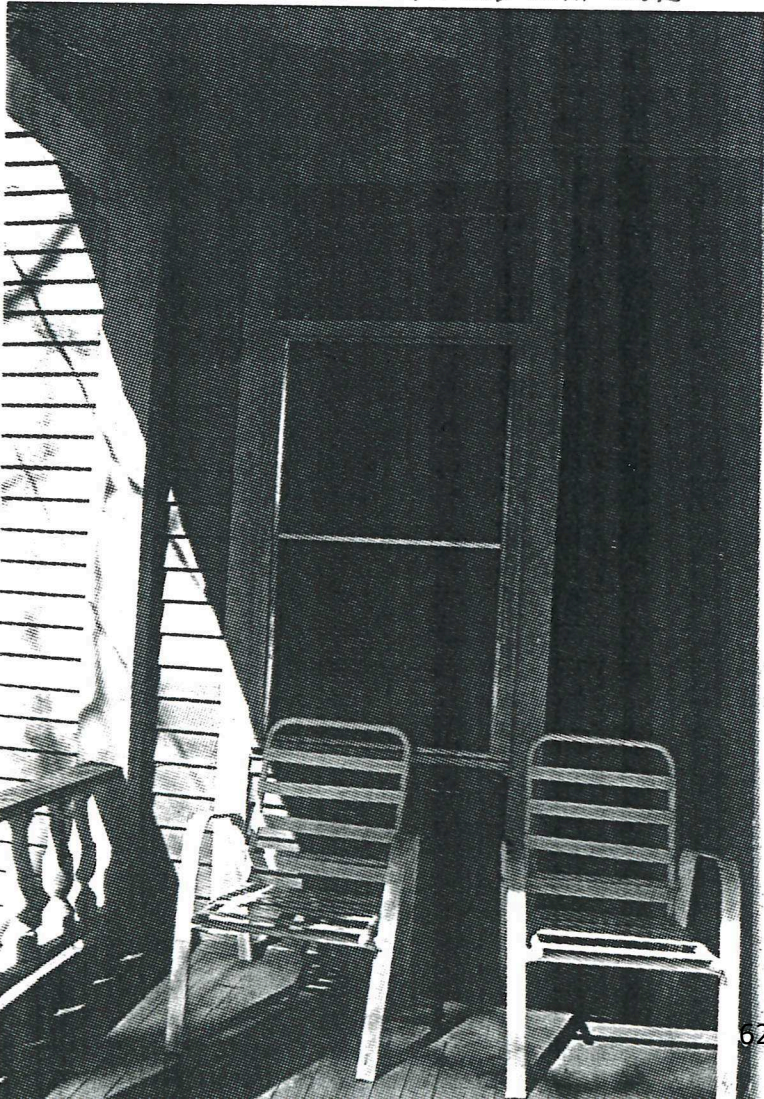
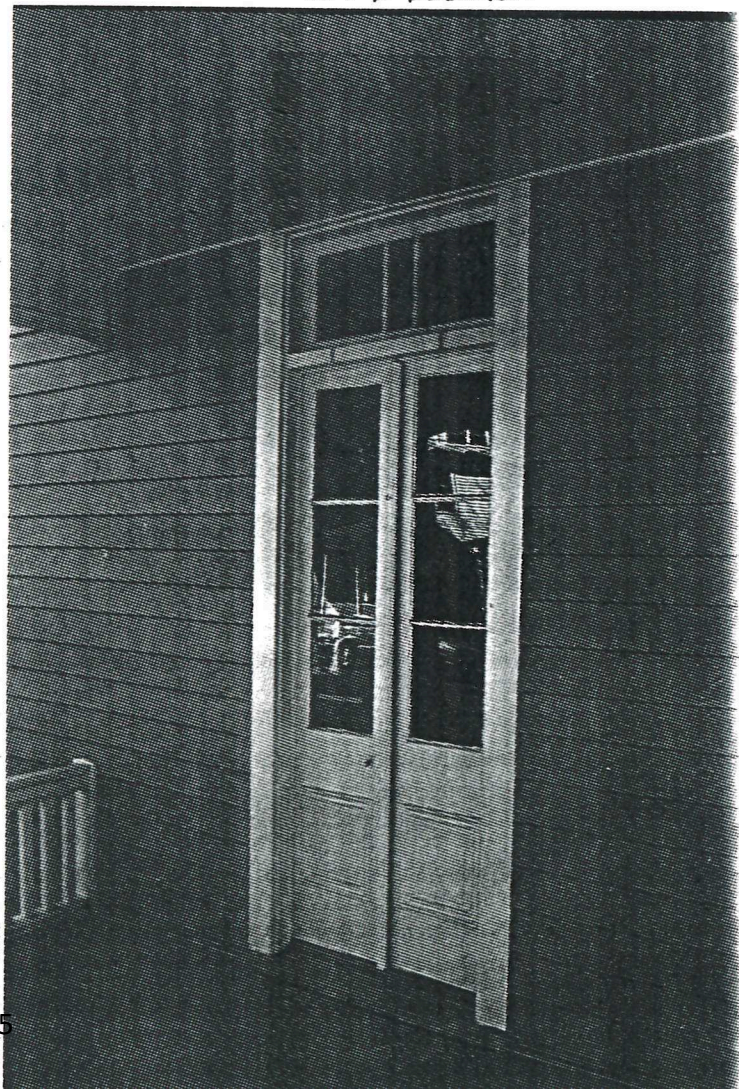
111 N. BLOODWORTH: DOOR TO BE COPIED FOR 325 E EDENTON

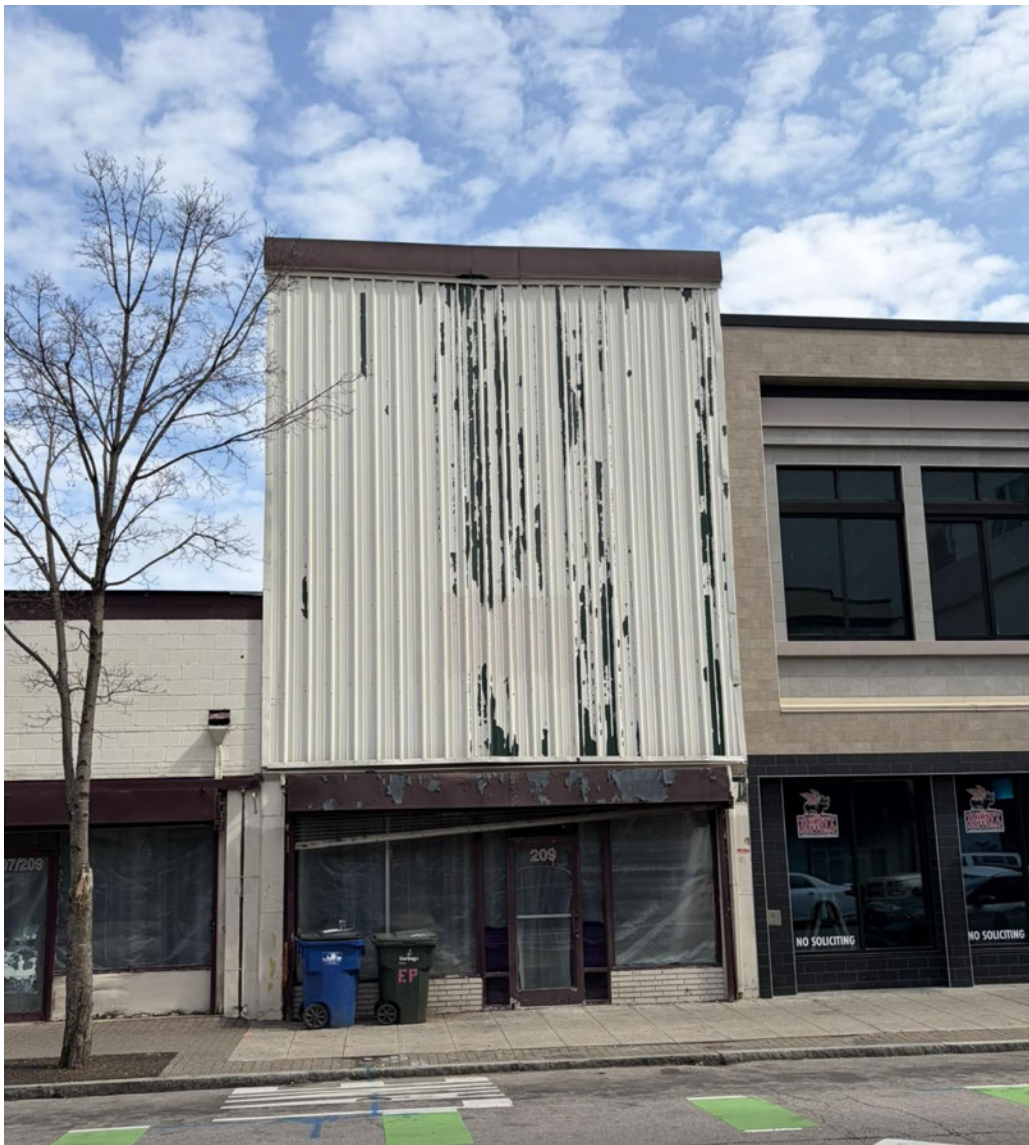
209 S Wilmington St.

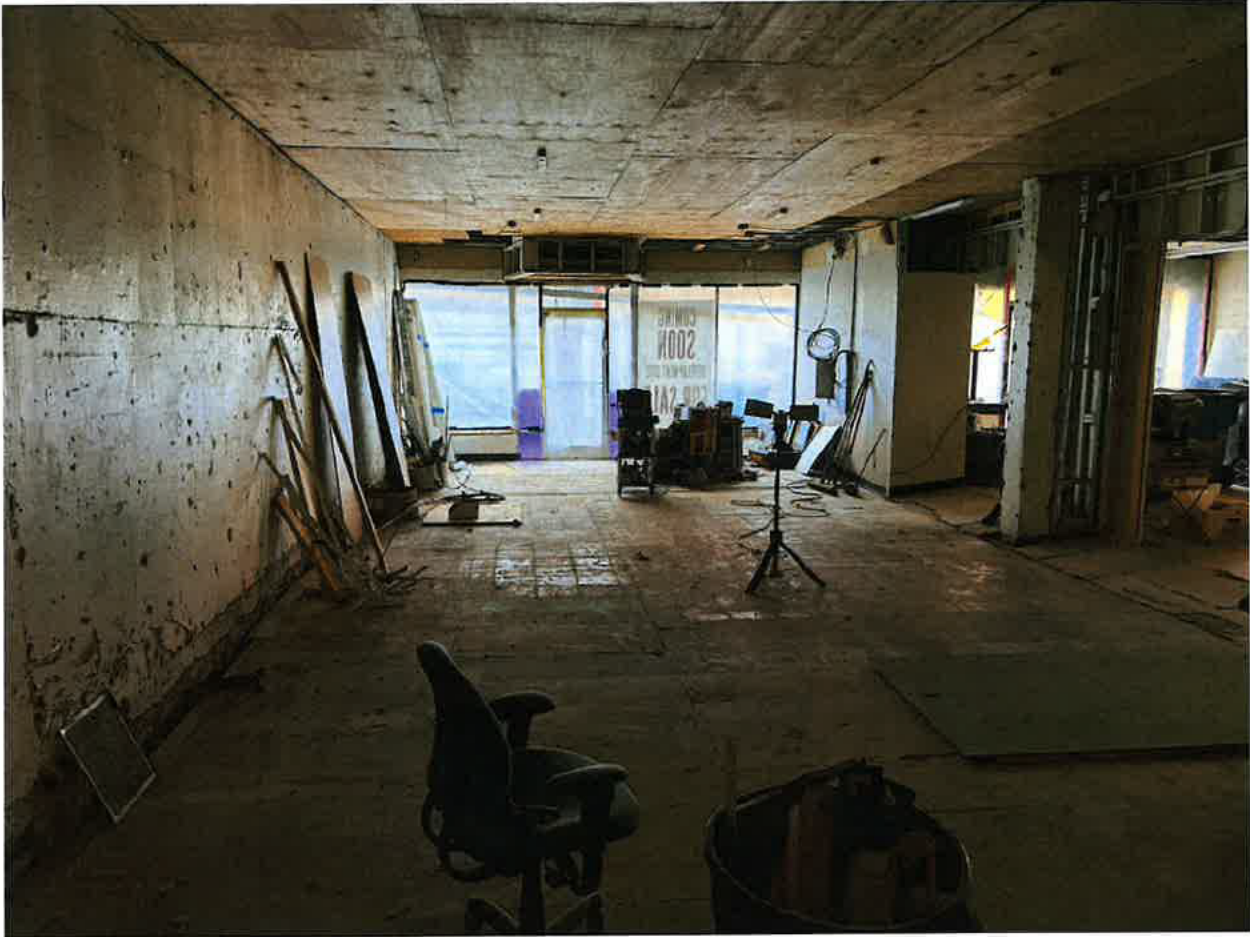
Photo 5: 209 S Wilmington Raleigh, NC (03/19/2026) 1st floor, Interior Facing West. In addition to the original storefront, much of the first-floor framing has been replaced and none of the original flooring remains.

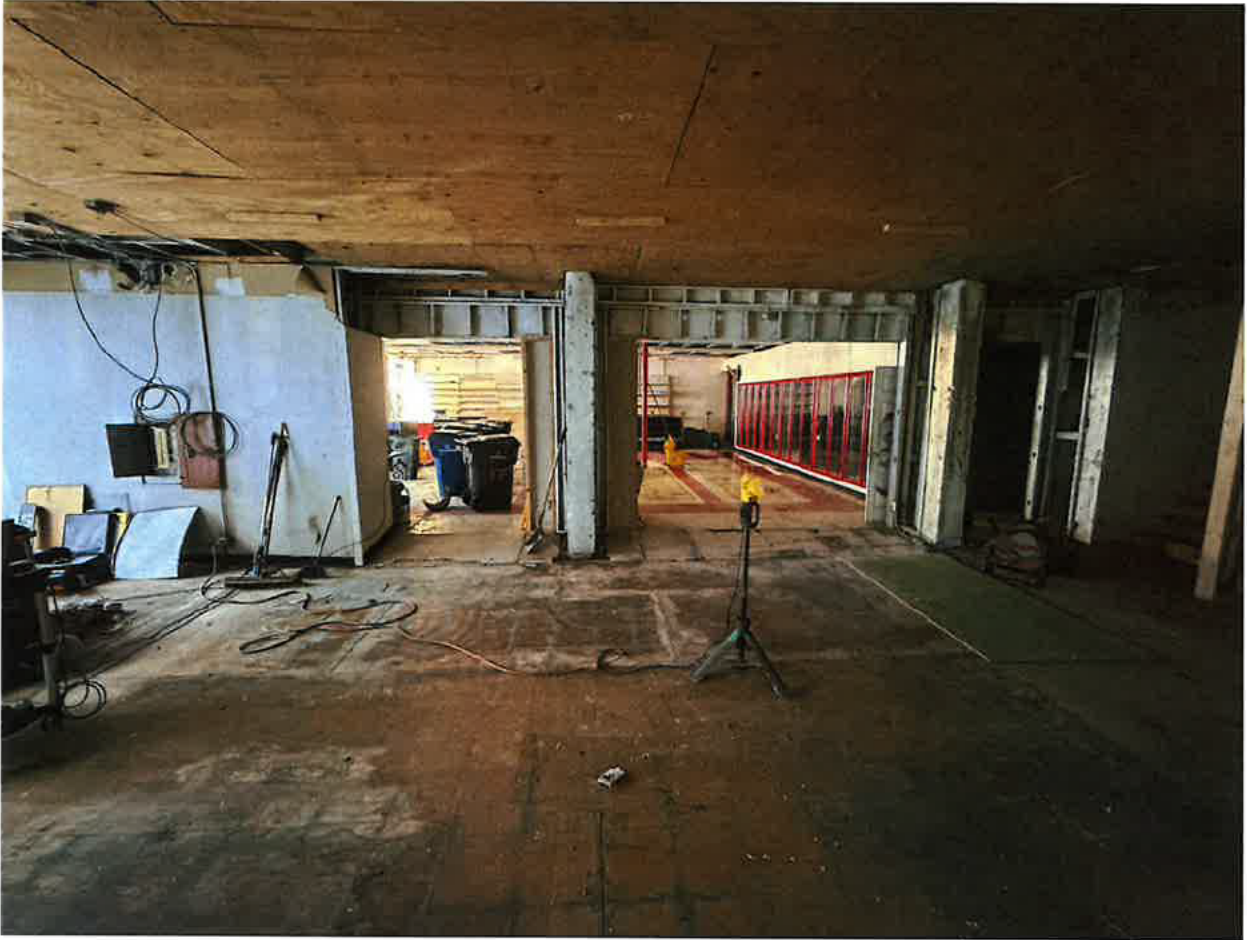
Photo 6: 209 S Wilmington Raleigh, NC (03/19/2026) 1st floor interior facing North, looking in to 205 . The north masonry wall on the 1st floor has been removed and replaced with steel columns and beams.

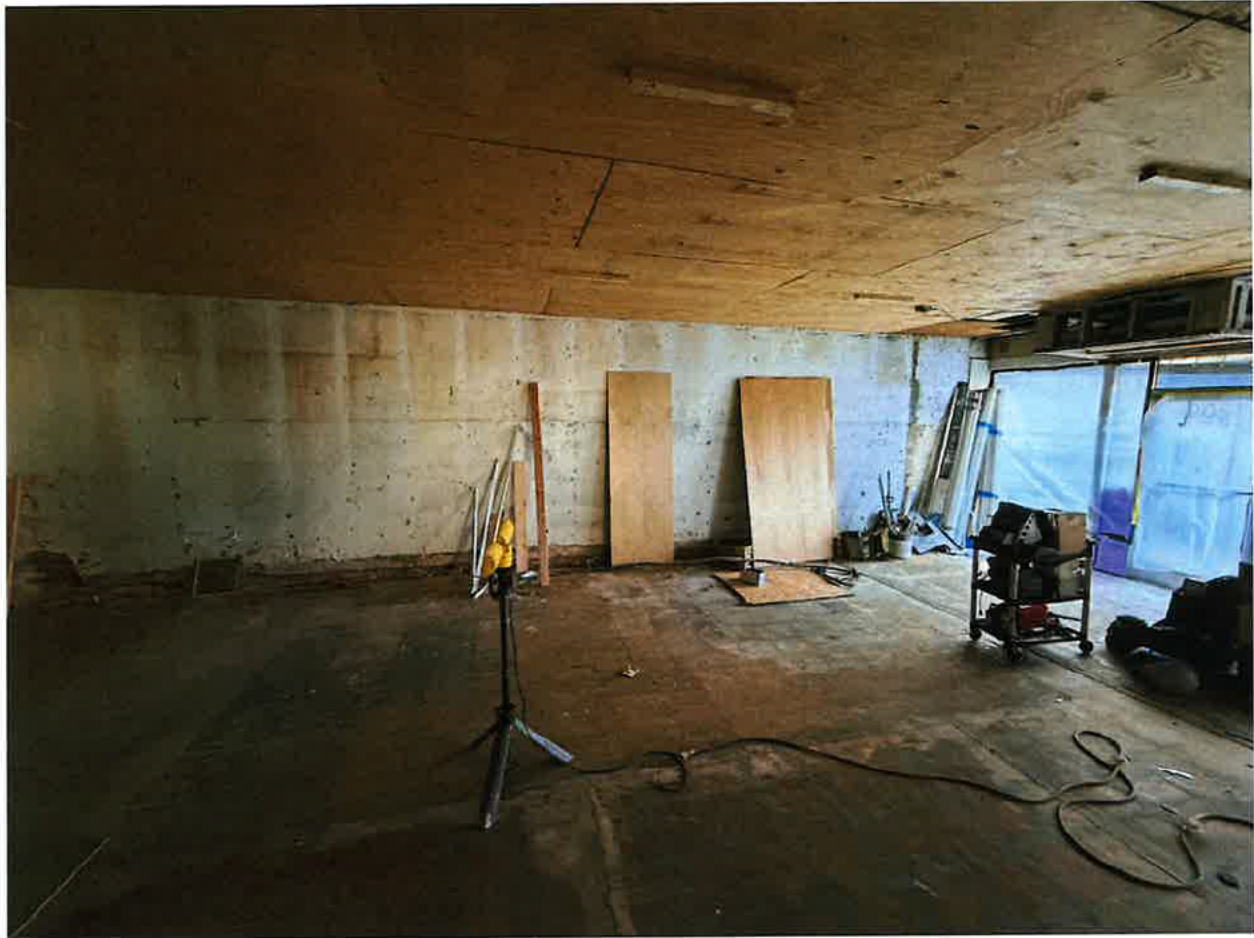
Photo 7: 209 S Wilmington Raleigh, NC (03/19/2026) 1st floor Interior Facing South West. Appears to be a separate, non-party wall with adjacent 211 S Wilmington St. building.

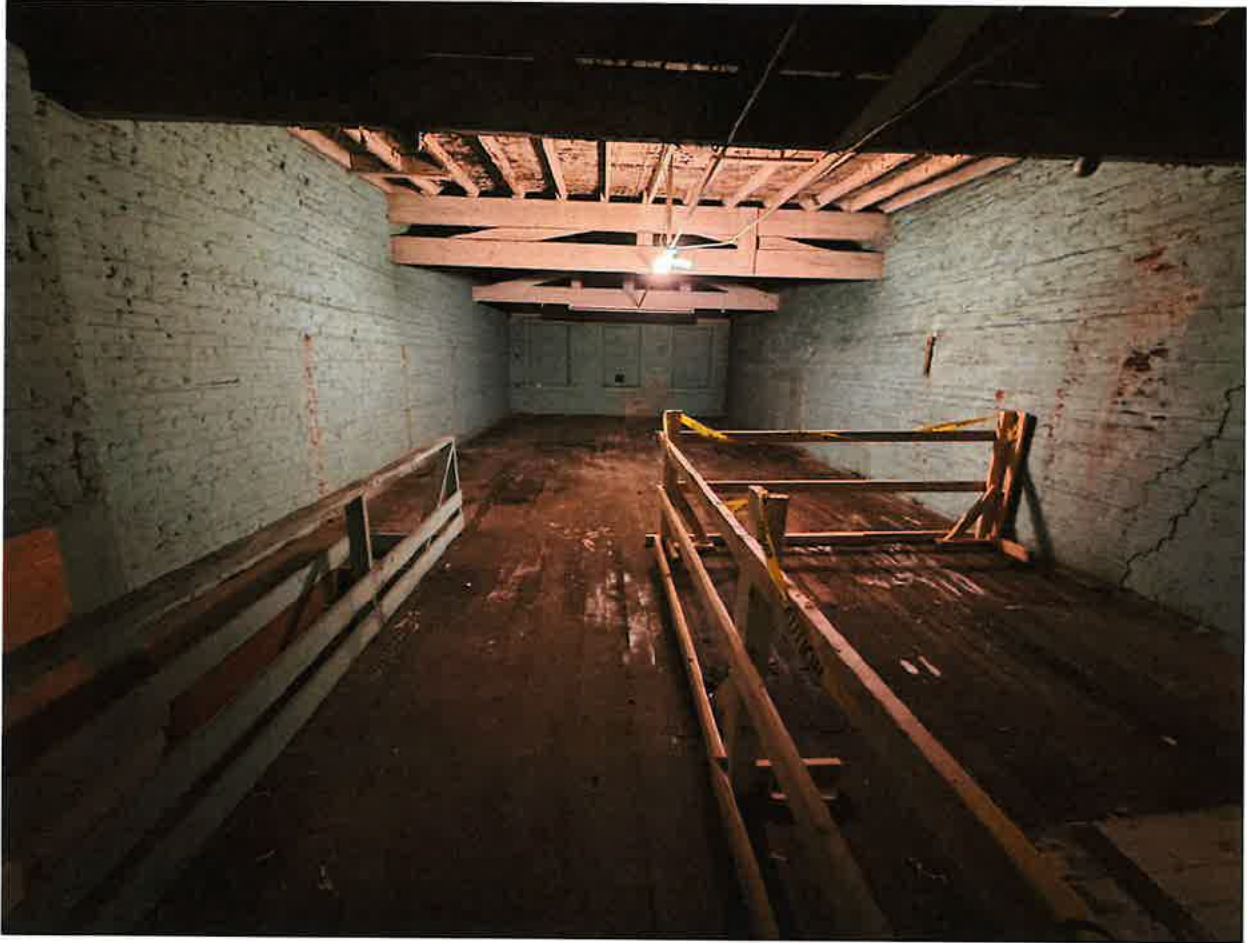
Photo 14: 209 S Wilmington Raleigh, NC (03/19/2026) 3rd floor Interior Facing East (Wilmington St) Significant rot on hardwood flooring and severe damage to floor and roof structures as well large cracking on North and South masonry walls.

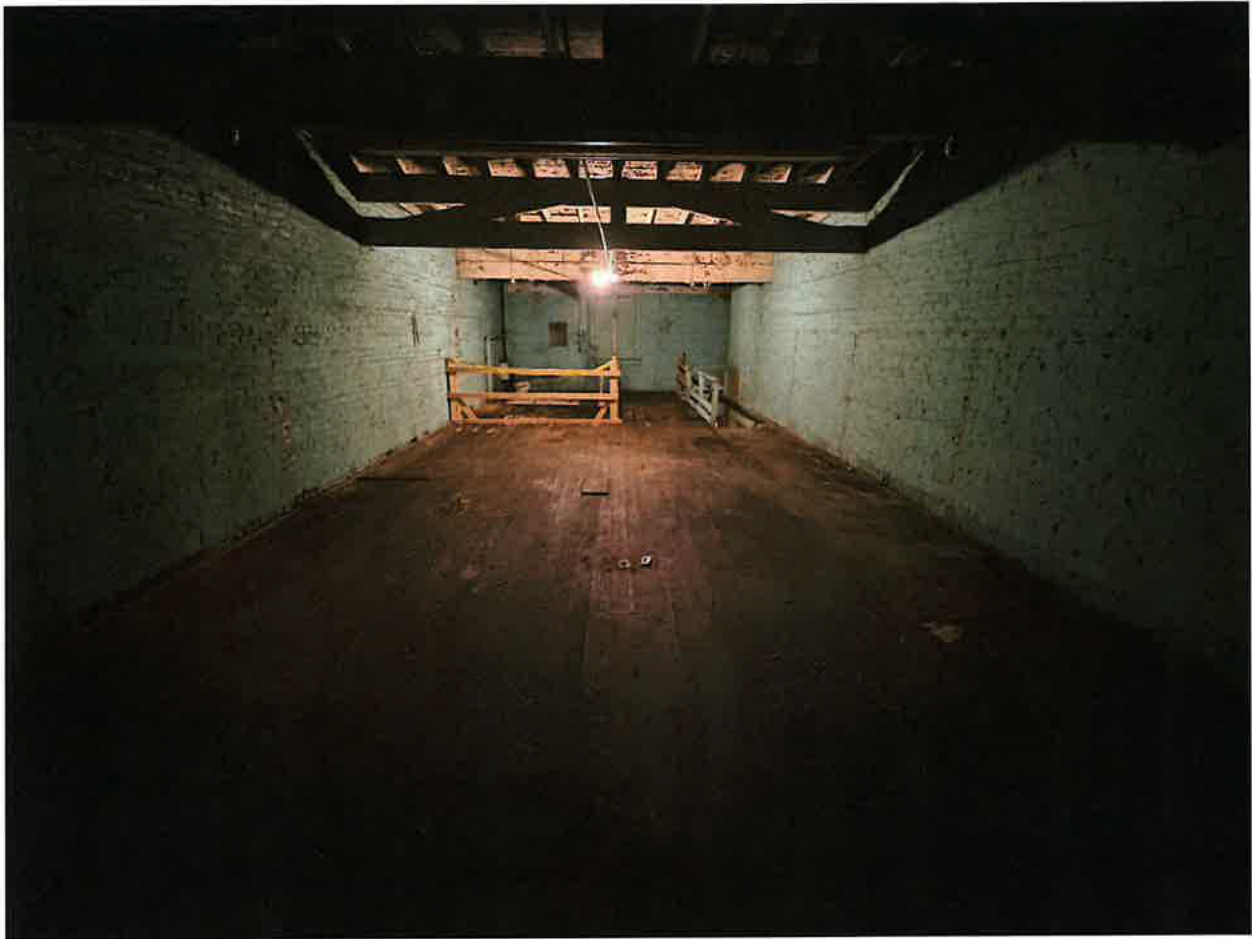
Photo 15: 209 S Wilmington Raleigh, NC (03/19/2026) 3rd floor Interior Facing West

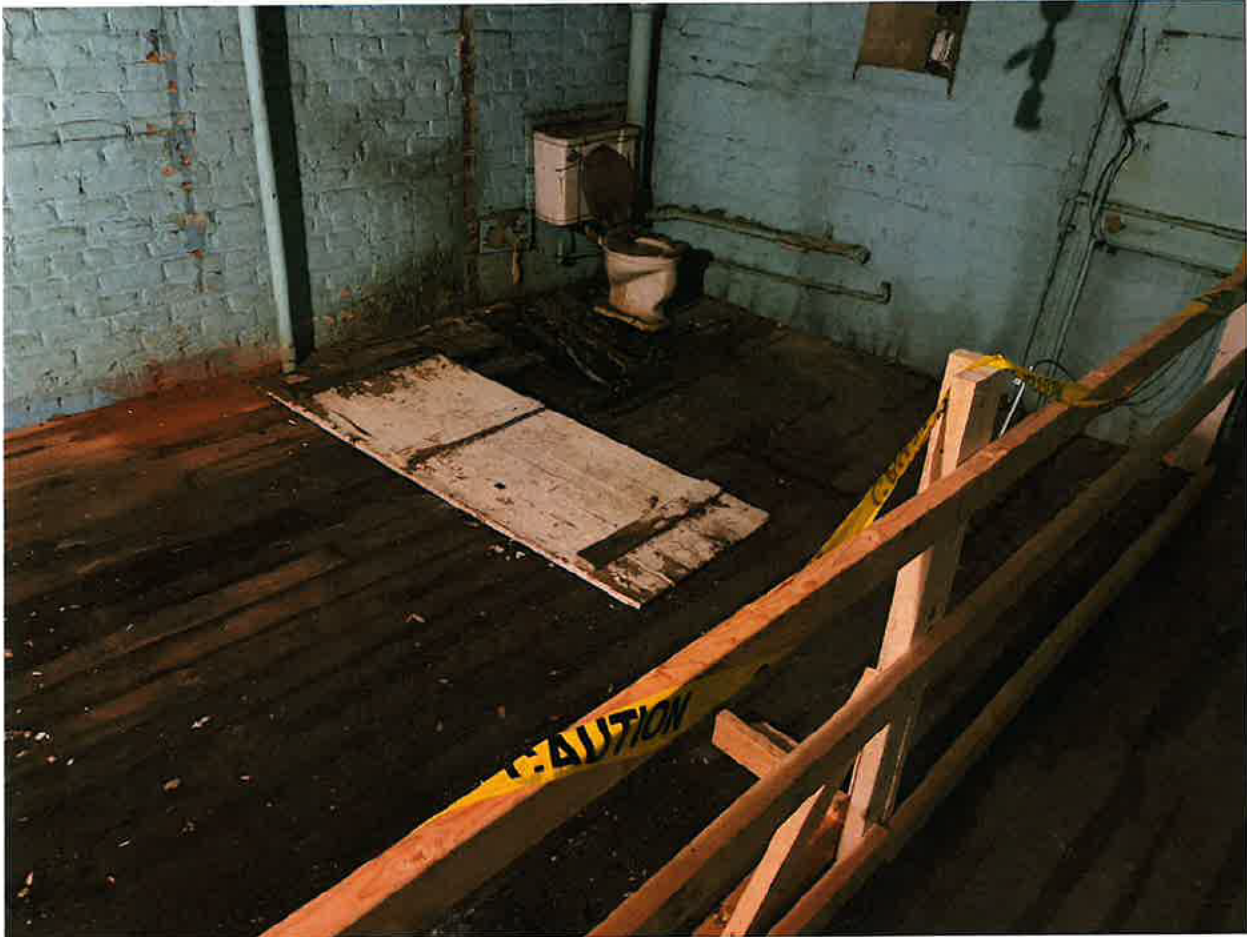
Photo 17: 209 S Wilmington St Raleigh, NC (03/19/2026) : 3rd floor rear major structural damage from plumbing and roof leaks.

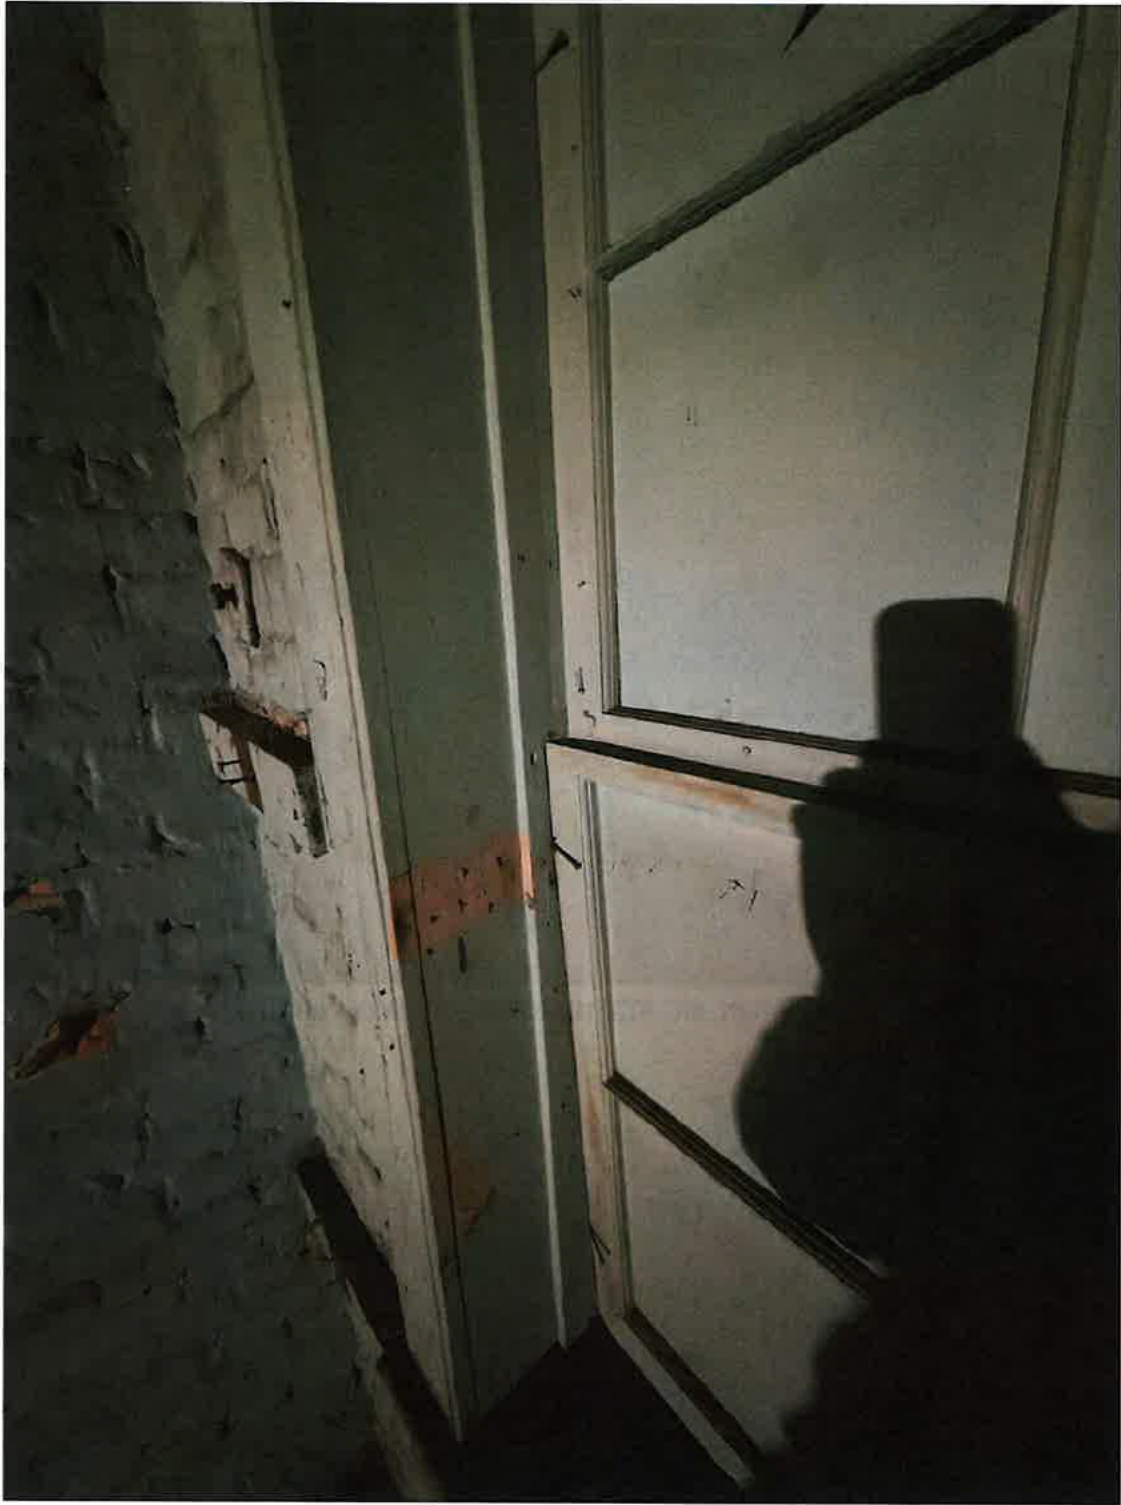
Photo 18: 209 S Wilmington St Raleigh, NC (03/19/2026) 3rd floor front, window sashes, tacked in place, Portland based stucco and wire lath beneath. Unknown if sashes are original.

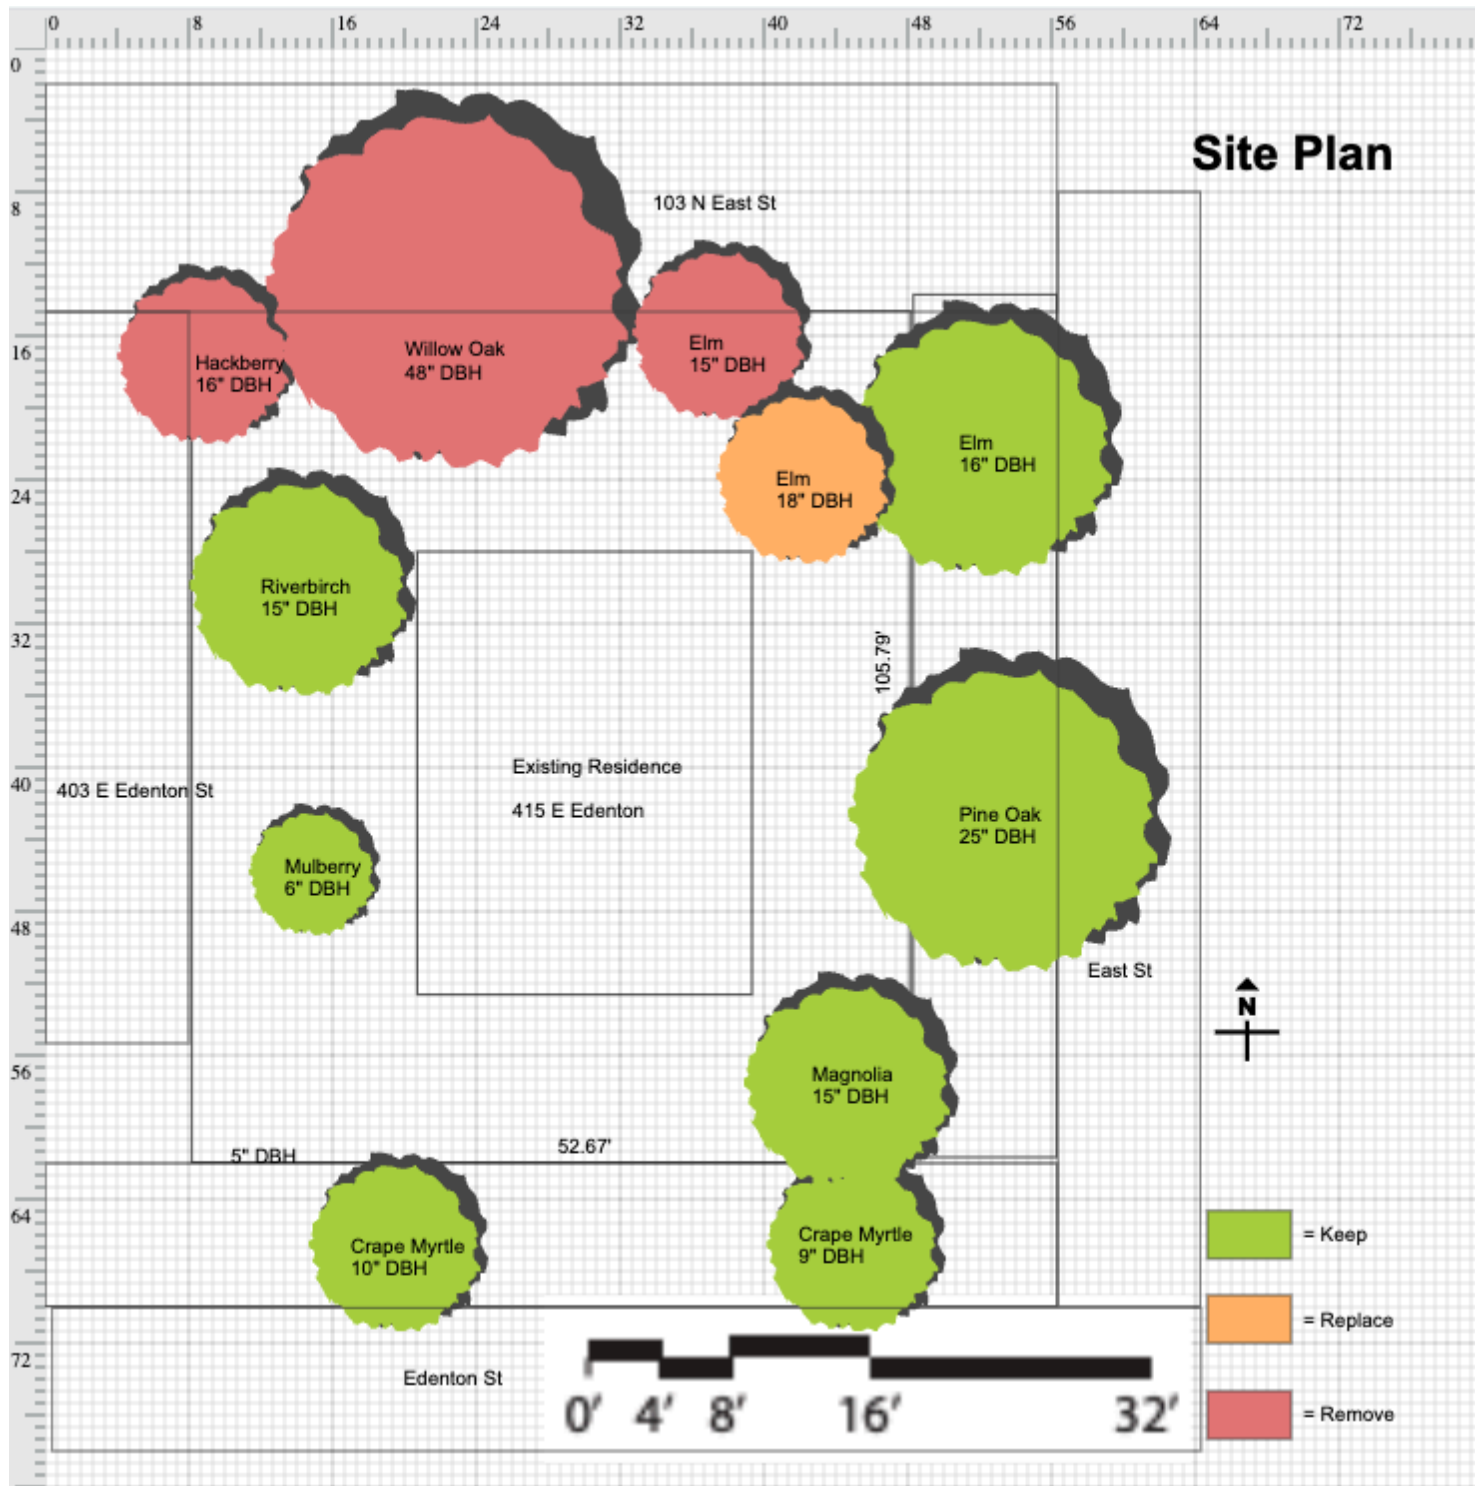
Aerial Photos of Canopy to be Removed

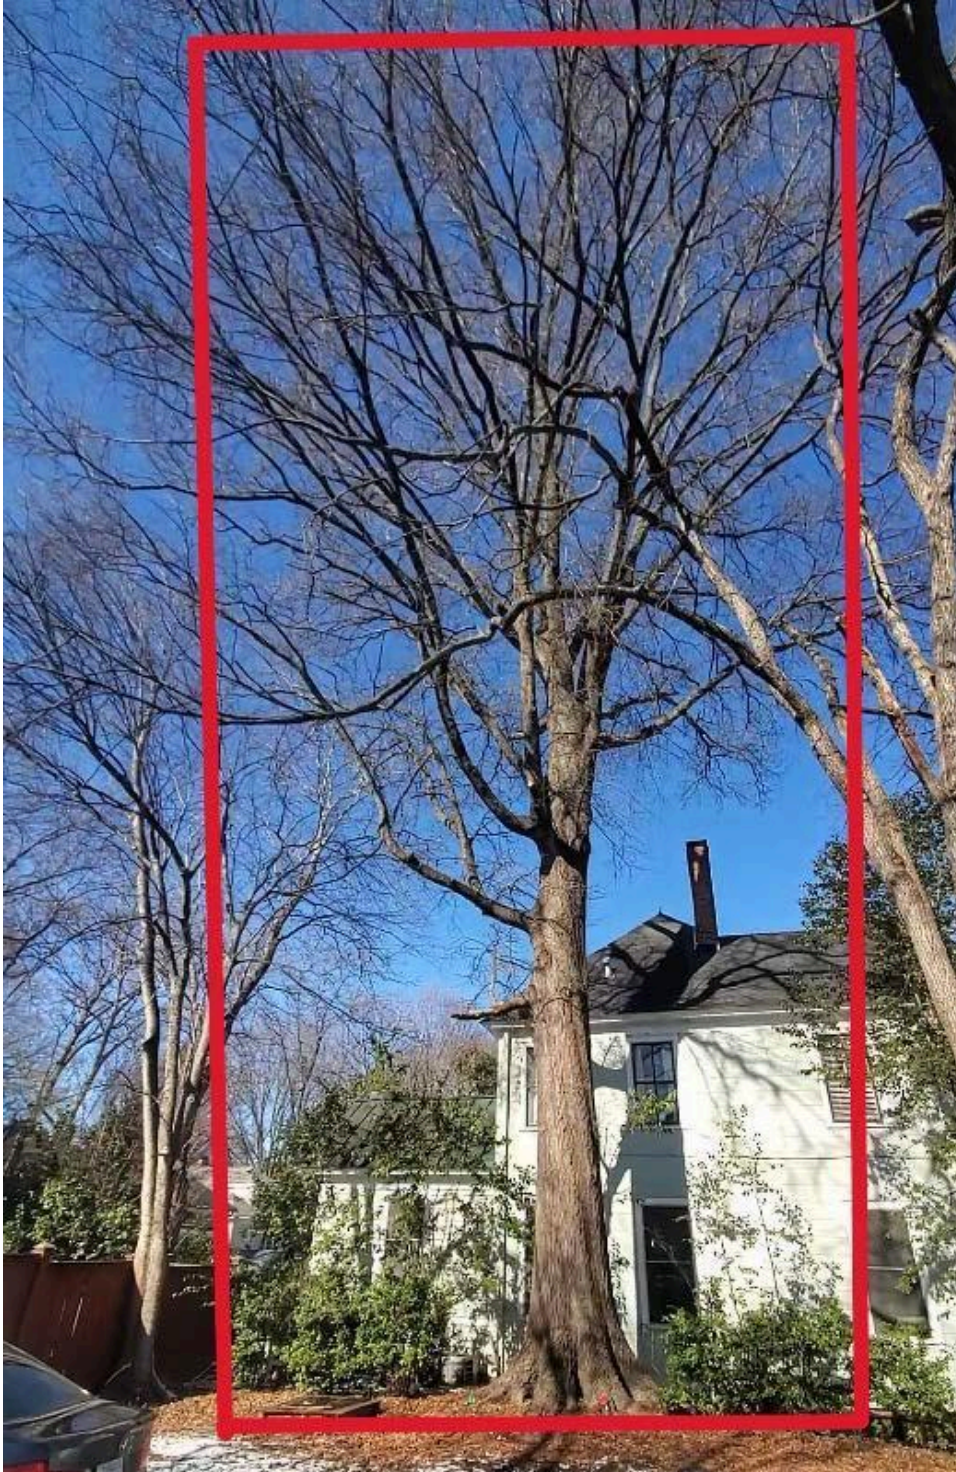
- 2. Hackberry tree 16 inch DBH x 35 feet tall: This tree is growing at an angle and into and damaging the wooden fence. This fence is on the property line and can not be moved. It is my recommendation to remove

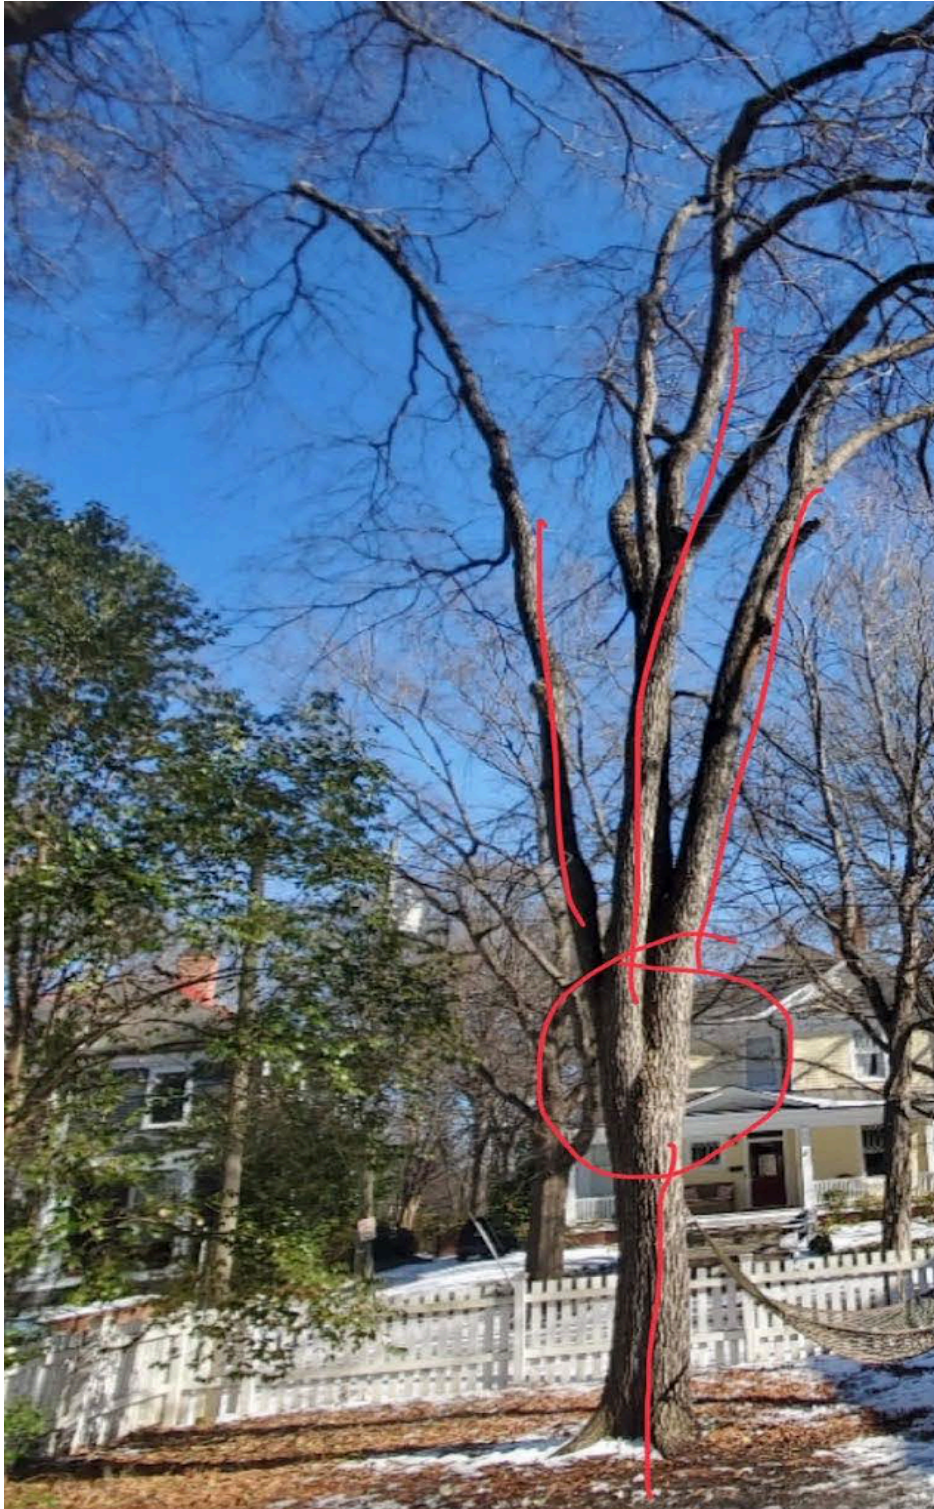
4. Elm tree 15 inch DBH x 38 feet tall: This tree is an “understory tree” and is bending out toward the sun (Phototropism) and has over 20 feet of lean. This tree at risk of uprooting and causing serious damage to persons or vehicles. It is my recommendation that this tree be removed

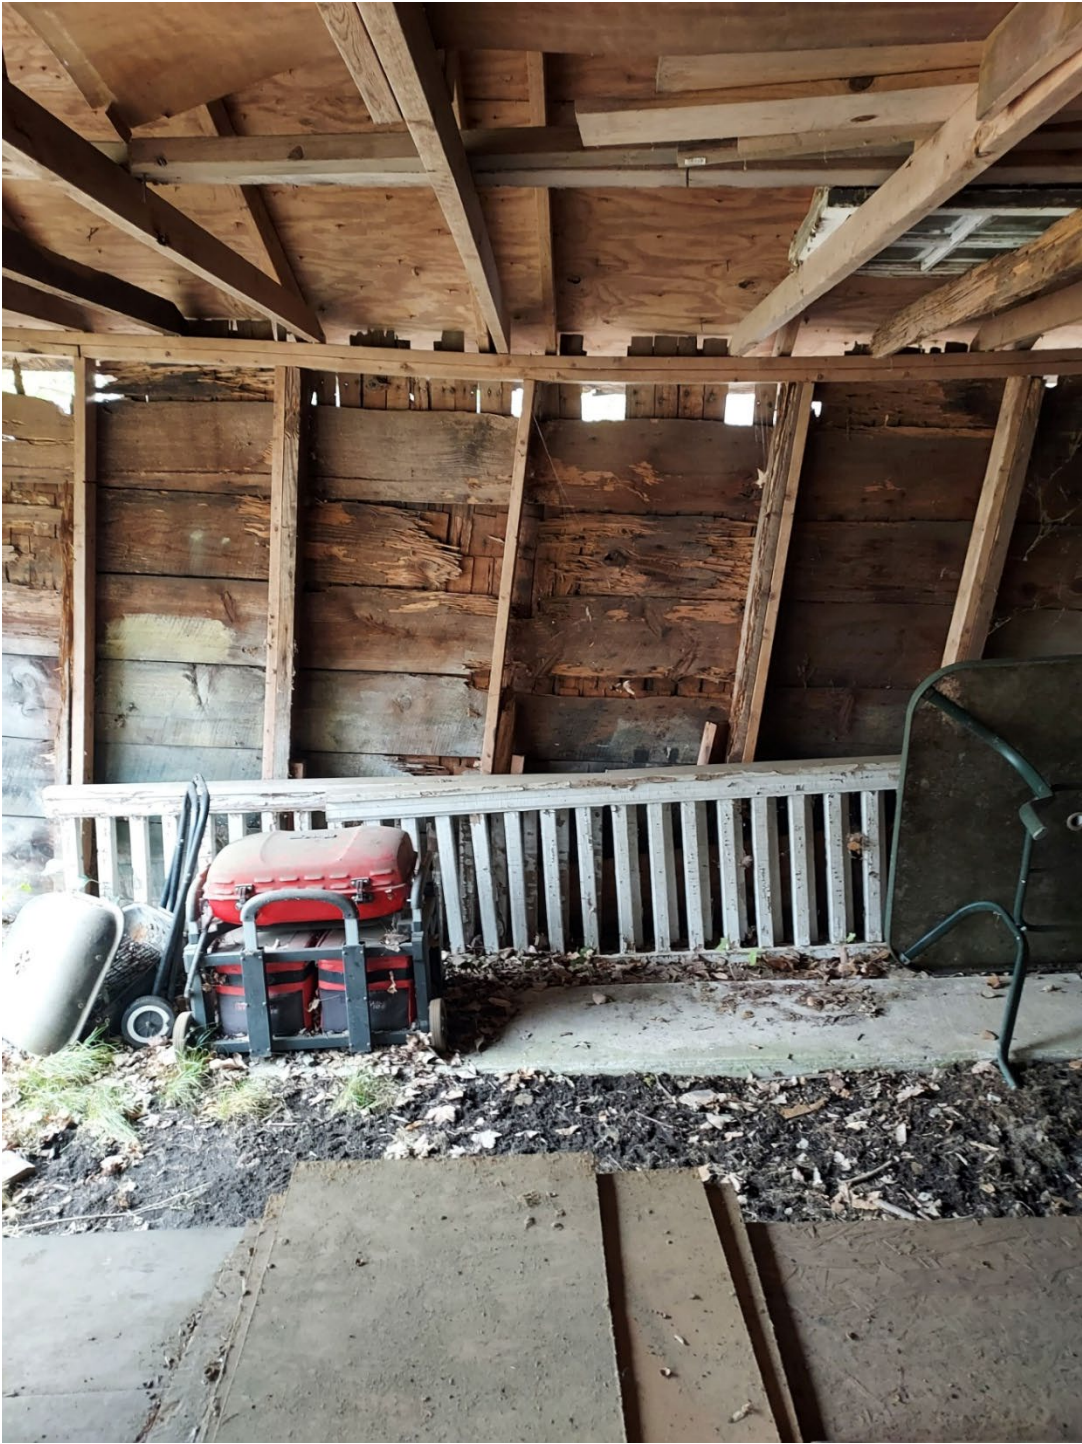
Inside West facing wall of garage, showing deterioration

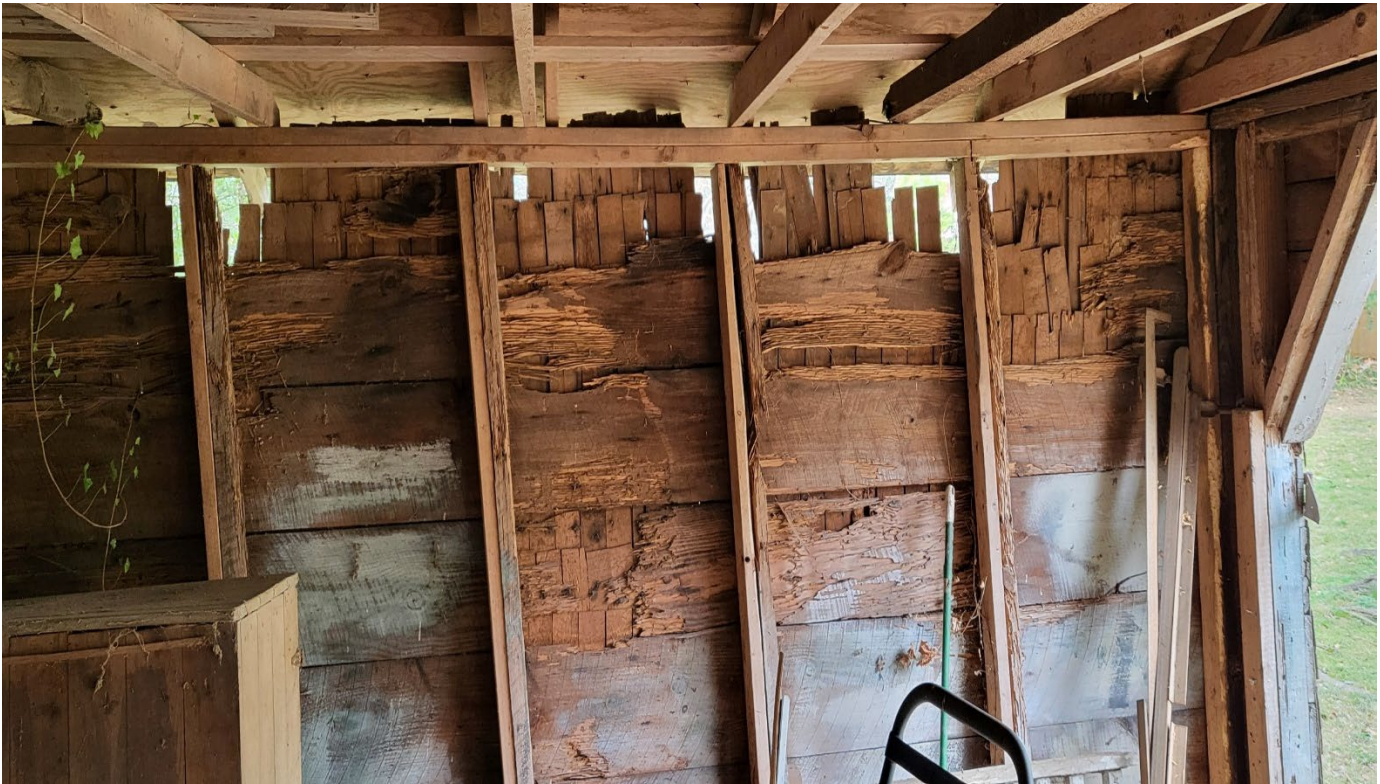
Closer view of inside West facing deteriorating wall and columns
