Thursday, April 23, 2026

RHDC - Certificate of Appropriateness Committee
05:00 PM

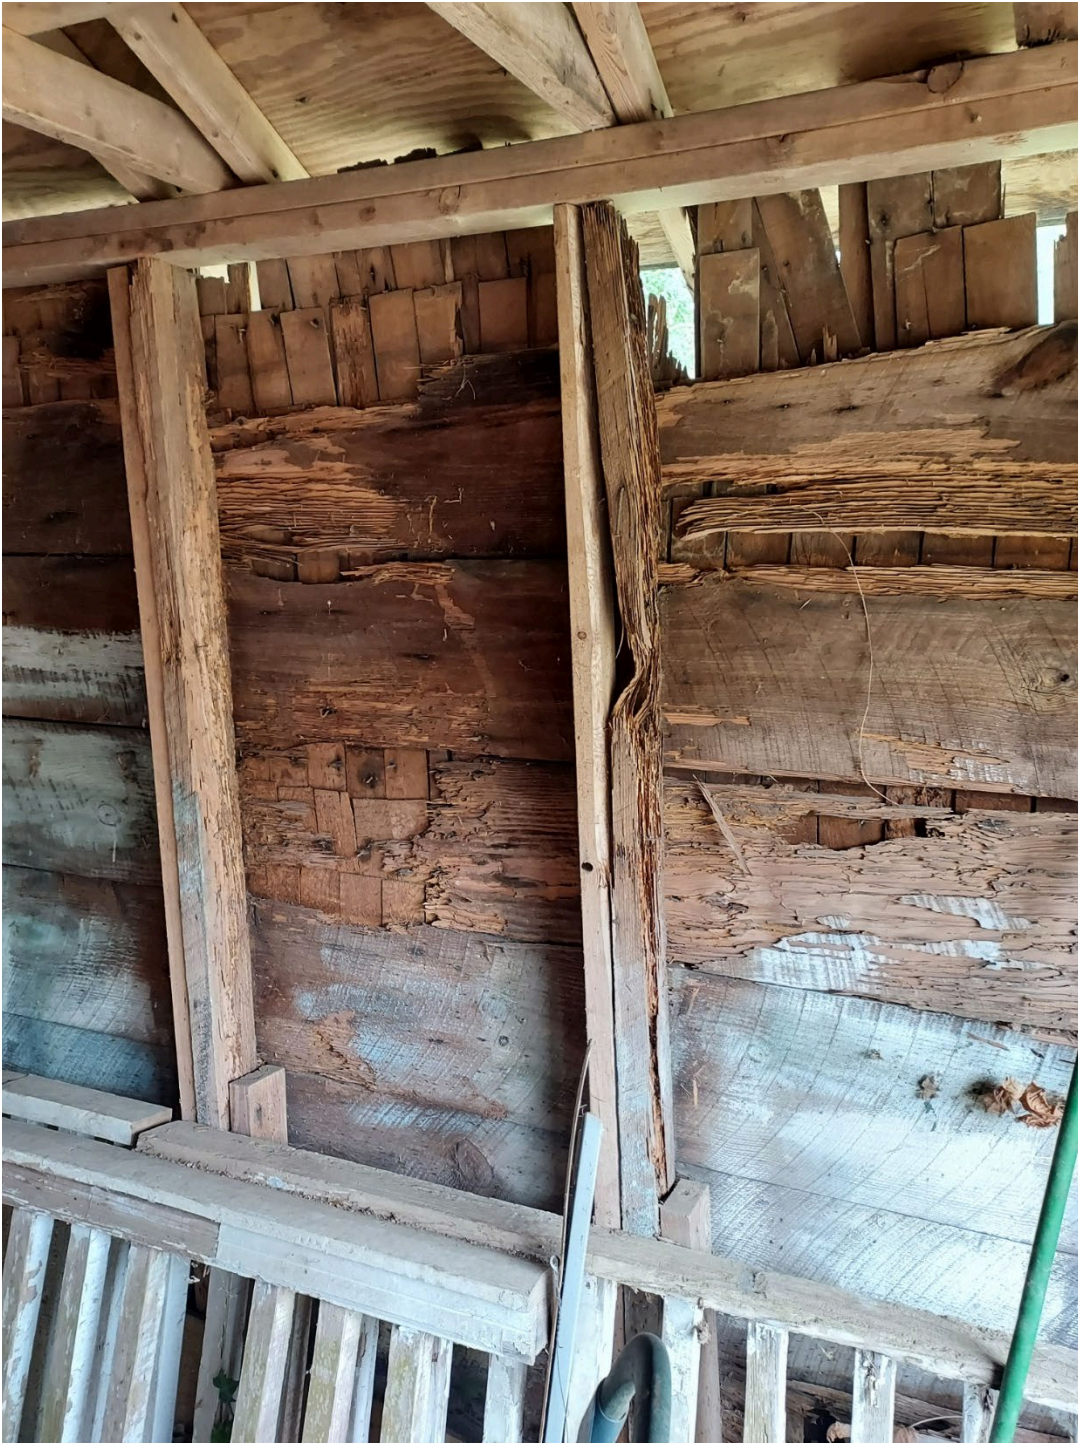
Outside West facing wall of garage, showing deterioration

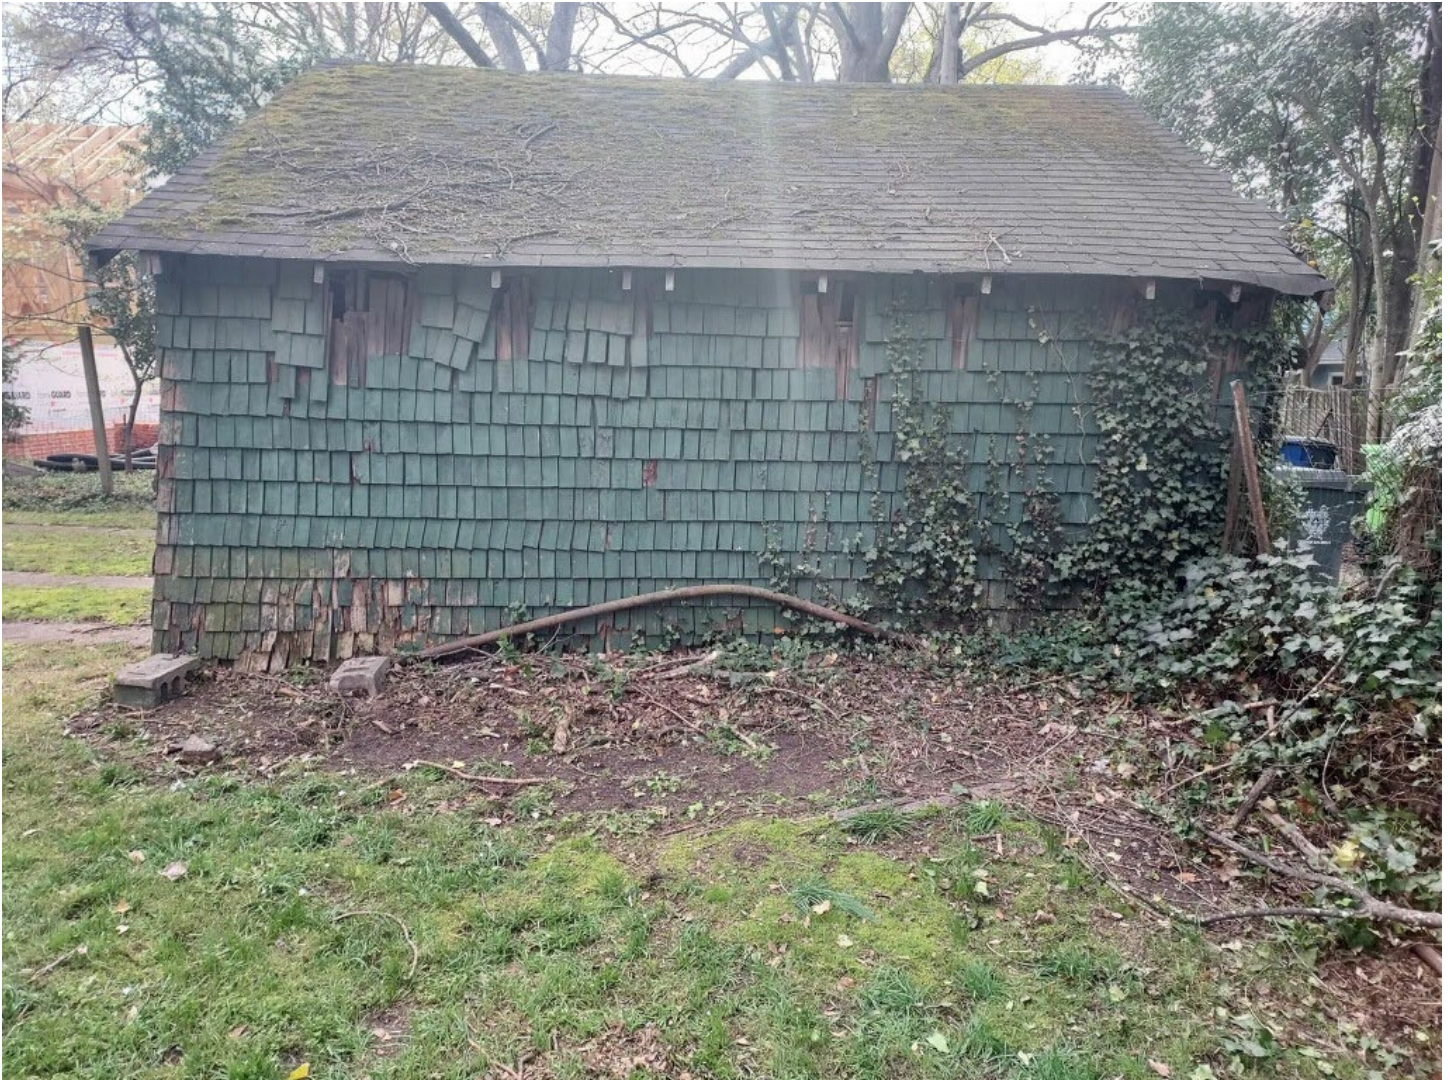
Back wall view of garage, taken from the alley behind 907 West Lenoir Street

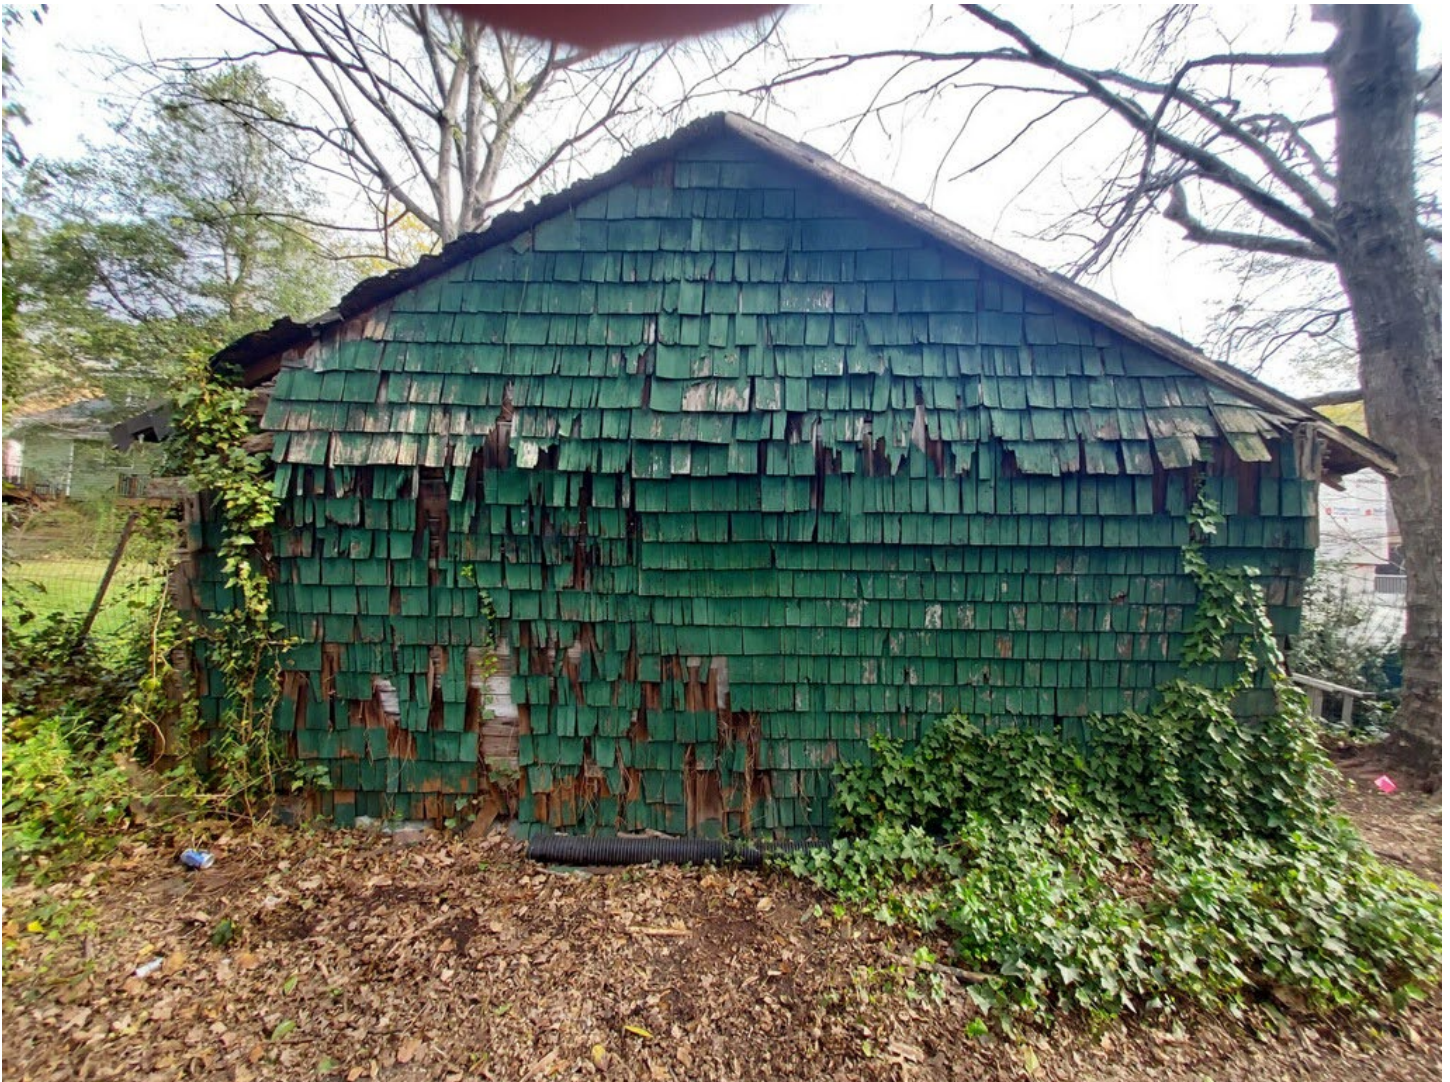
Picture 10 Detached Garage at 907 West Lenoir Street Raleigh, NC

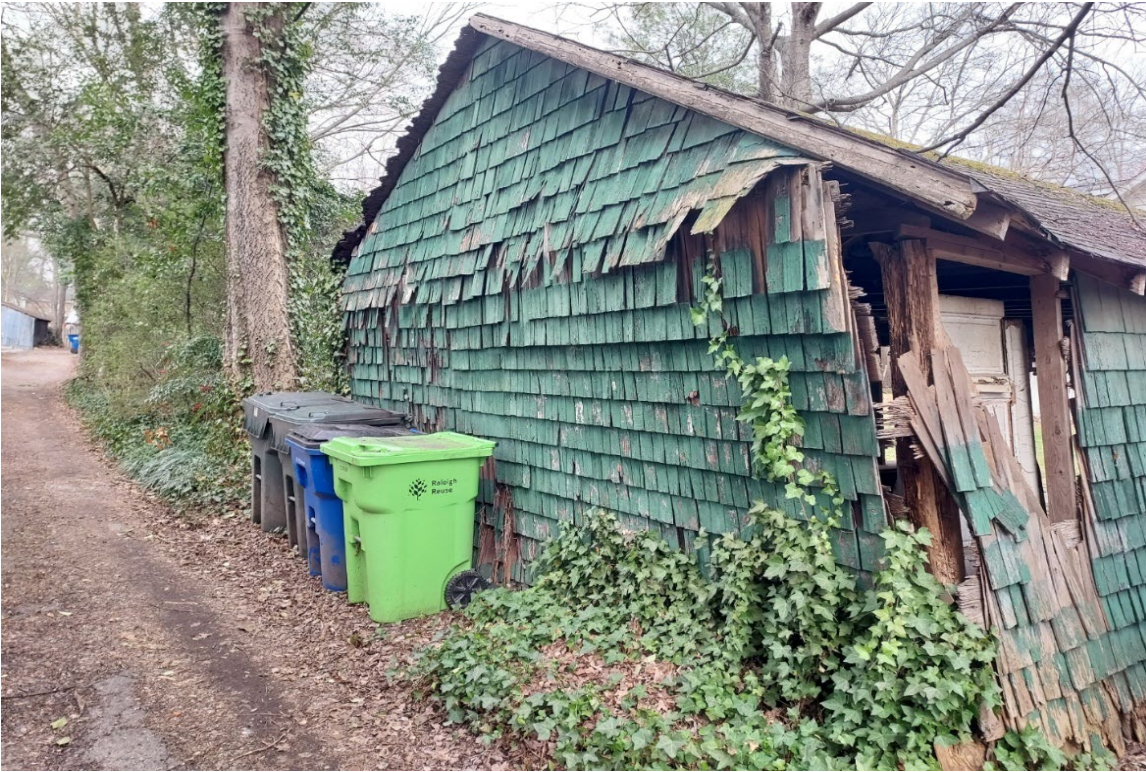
Picture 11 Detached Garage at 907 West Lenoir Street Raleigh, NC

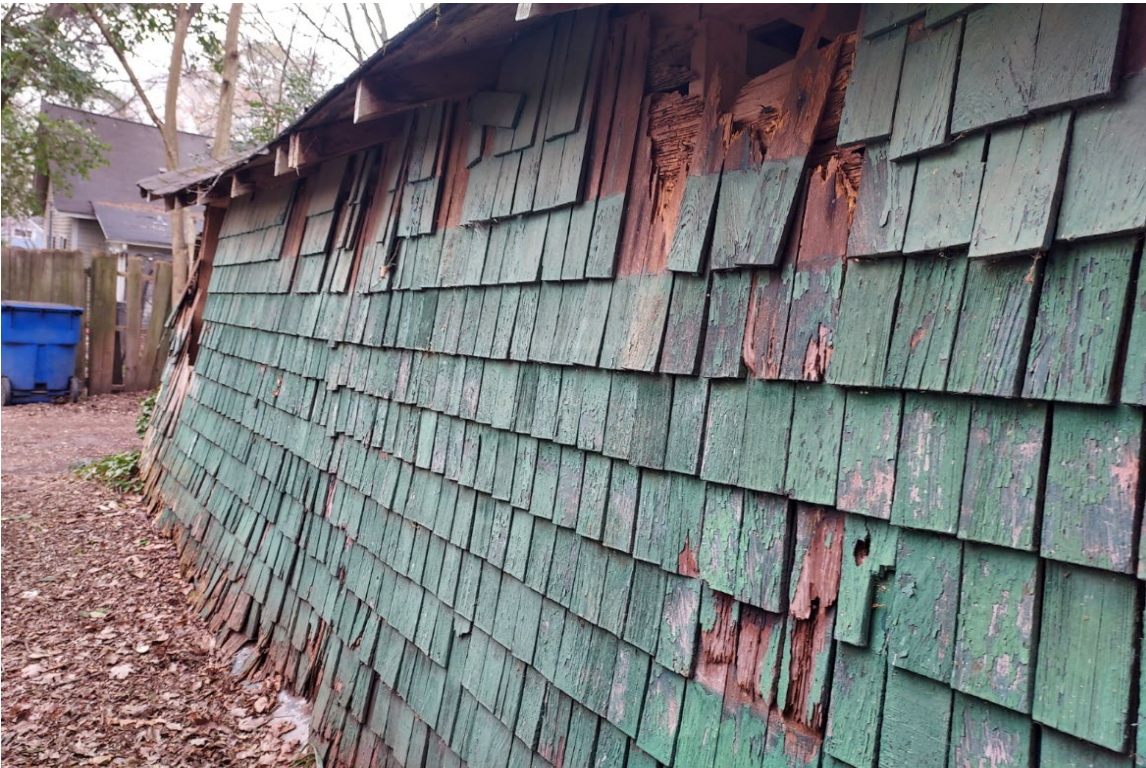
Back view of garage, taken from the alley behind 907 West Lenoir Street

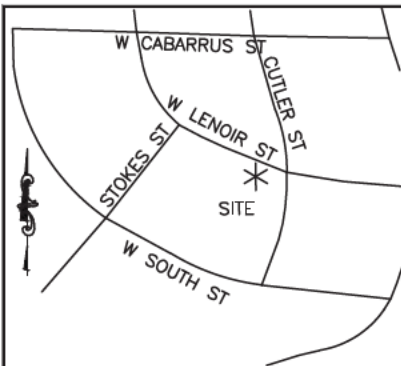
VICINITY MAP (N.T.S.)

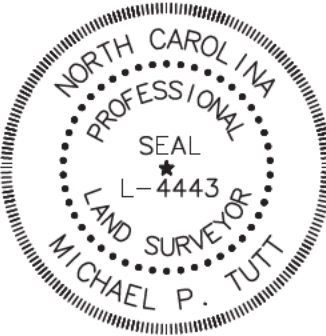
I, MICHAEL PRESTON TUTT, CERTIFY THAT THIS MAP WAS DRAWN UNDER MY SUPERVISION FROM AN ACTUAL SURVEY AND FROM REFERENCES NOTED; THAT THE RATIO OF PRECISION BEFORE ADJUSTMENTS WAS 1:71,506 WITNESS MY ORIGINAL SIGNATURE, 9TH OF MARCH, 2026.
