File #: COA-0037-2026

Property street address: 209 S. Wilmington St

Historic district: Moore Square

## 209 S Wilmington St. COA for Demolition (COA-0037-2026)

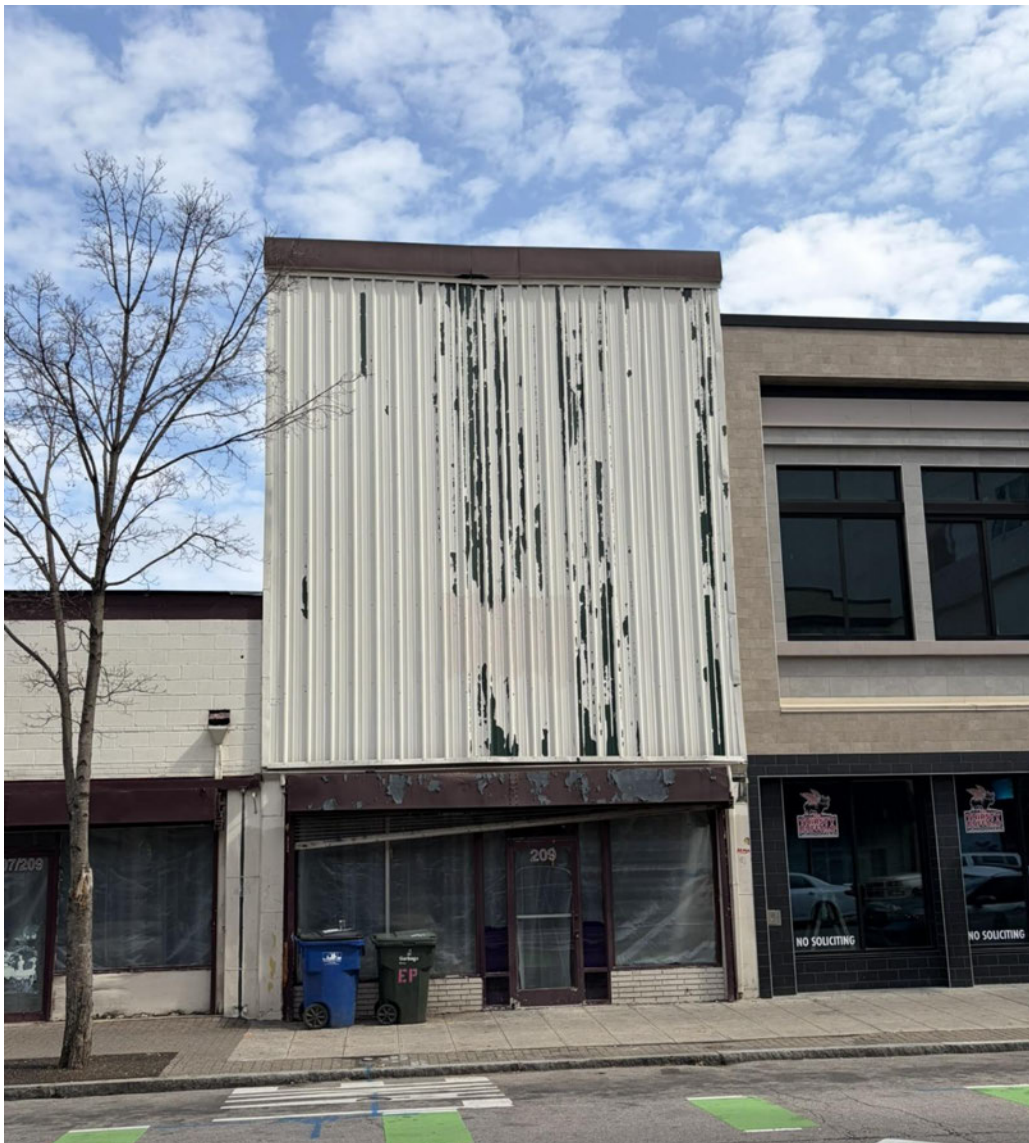
The original masonry façade has been covered on the upper two stories with first a Portland based stucco and wire lath, and then with a painted metal cladding. Unfortunately, the wire lath and stucco appear to have been attached and then rendered directly to the brick, rather than on furring strips. It is likely, given the age of the brick and installation methods of the stucco, removal will damage the brick beneath beyond the point of salvage or repair. Original double hung windows are completely missing from 2<sup>nd</sup> floor and the sashes that are in place on 3<sup>rd</sup> are tacked in place, and questionable if original. The original storefront has been completely removed.

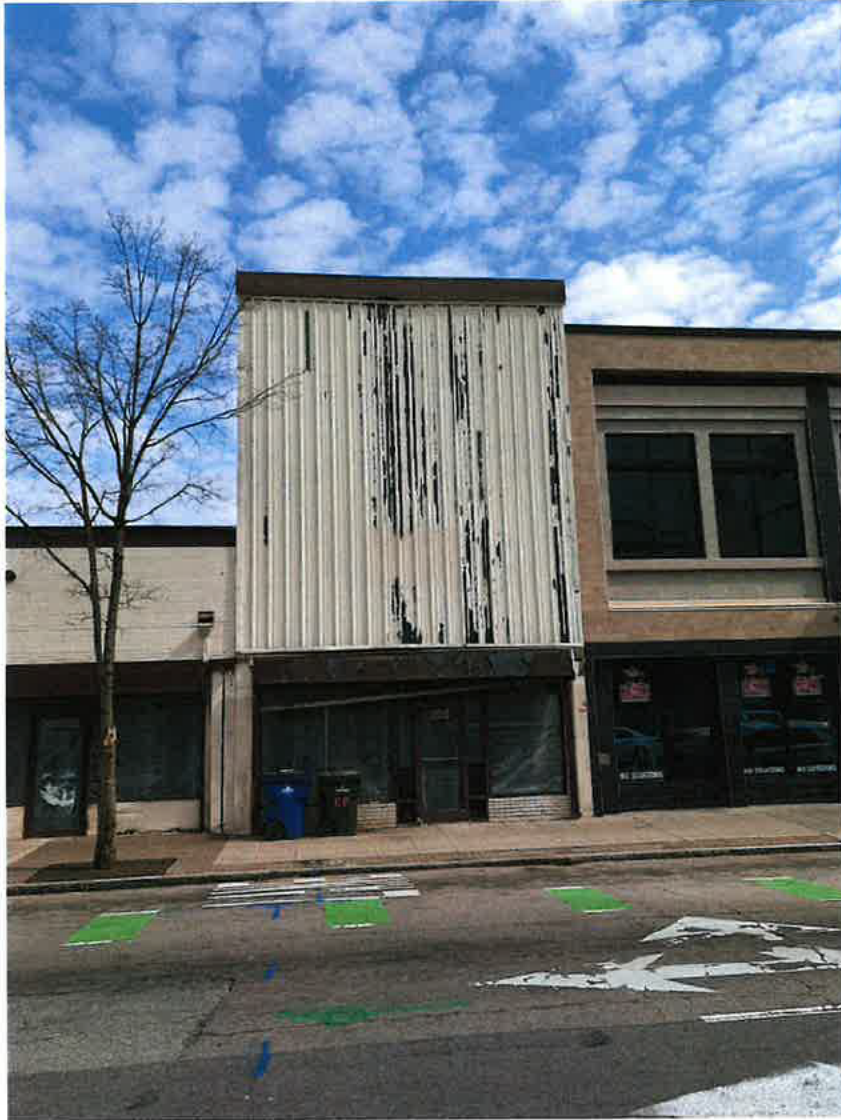
Photo 1: 209 S. Wilmington St Raleigh, NC (03/9/2026) Front Façade

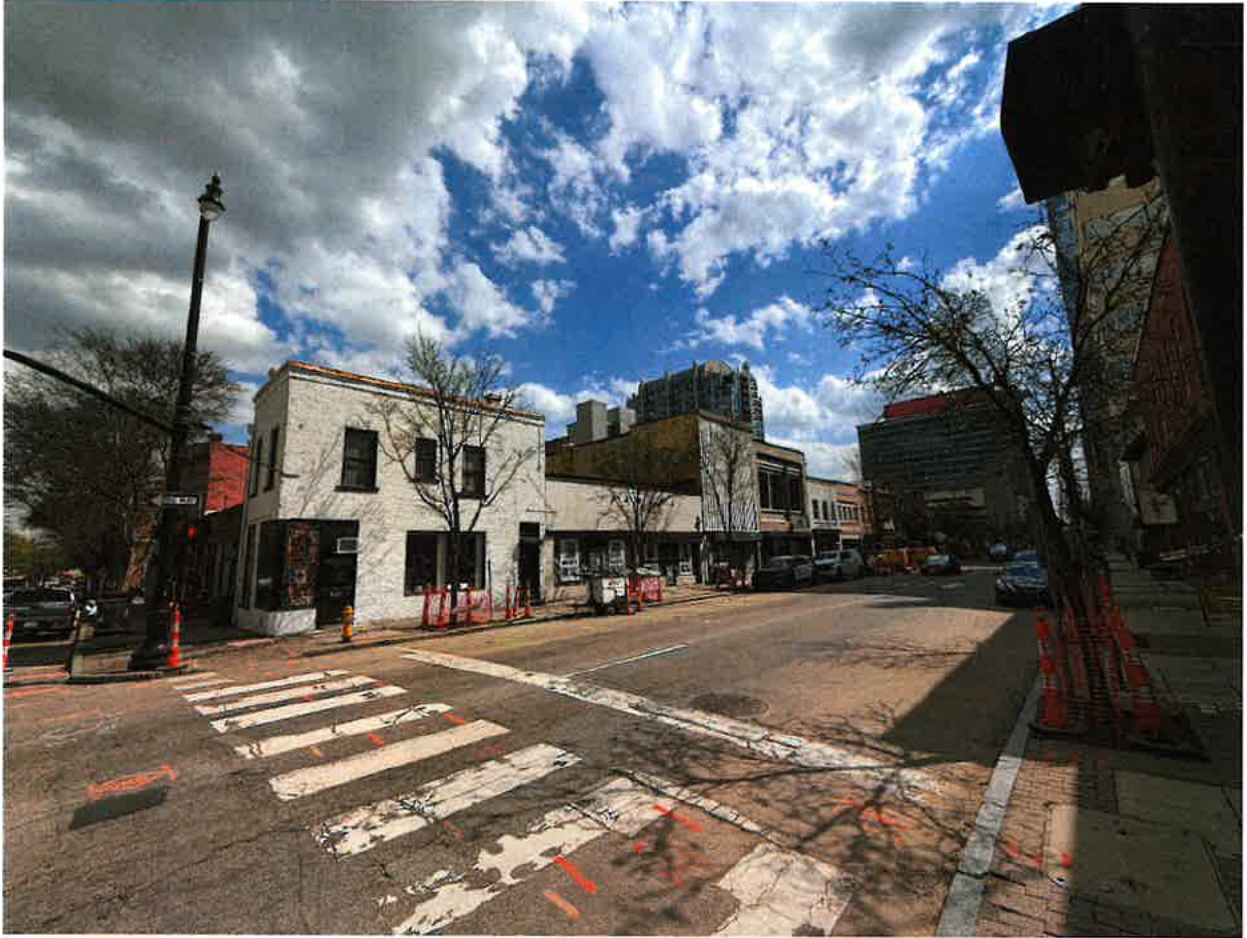
Photo 2: 209 S. Wilmington St. Raleigh, NC (03/19/2026) View from Wilmington and Hargett Facing Southeast

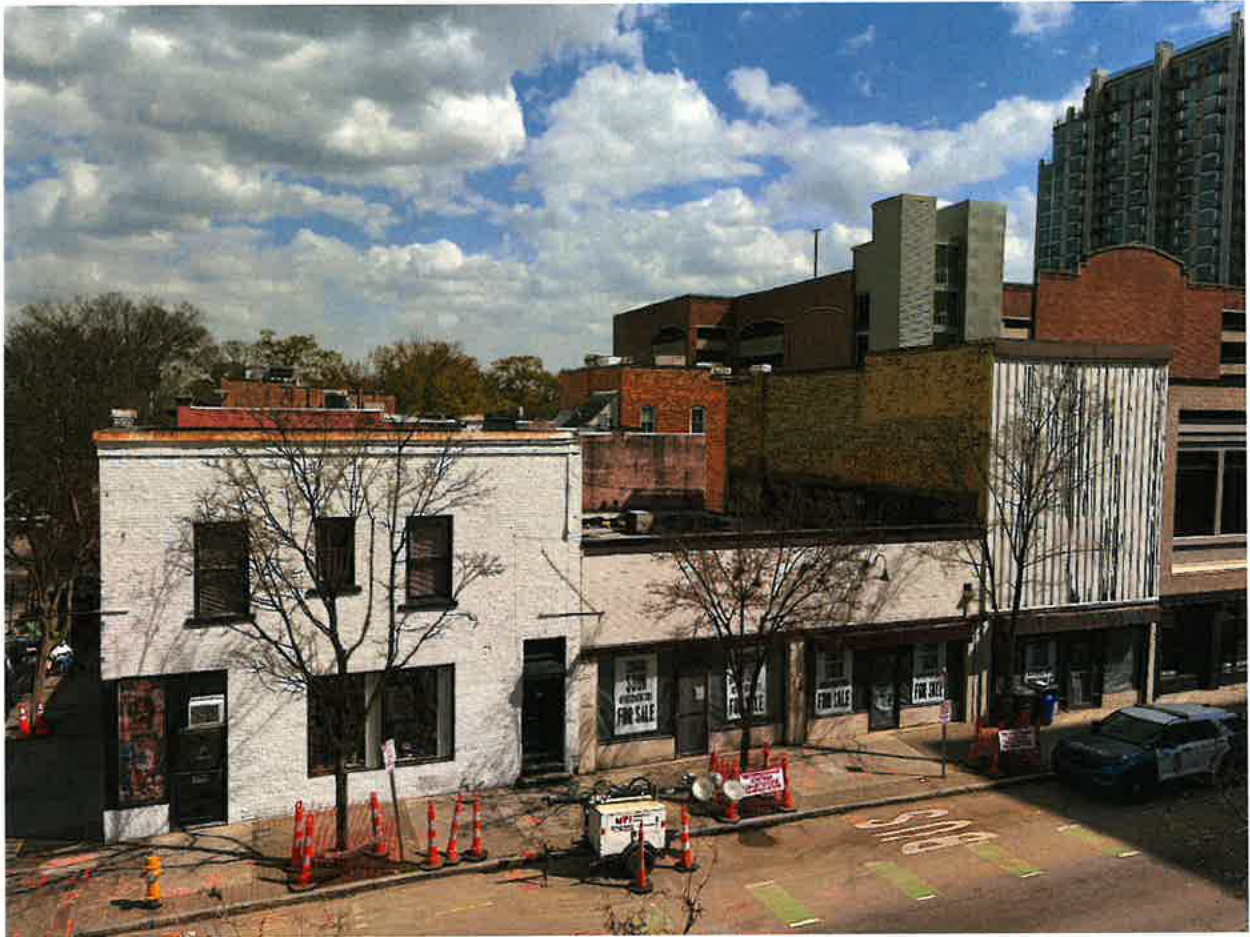
Photo 3: 209 S. Wilmington St. Raleigh, NC (03/19/2026) View from 20 E Hargett St Rooftop

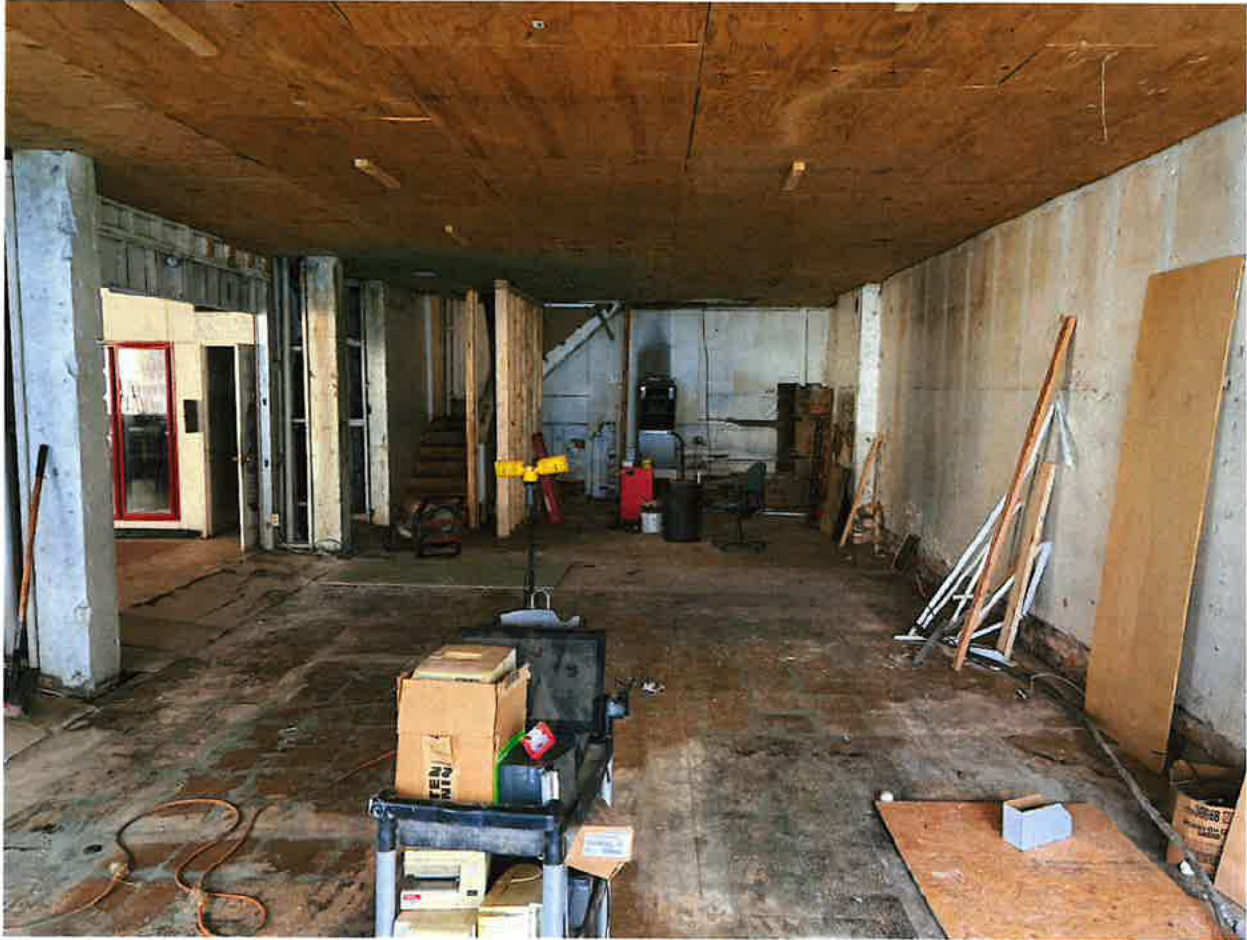
Photo 4: 209 S Wilmington Raleigh, NC (03/19/2026) 1<sup>st</sup> floor, Interior Facing East. No original ceiling material remains, all plywood clad in floor joists. Rear stairs are not original and in disrepair.

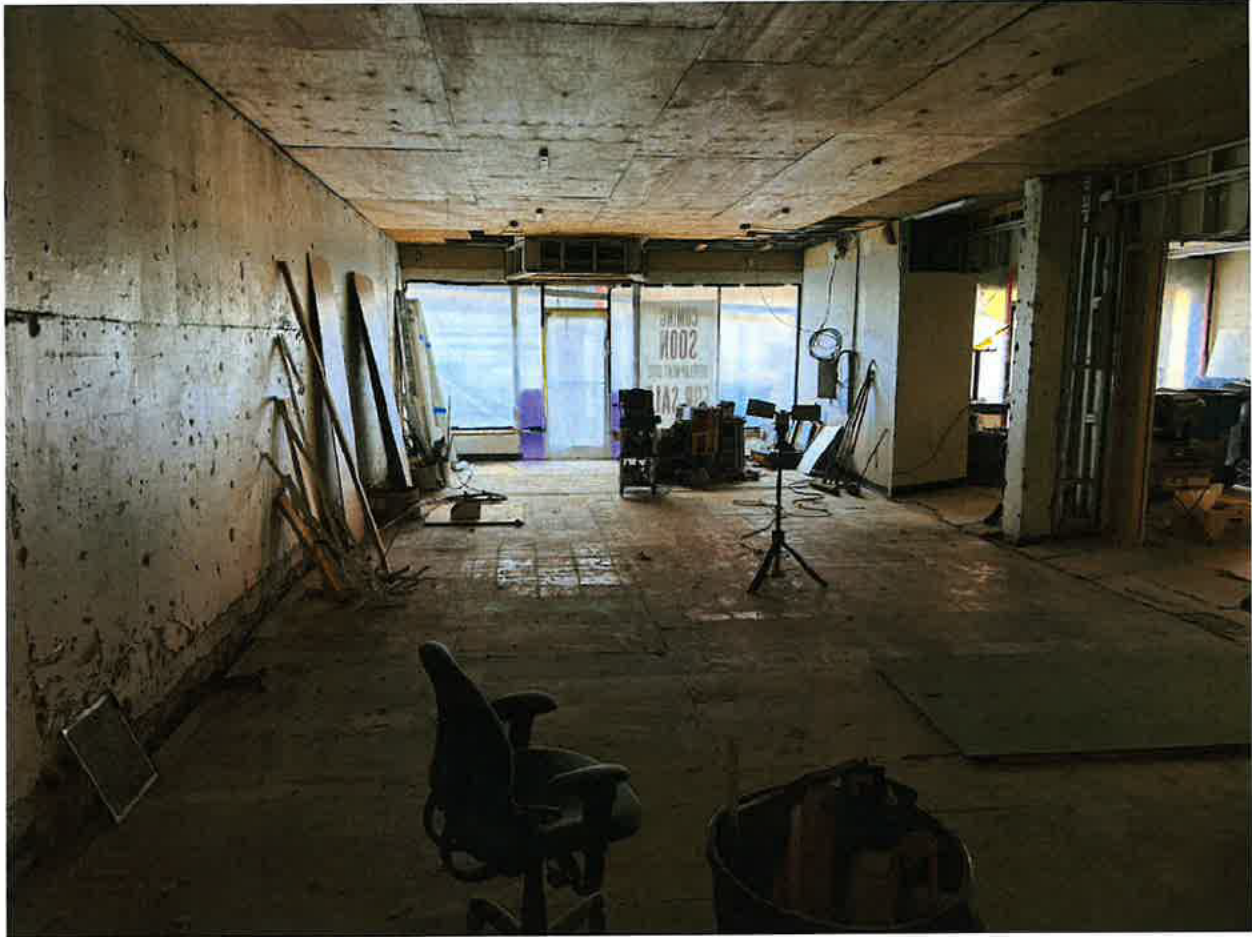
Photo 5: 209 S Wilmington Raleigh, NC (03/19/2026) 1<sup>st</sup> floor, Interior Facing West. In addition to the original storefront, much of the first-floor framing has been replaced and none of the original flooring remains.

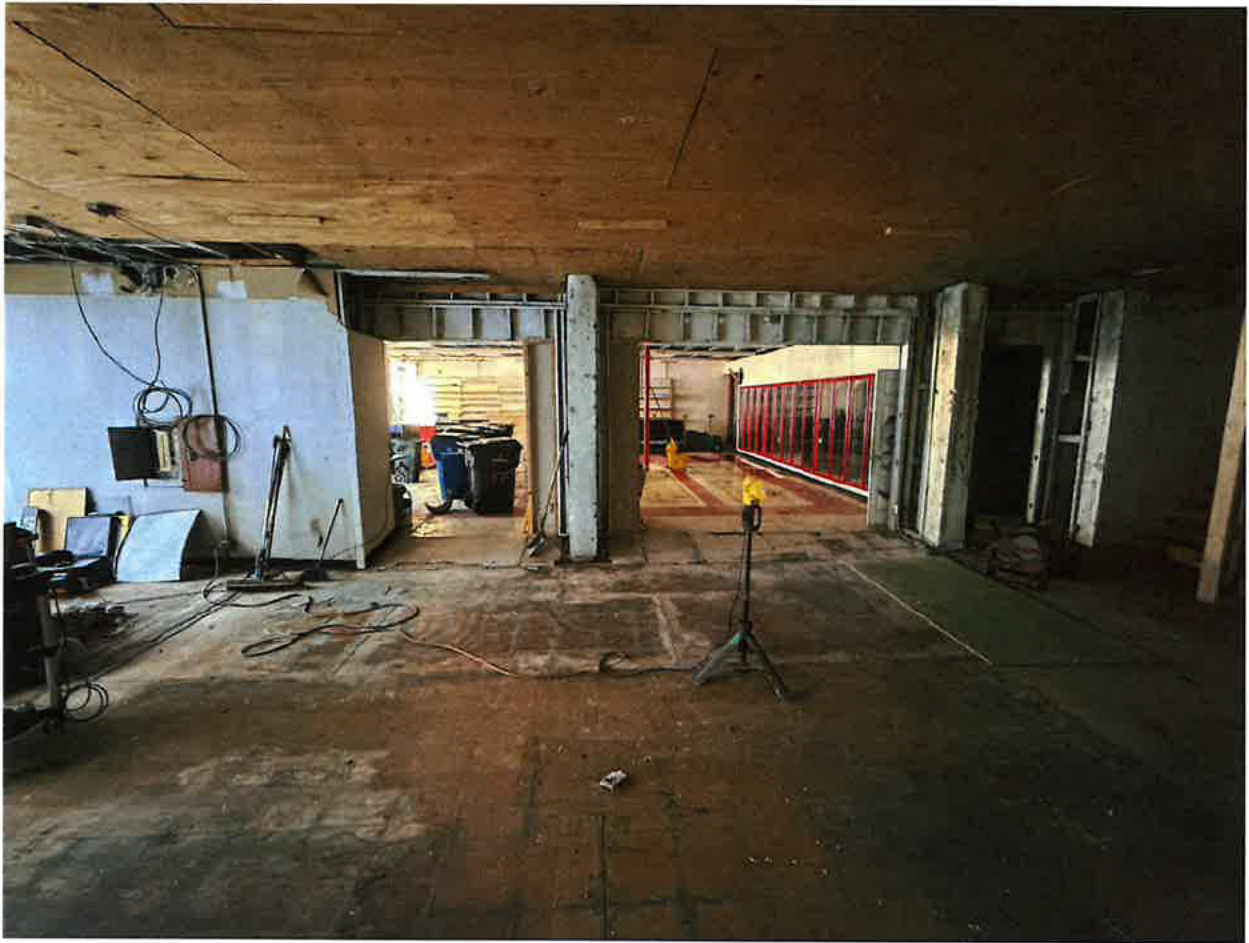
Photo 6: 209 S Wilmington Raleigh, NC (03/19/2026) 1<sup>st</sup> floor interior facing North, looking in to 205 . The north masonry wall on the 1<sup>st</sup> floor has been removed and replaced with steel columns and beams.

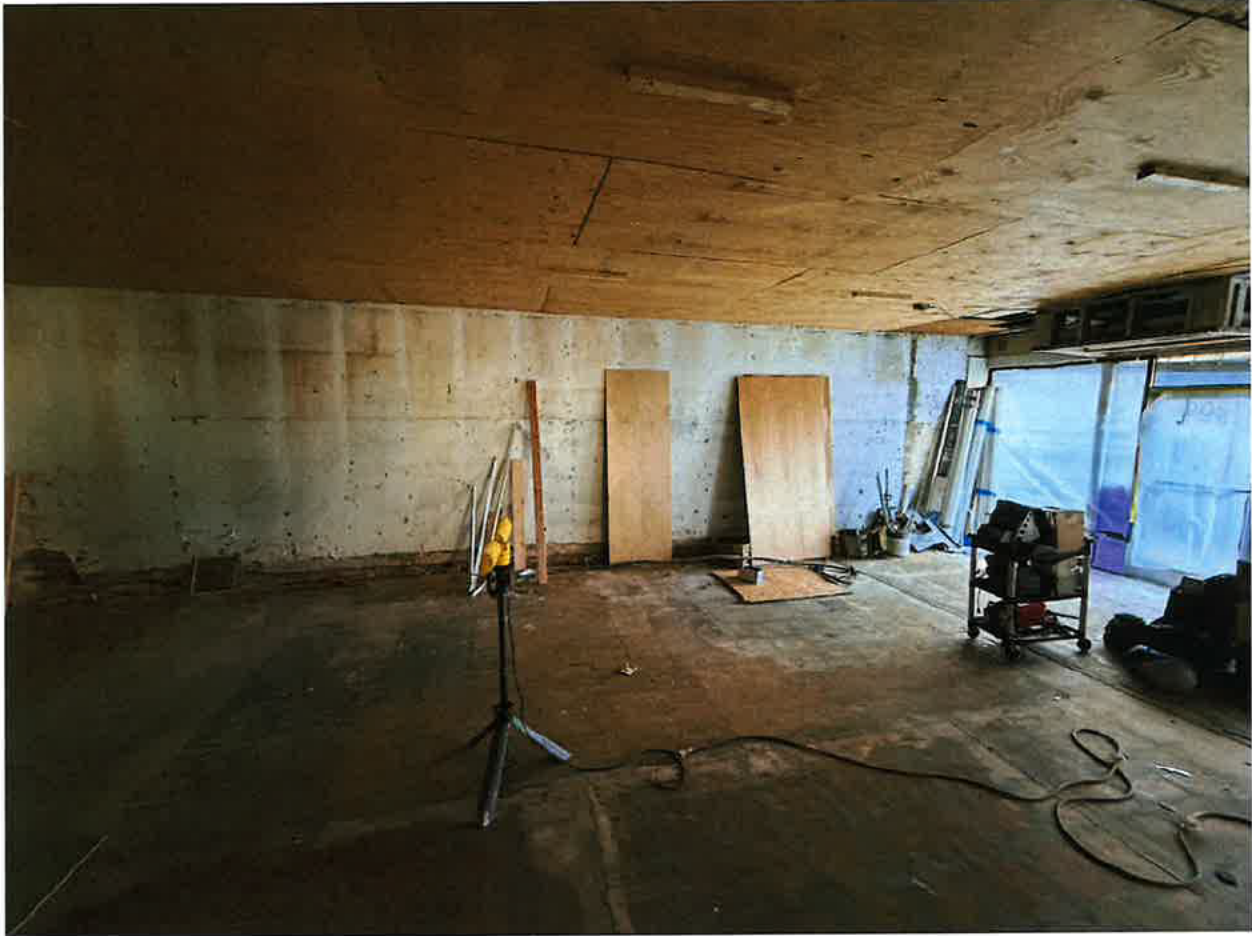
Photo 7: 209 S Wilmington Raleigh, NC (03/19/2026) 1<sup>st</sup> floor Interior Facing South West. Appears to be a separate, non-party wall with adjacent 211 S Wilmington St. building.

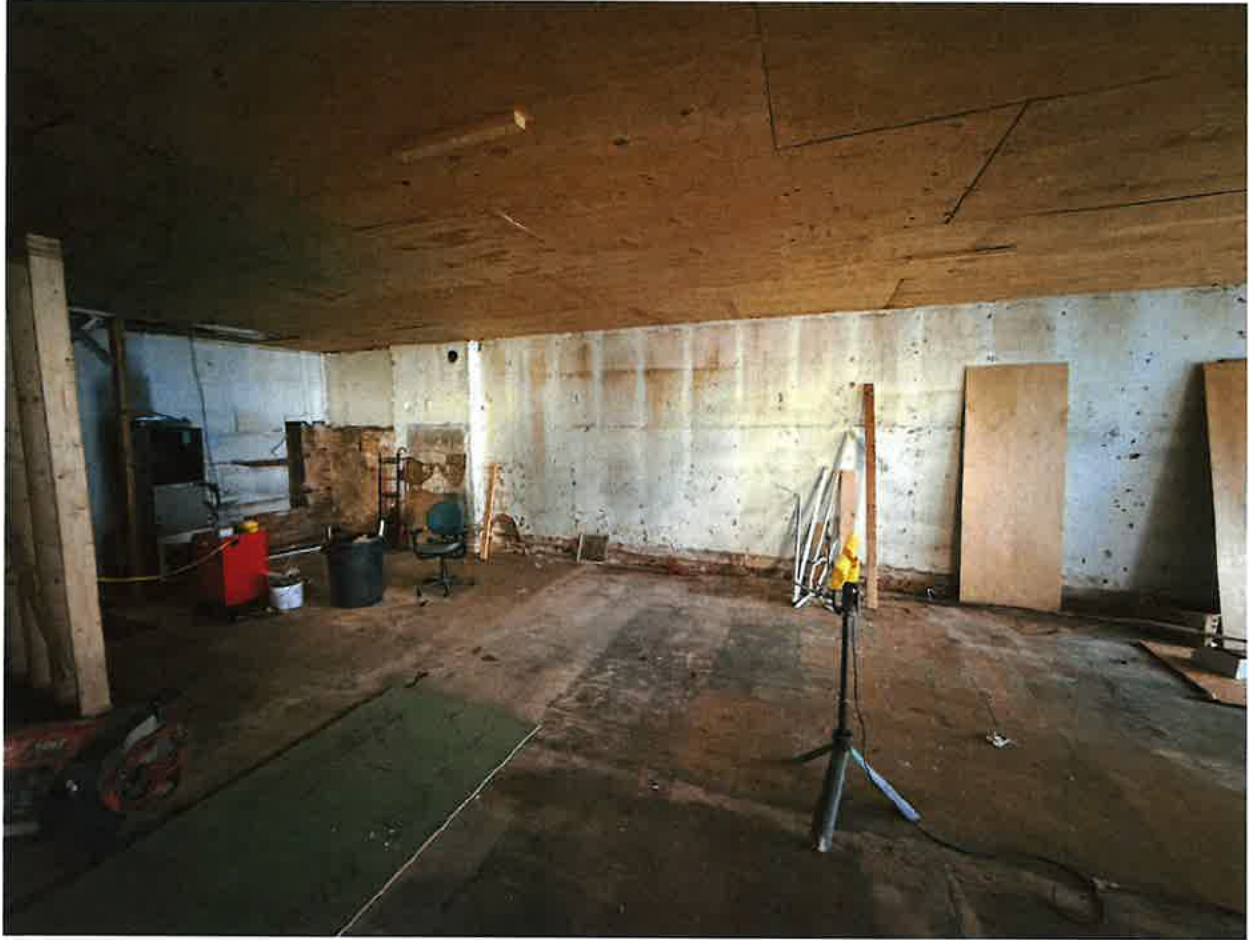
Photo 8: 209 S Wilmington Raleigh, NC (03/19/2026) 1<sup>st</sup> floor Interior Facing South East

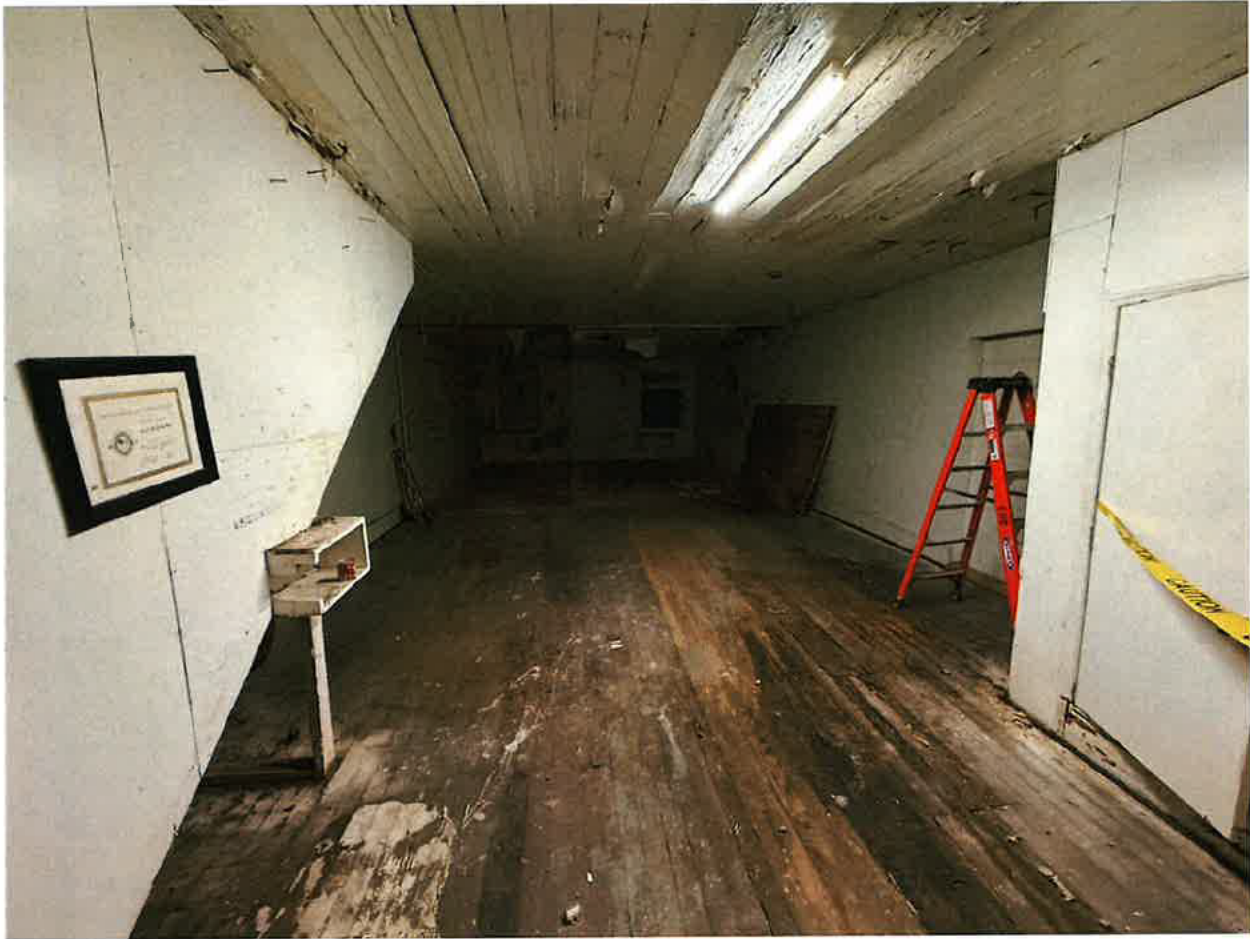
Photo 9: 209 S Wilmington Raleigh, NC (03/19/2026) 2<sup>nd</sup> floor Interior Facing West (Wilmington St) Wood flooring has been patched several times and is rotting. Same for T&G ceiling.

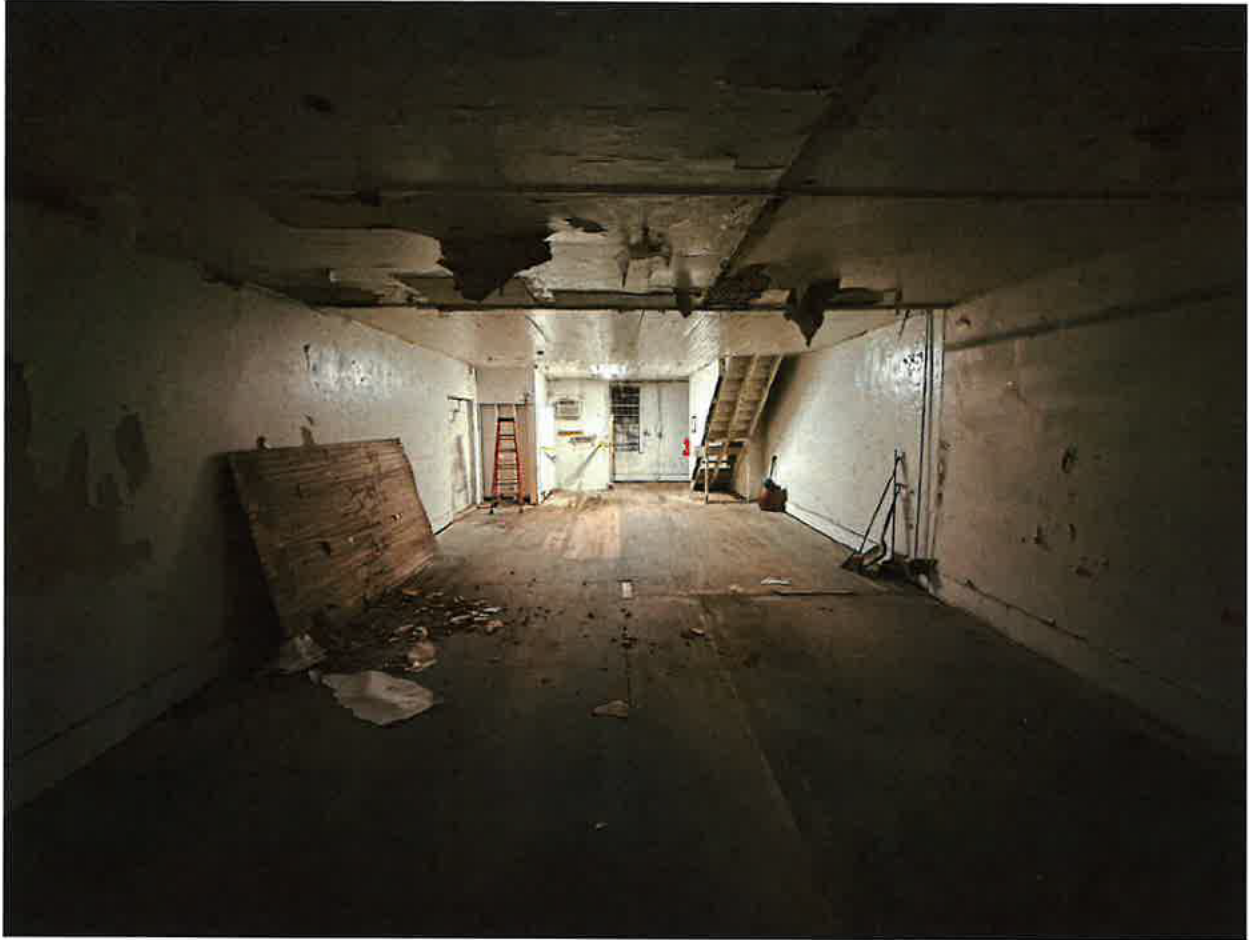
Photo 10: 209 S Wilmington Raleigh, NC (03/19/2026) 2<sup>nd</sup> floor Interior Facing East (rear alley)

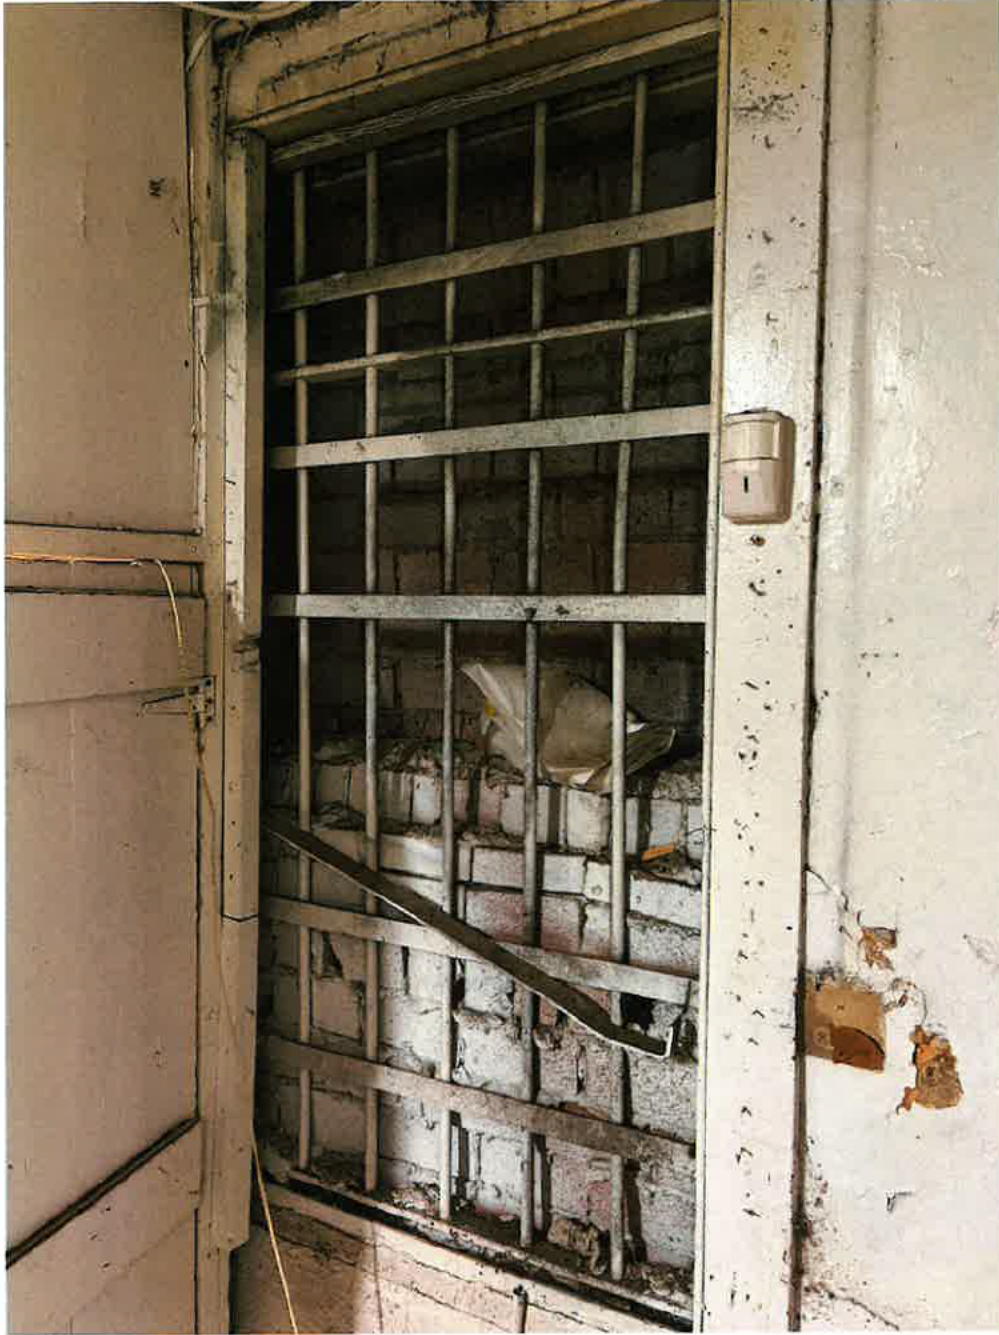
Photo 11: 209 S Wilmington Raleigh, NC (03/19/2026) 2<sup>nd</sup> floor, rear bricked in window. All doorways and window openings on the rear façade are bricked up with little or no remaining millwork.

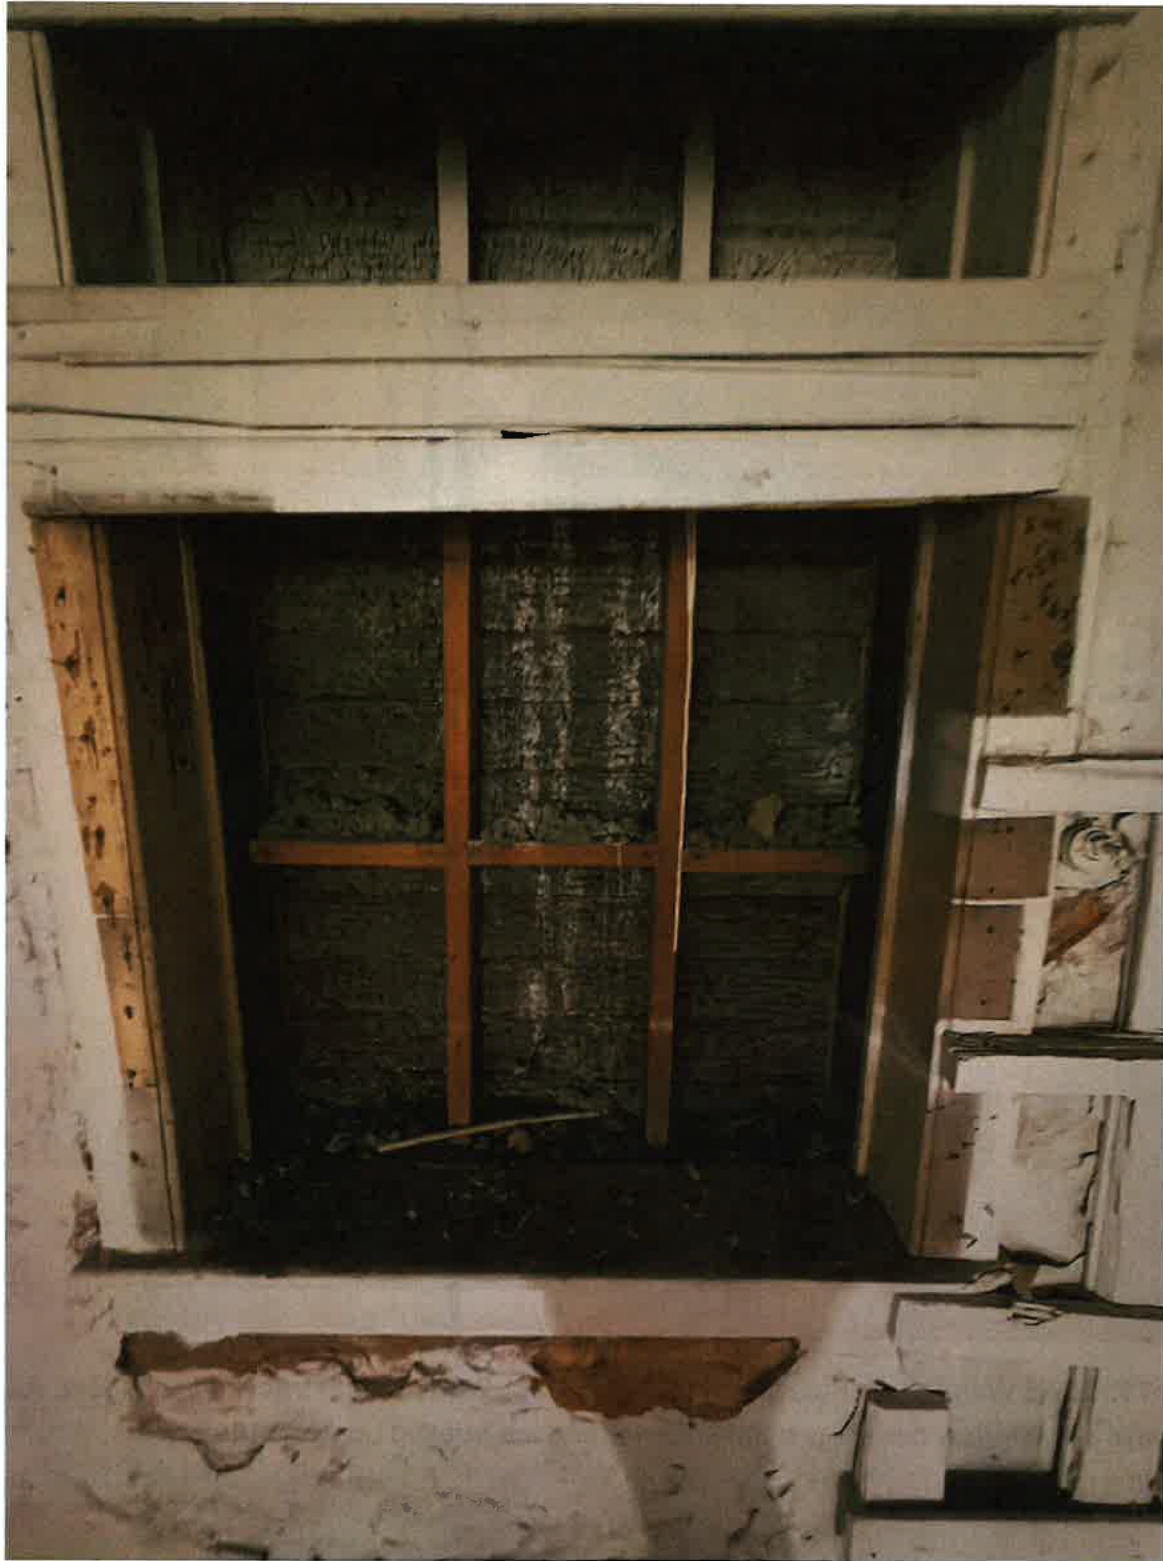
Photo 12: 209 S Wilmington Raleigh, NC (03/19/2026) 2<sup>nd</sup> floor, front window opening with wire lath and Portland based stucco rendering directly to the masonry façade. No sashes and little or no original millwork.

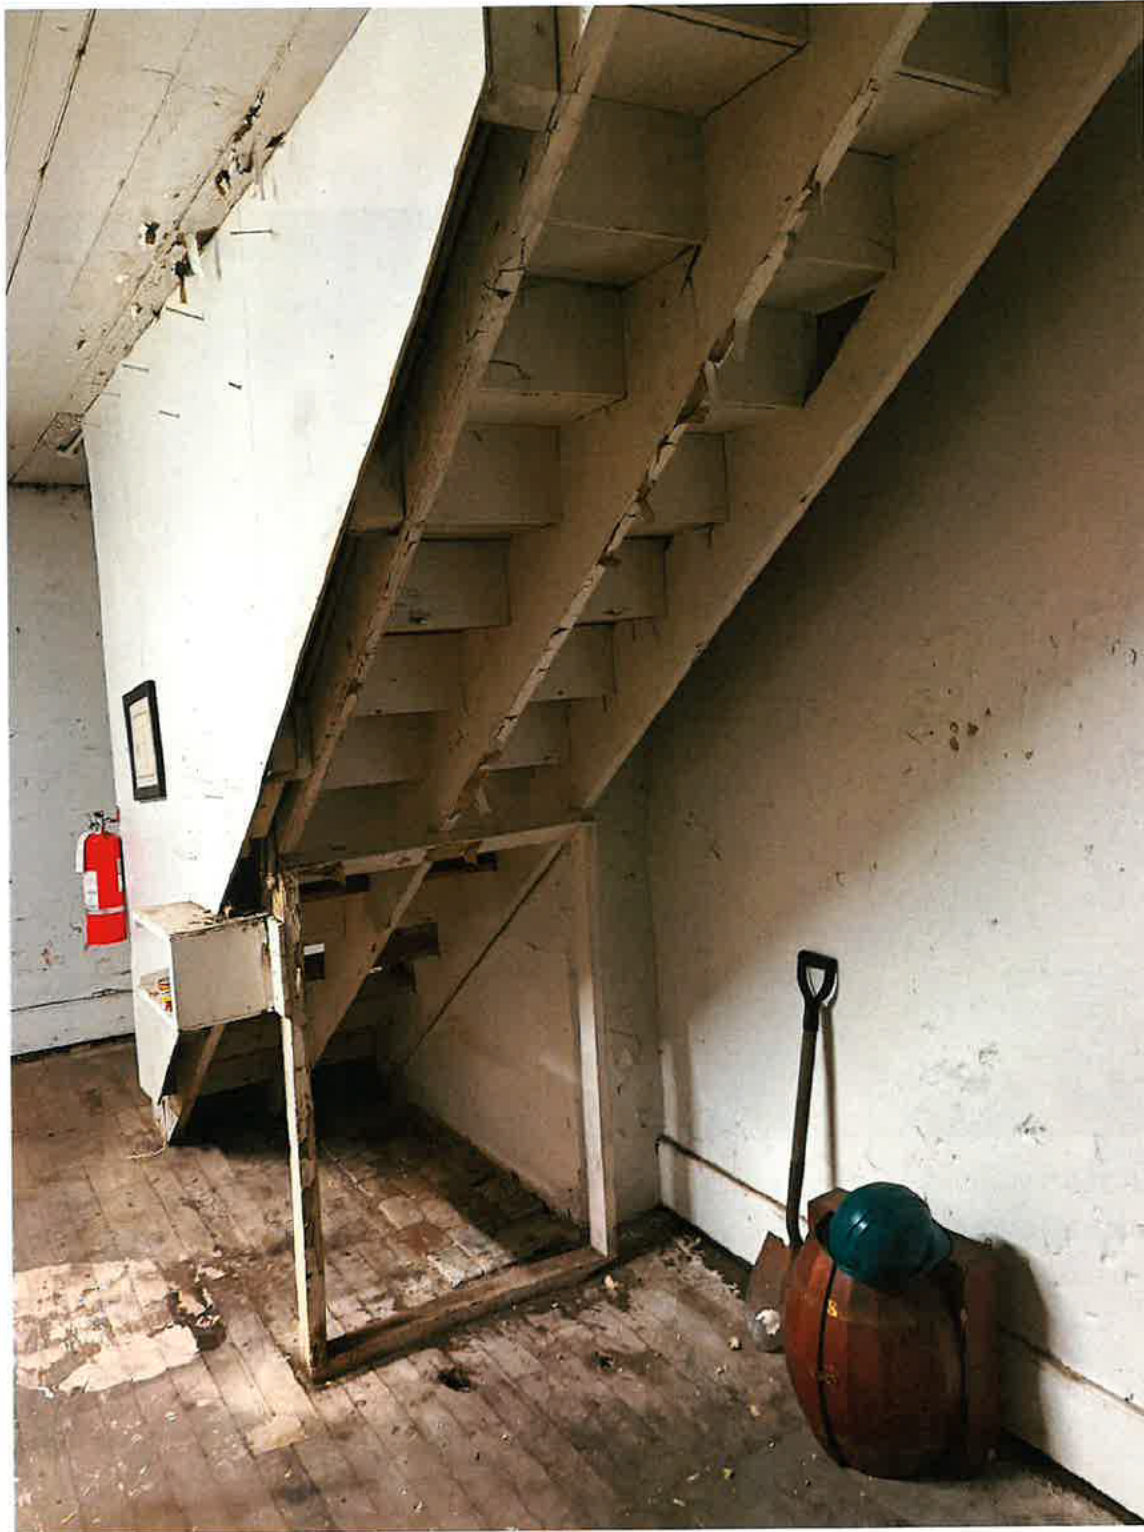
Photo 13: 209 S Wilmington Raleigh, NC (03/19/2026) 2<sup>nd</sup> floor, non-original stair to 3<sup>rd</sup> floor

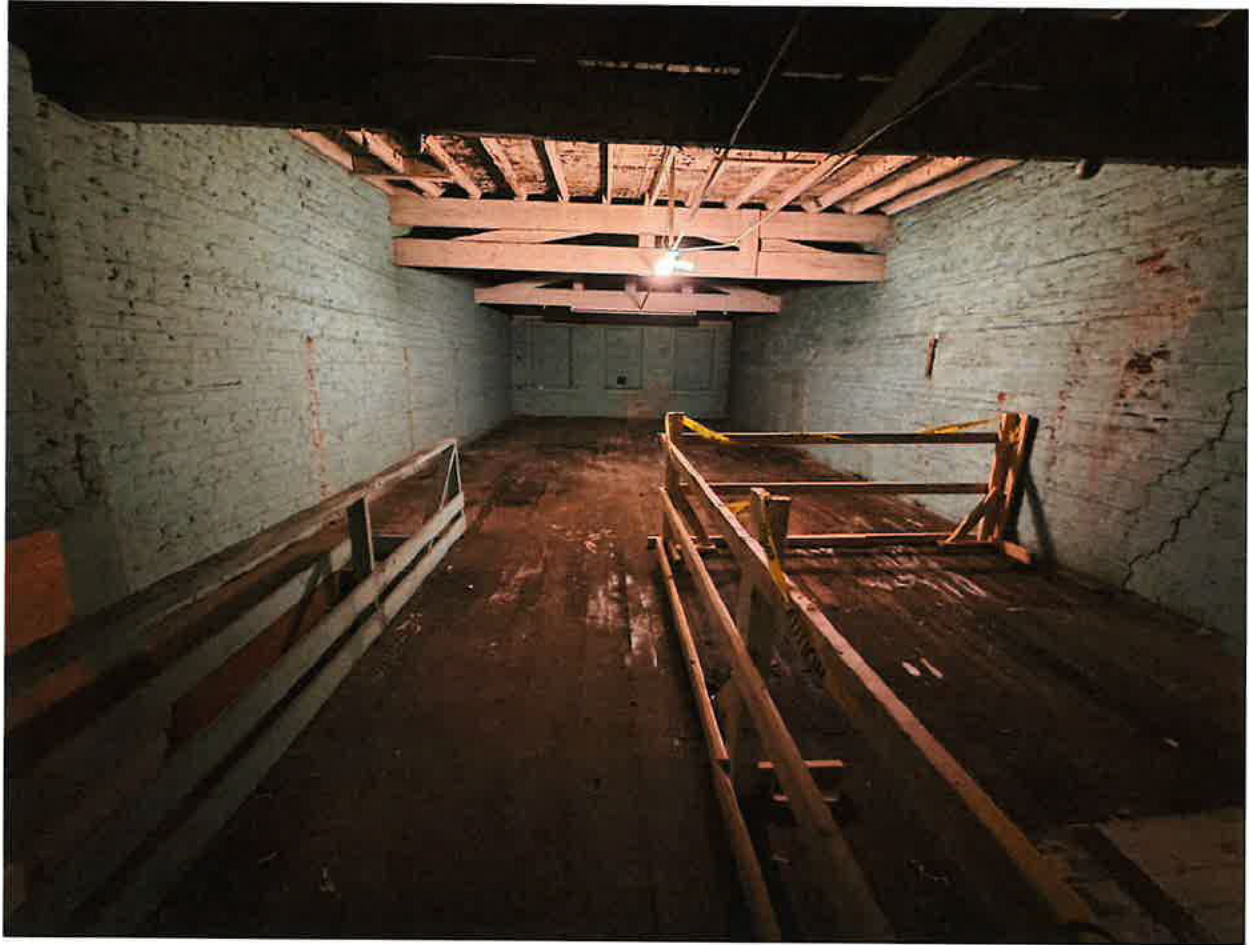
Photo 14: 209 S Wilmington Raleigh, NC (03/19/2026) 3<sup>rd</sup> floor Interior Facing East (Wilmington St) Significant rot on hardwood flooring and severe damage to floor and roof structures as well large cracking on North and South masonry walls.

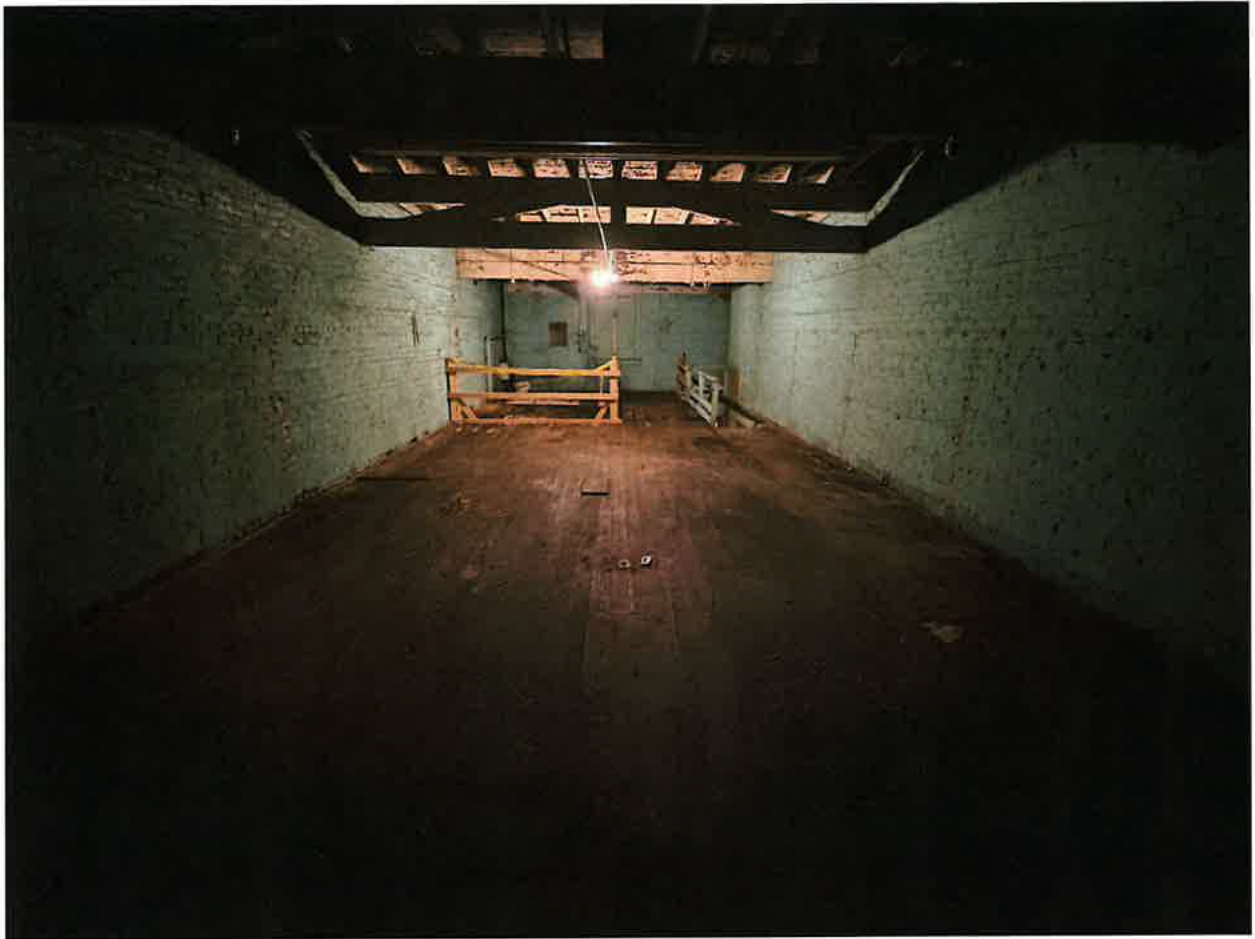
Photo 15: 209 S Wilmington Raleigh, NC (03/19/2026) 3<sup>rd</sup> floor Interior Facing West

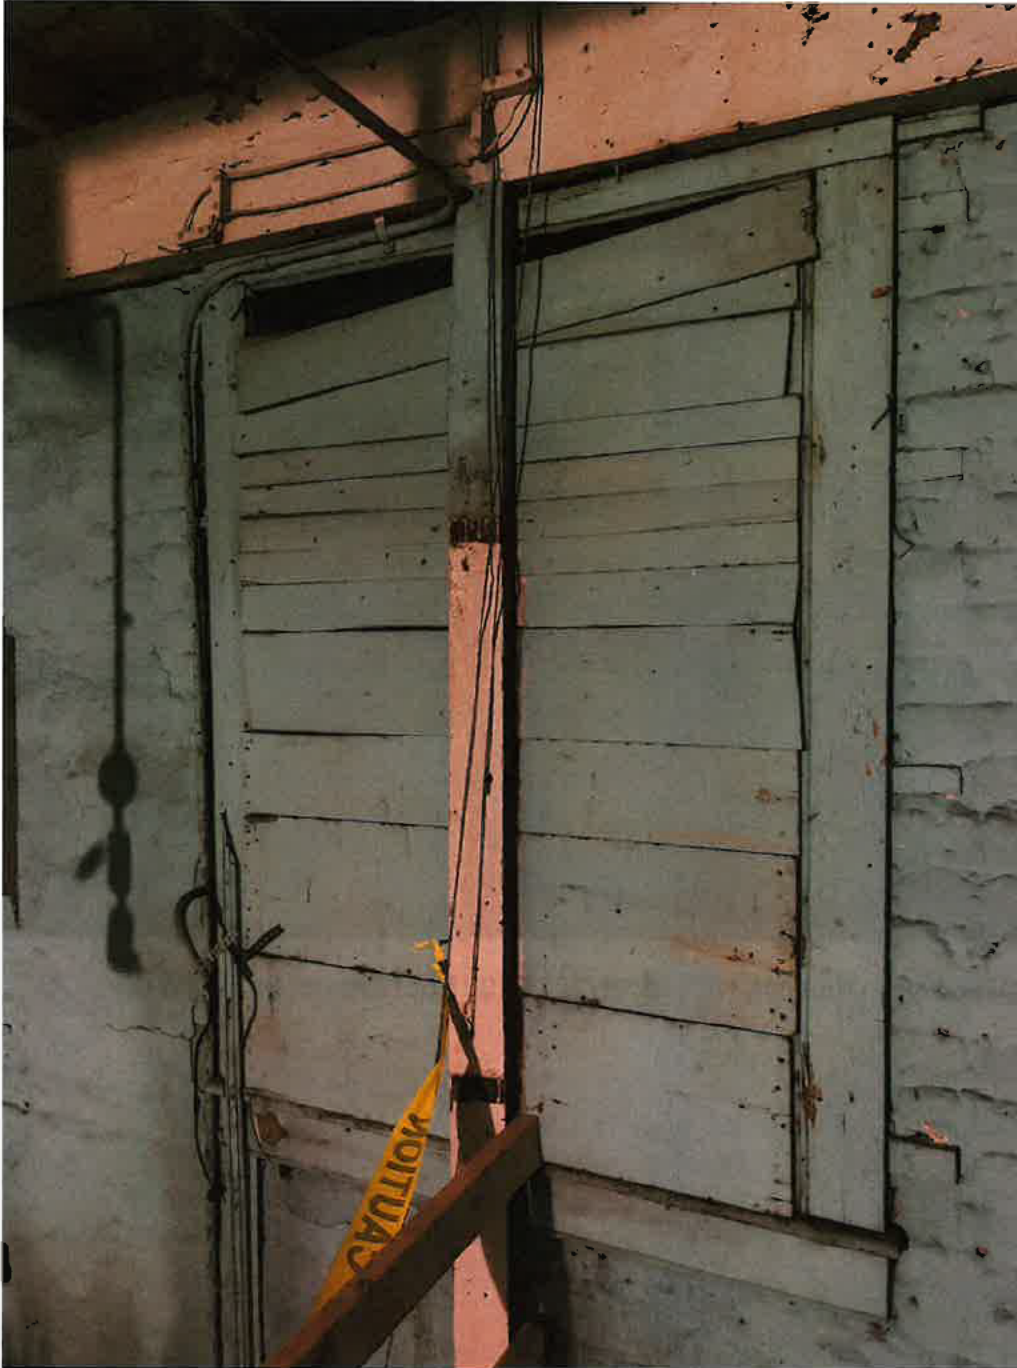
Photo 16: 209 S Wilmington St Raleigh, NC (03/19/2026) 3<sup>rd</sup> floor rear bricked in and boarded up window openings with little remaining millwork.
