File #: COA-0037-2026

Property street address: 209 S. Wilmington St

Historic district: Moore Square

## 209 S Wilmington St. COA for Demolition (COA-0037-2026)

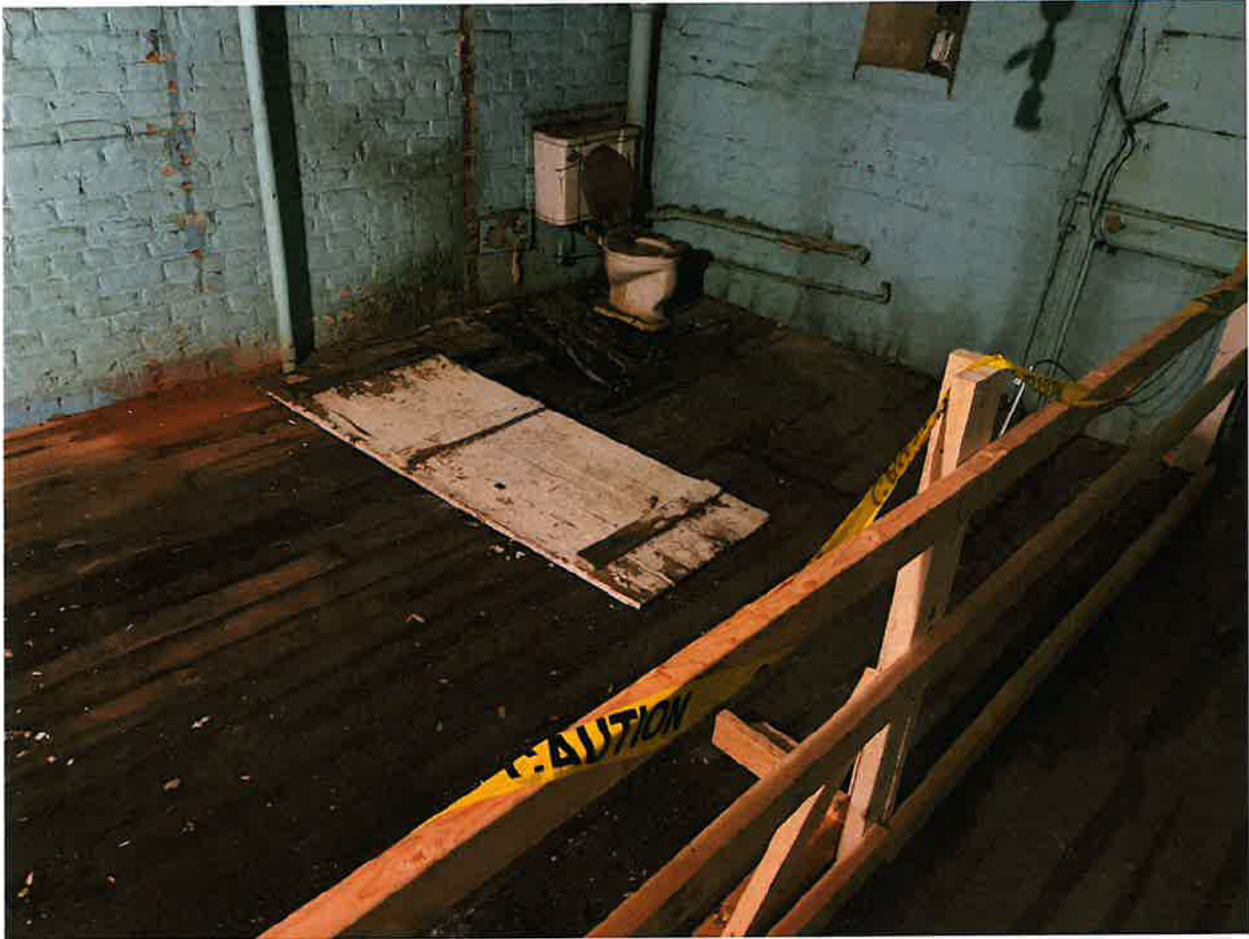
Photo 17: 209 S Wilmington St Raleigh, NC (03/19/2026) : 3<sup>rd</sup> floor rear major structural damage from plumbing and roof leaks.

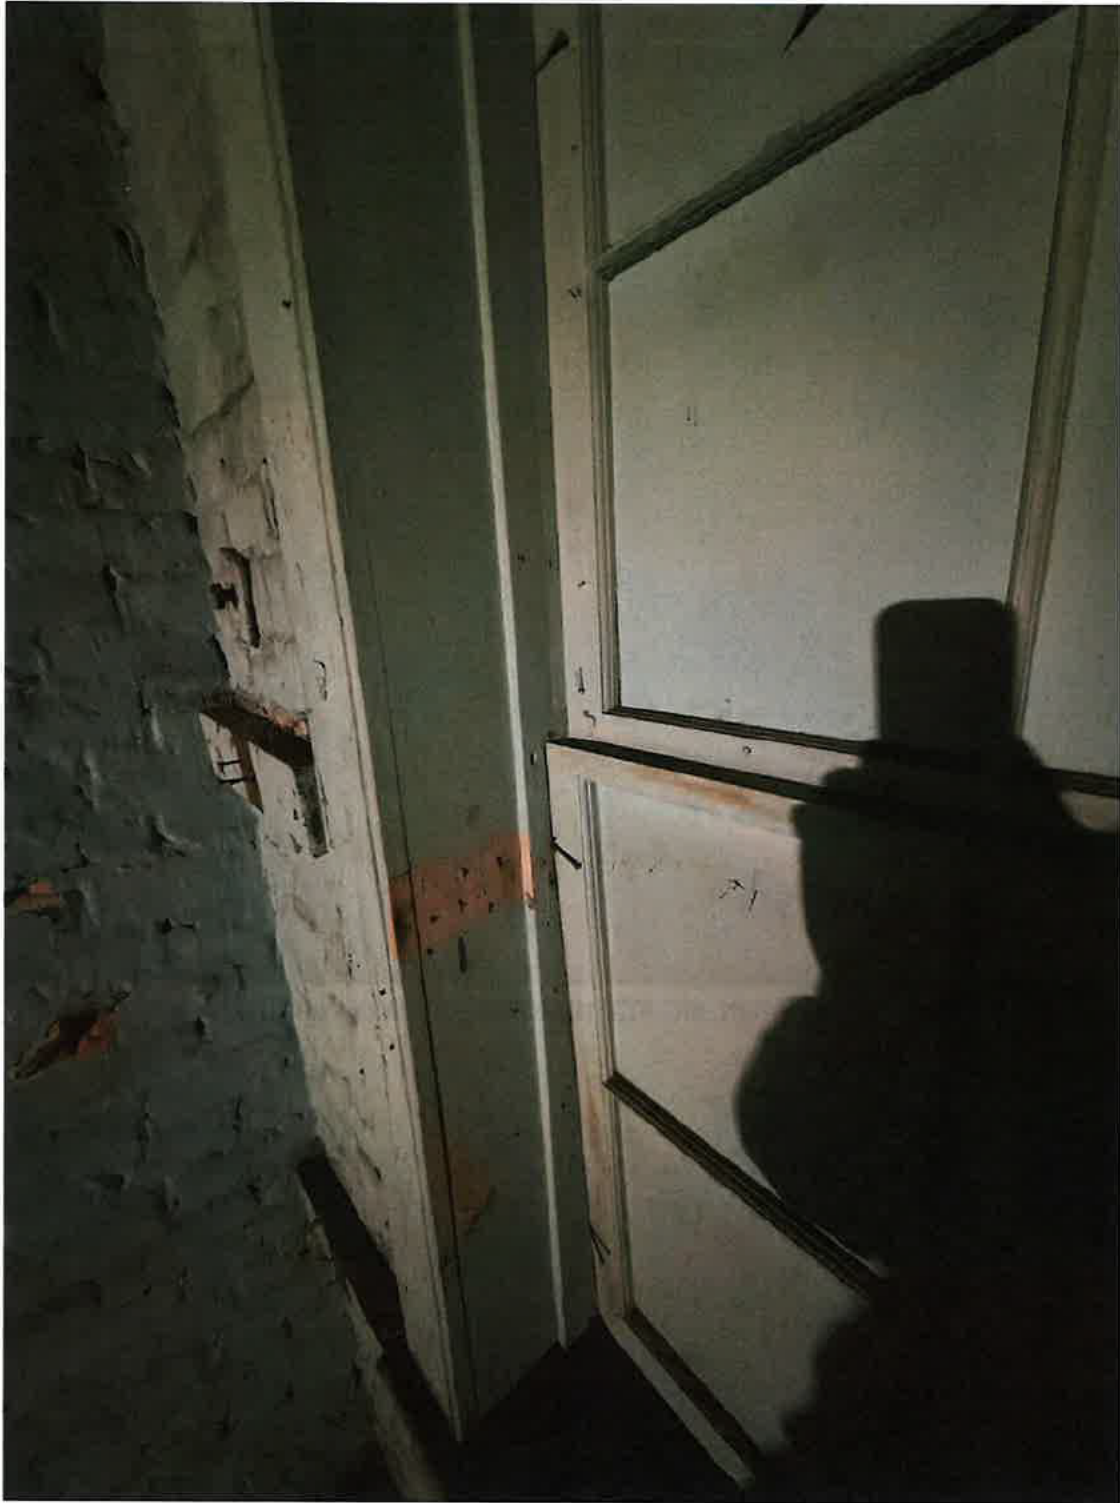
Photo 18: 209 S Wilmington St Raleigh, NC (03/19/2026) 3<sup>rd</sup> floor front, window sashes, tacked in place, Portland based stucco and wire lath beneath. Unknown if sashes are original.

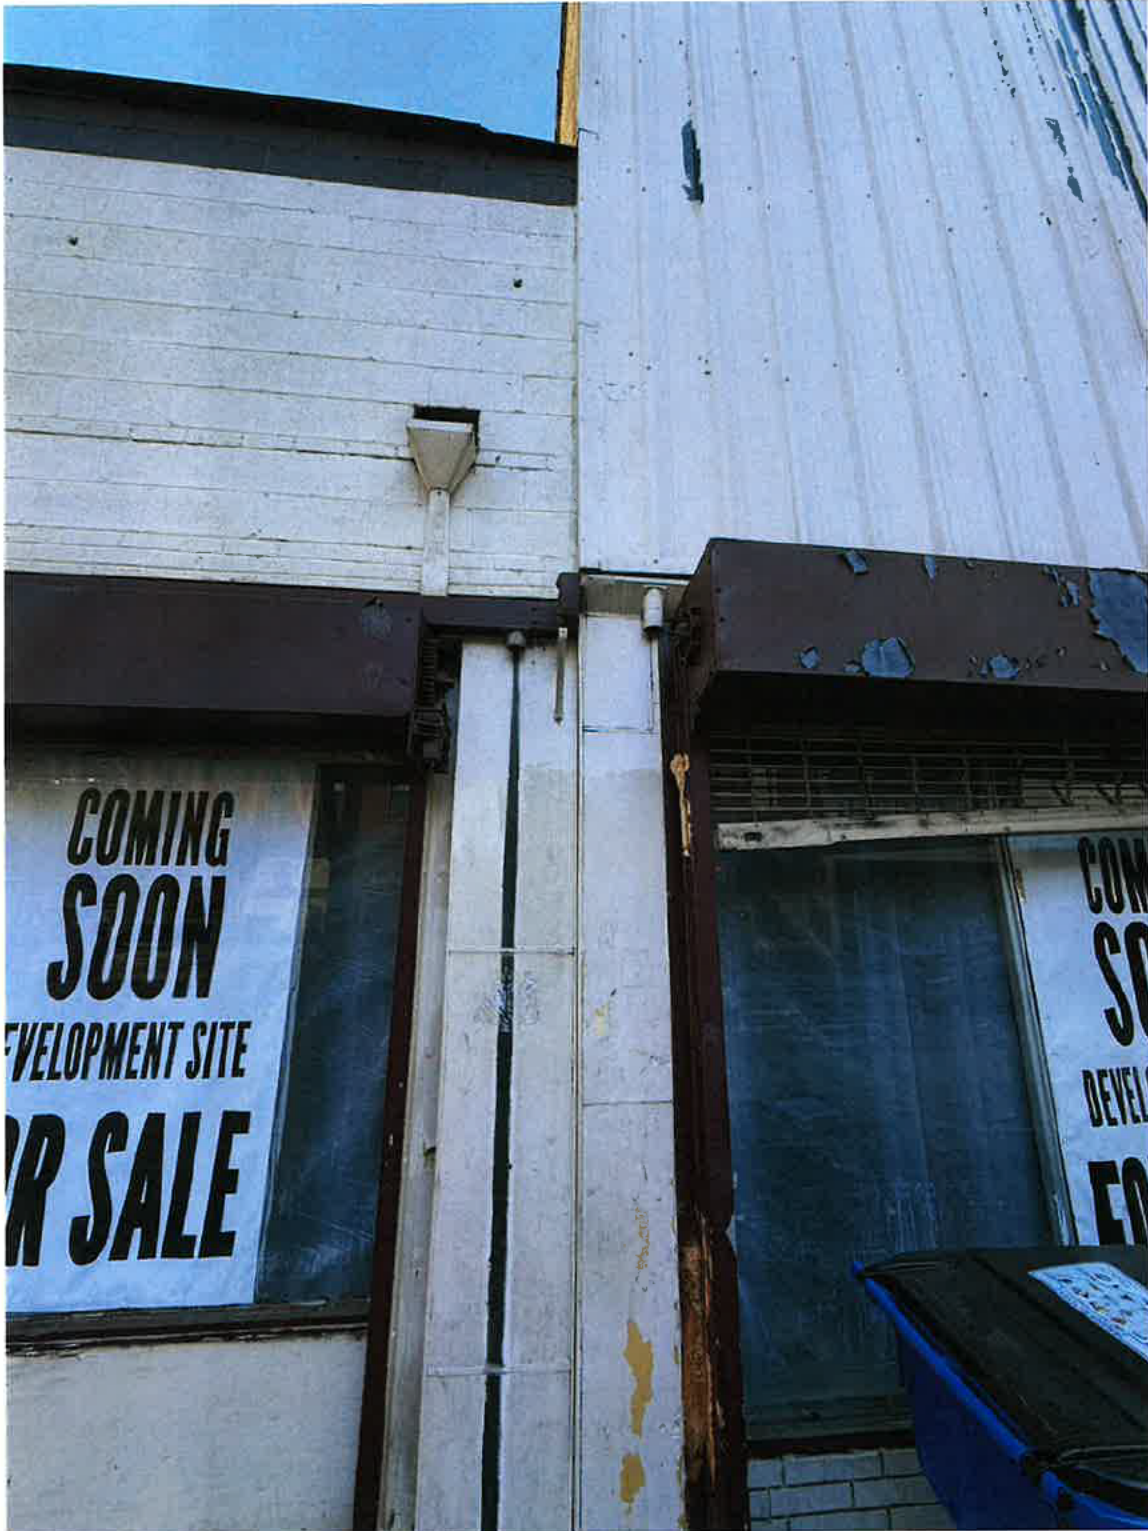
Photo 19: 209 S. Wilmington St Raleigh, NC (03/19/2026) 209 S. Wilmington St. independent of 205 S Wilmington St. The load bearing masonry wall is separate from 205, however, much of the north masonry wall was removed at the 1<sup>st</sup> floor

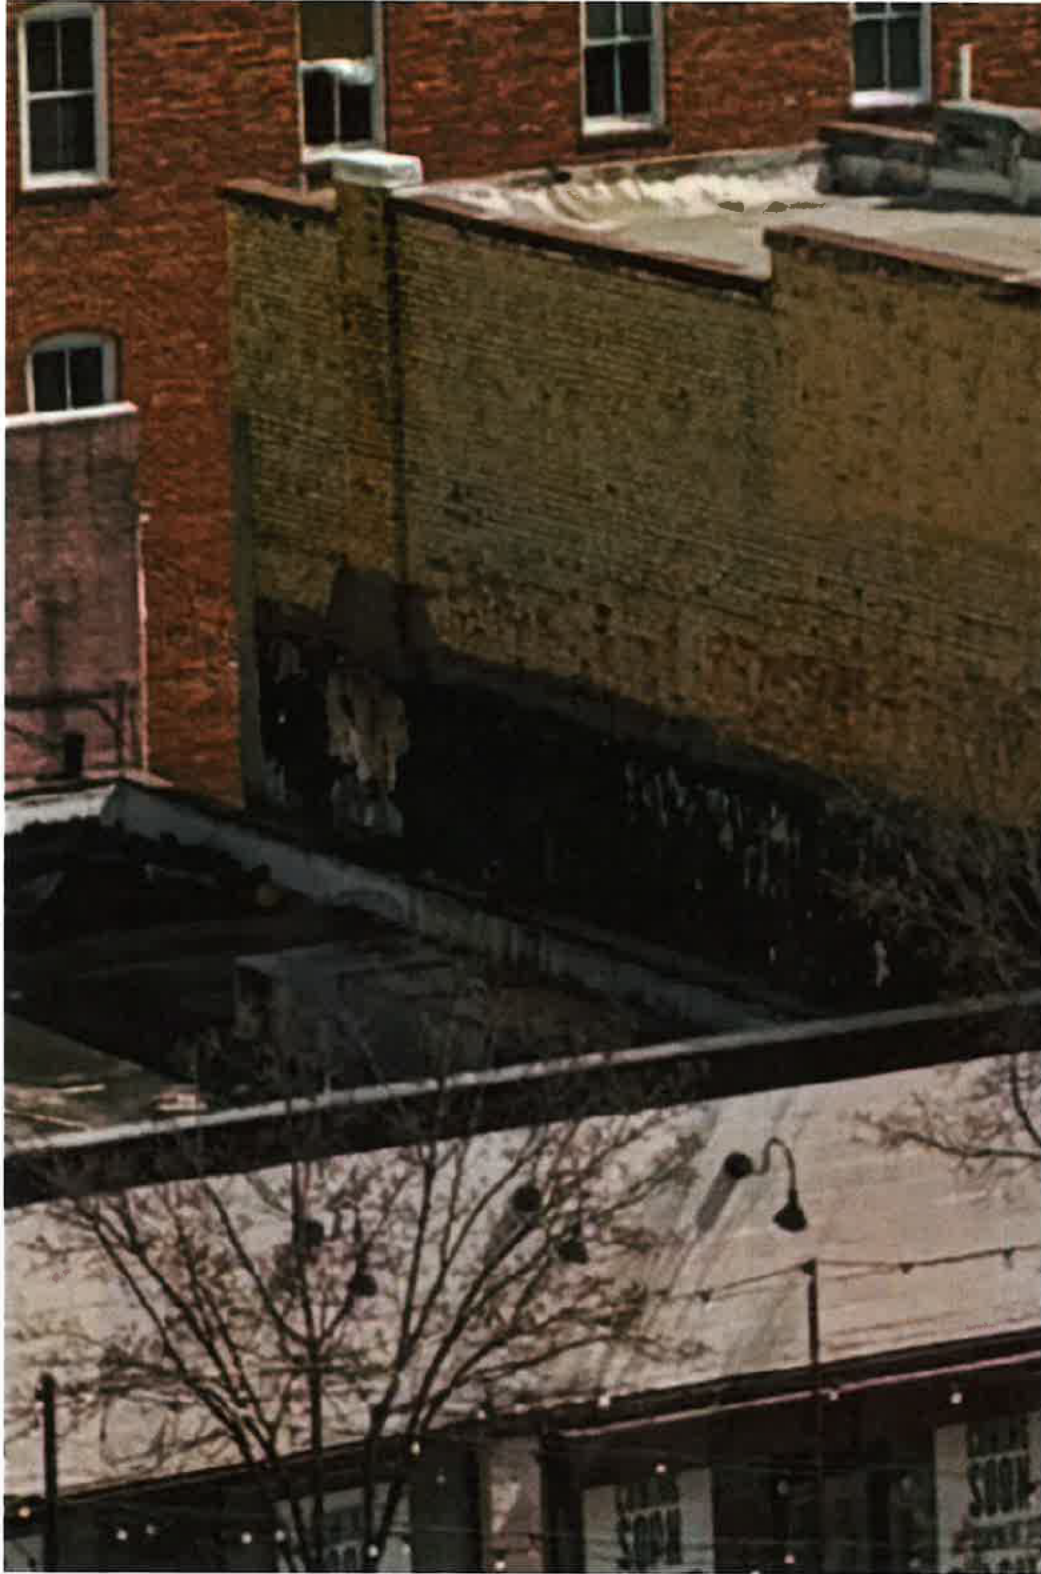
Photo 20: 209 S. Wilmington Raleigh, NC (03/19/2026) Parapet of 205 S. Wilmington shows independent from 209 S. Wilmington

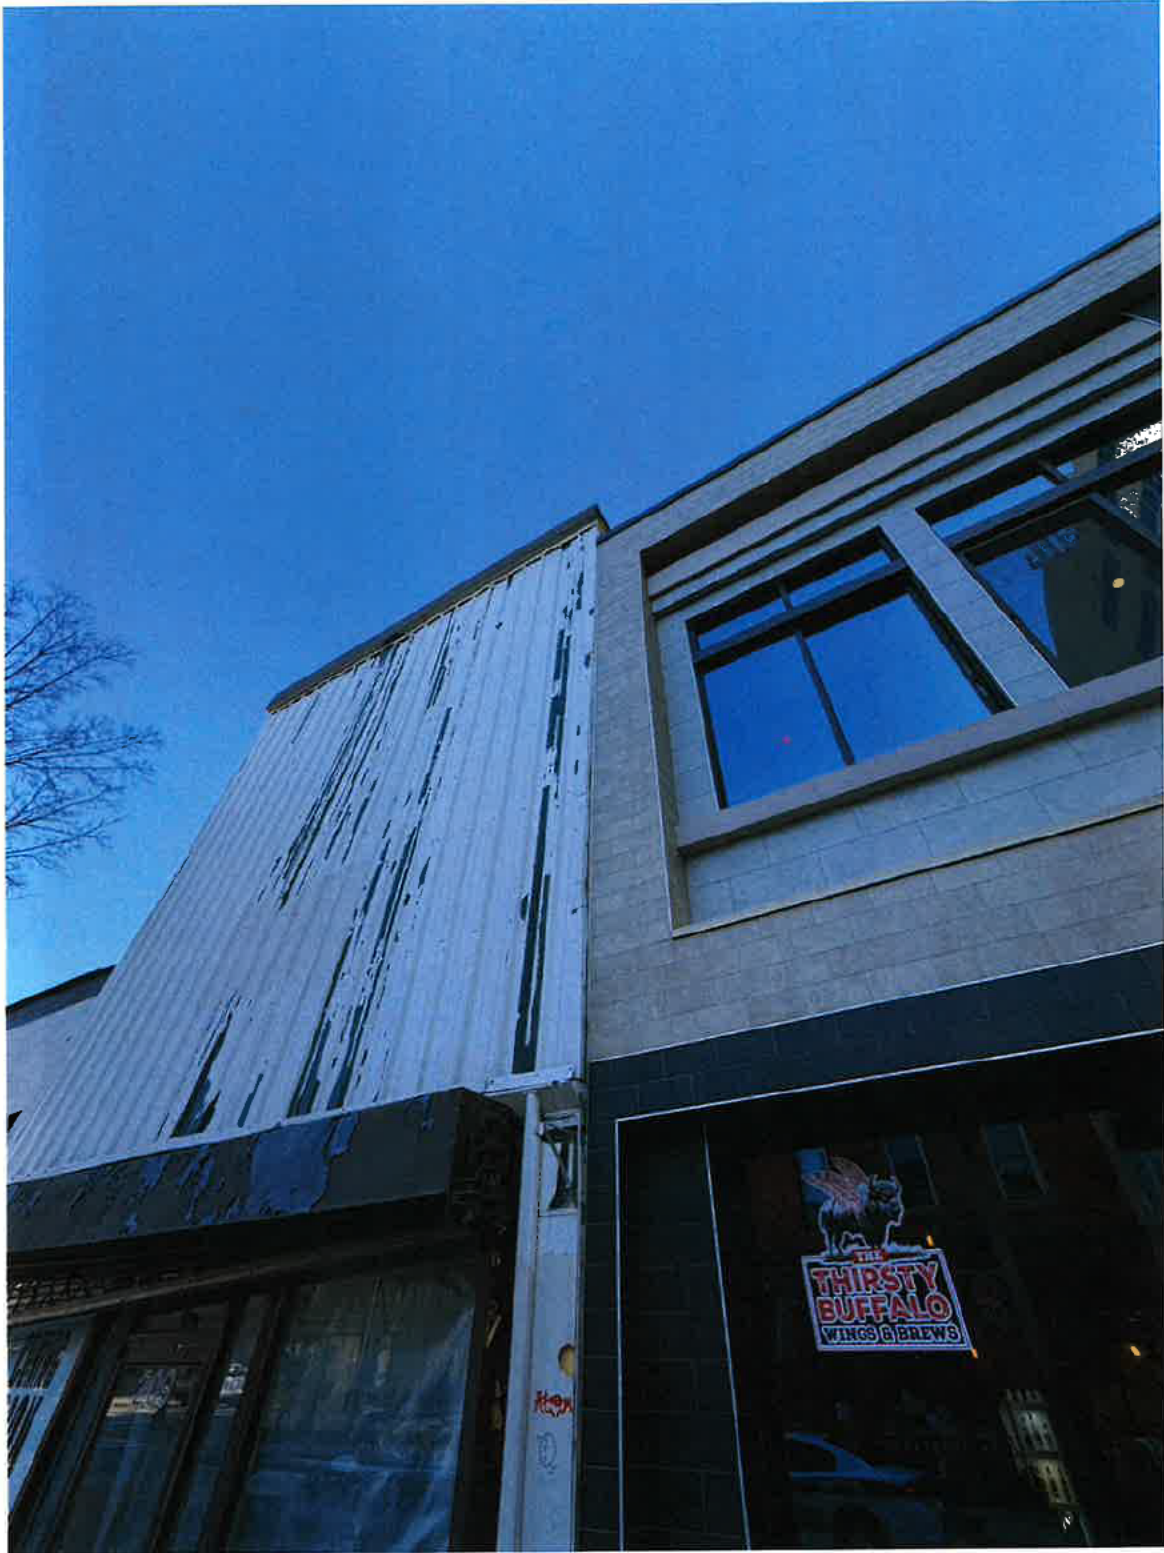
Photo 21: 209 S. Wilmington St Raleigh, NC (03/19/2026) 209 S. Wilmington St. and 211 S. Wilmington facades appear to be structural independent.

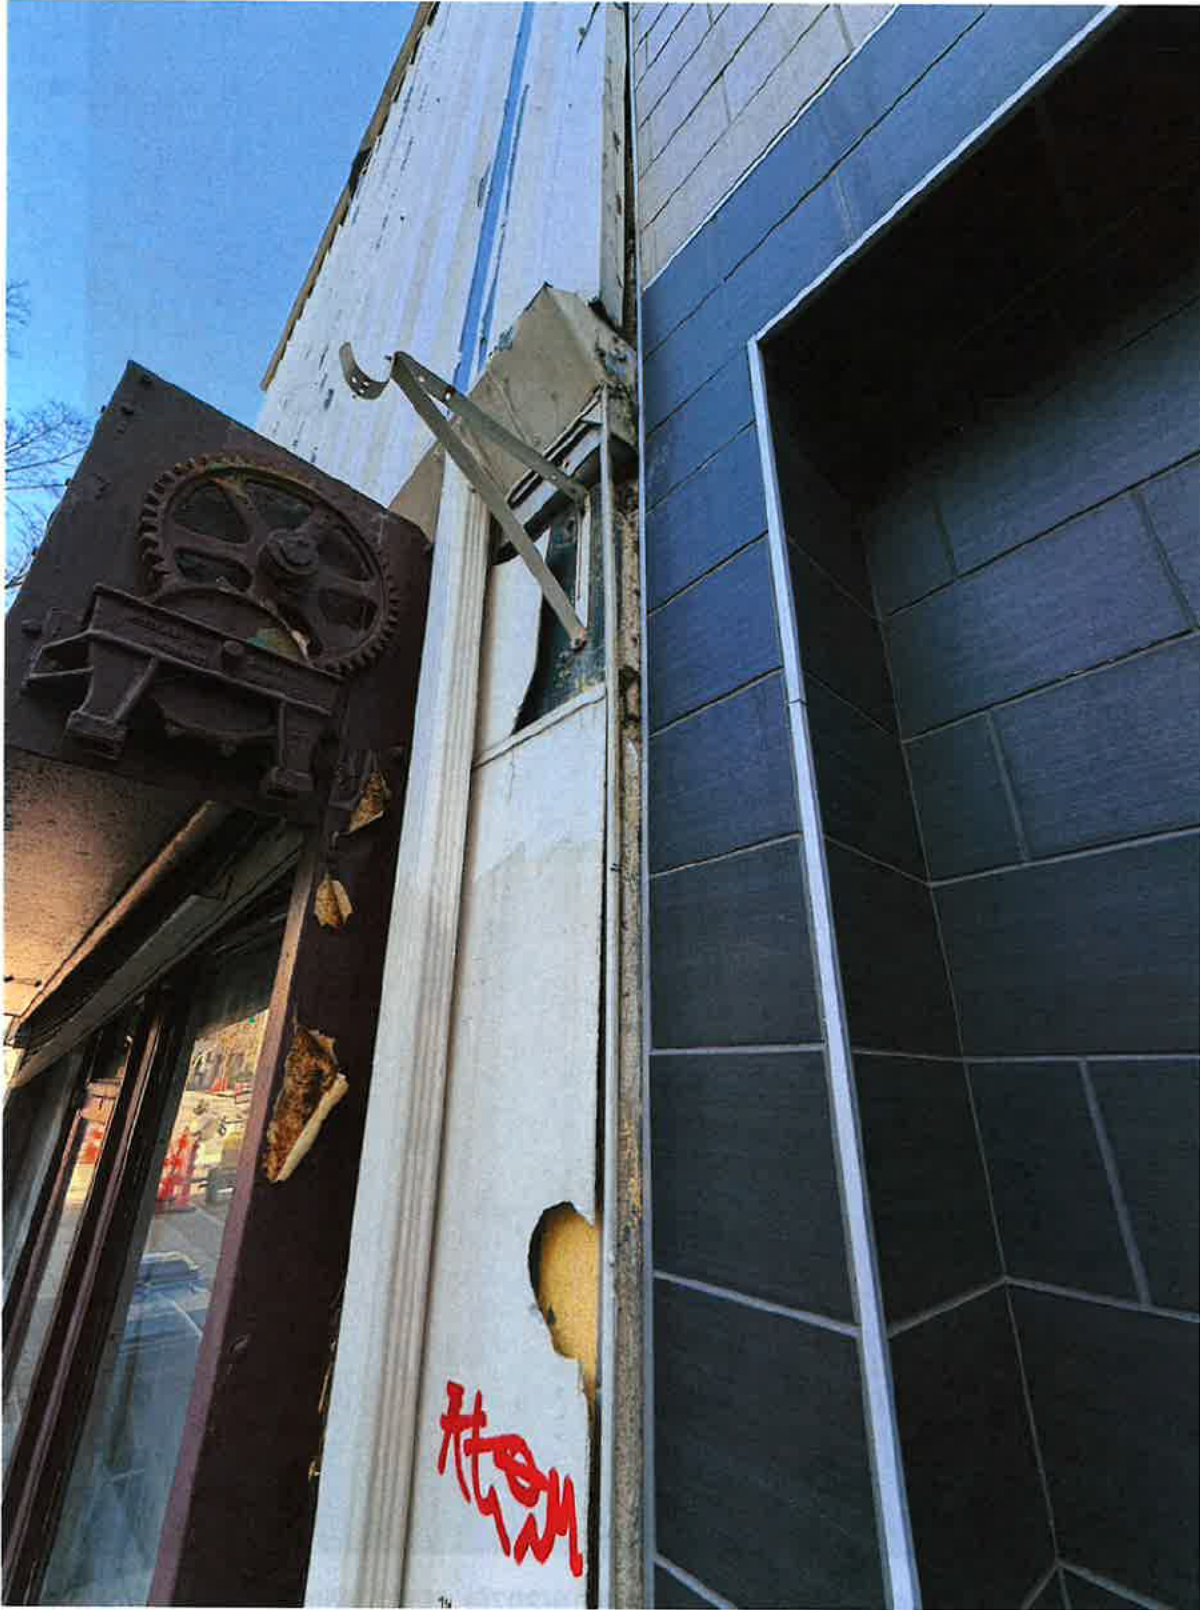
Photo 22: 209 S. Wilmington St Raleigh, NC (03/19/2026) Detail of 209 S. Wilmington St. wall independent of 211 S Wilmington St. Evidence of stucco direct to brick can be seen.

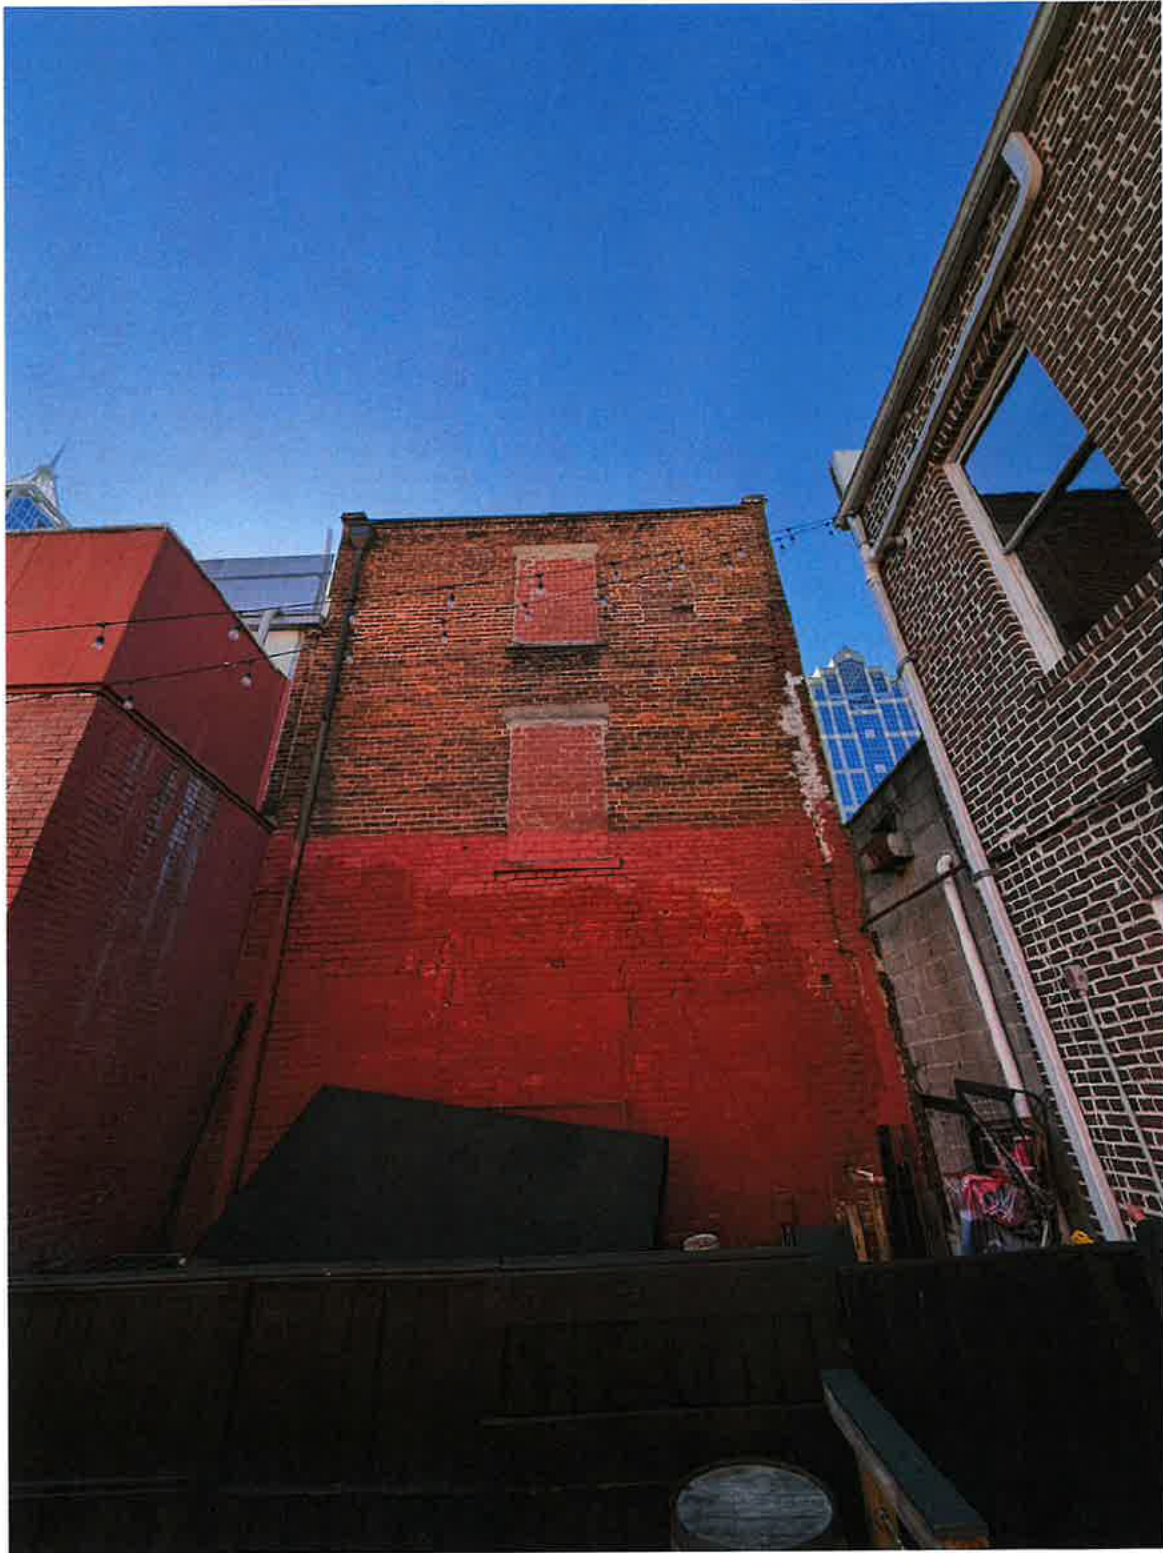
Photo 23: 209 S Wilmington St. Raleigh, NC (03/19/2026) Rear Façade with bricked in window openings.

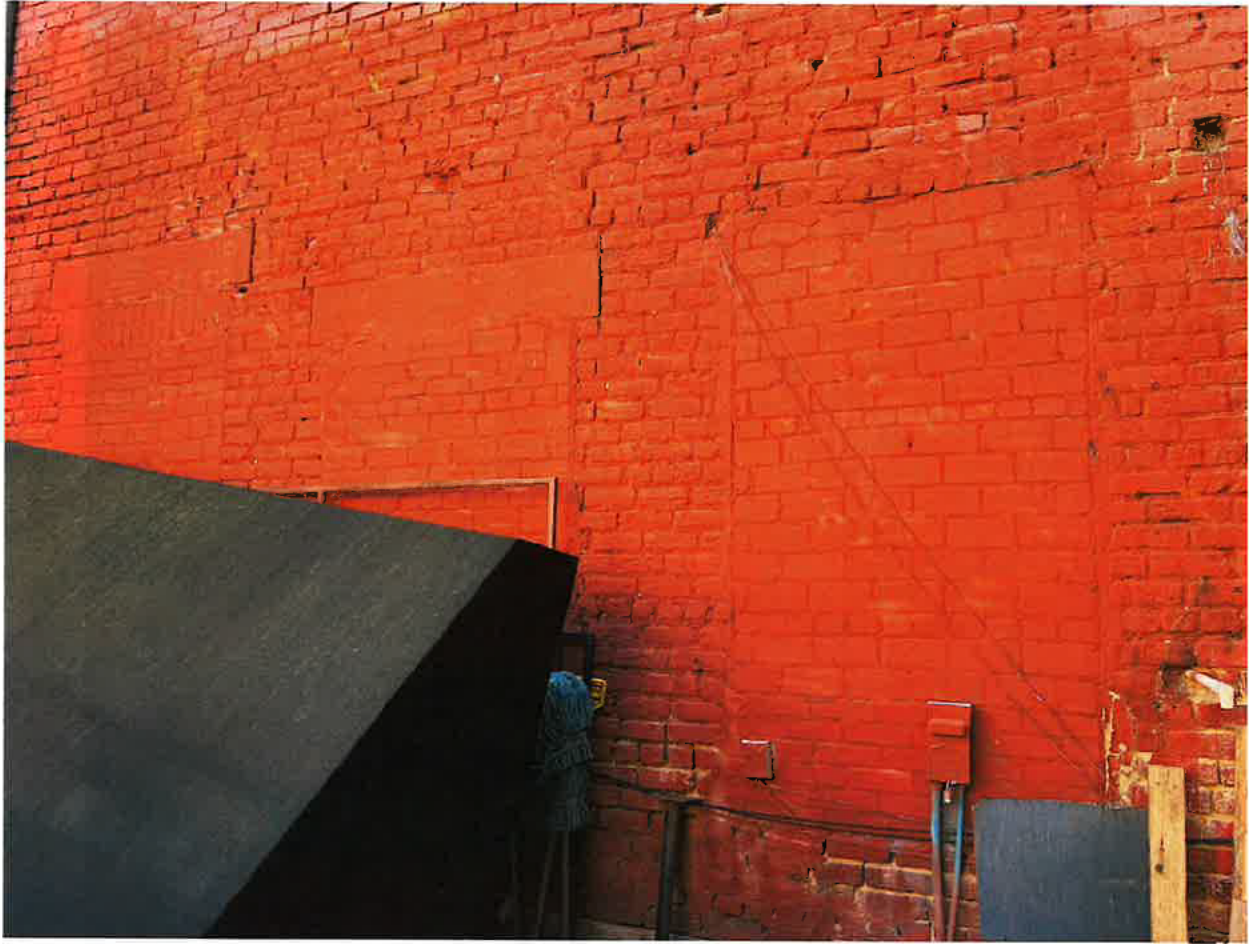
Photo 24: 209 S Wilmington St. Raleigh, NC (03/19/2026) Rear Façade, bricked in openings

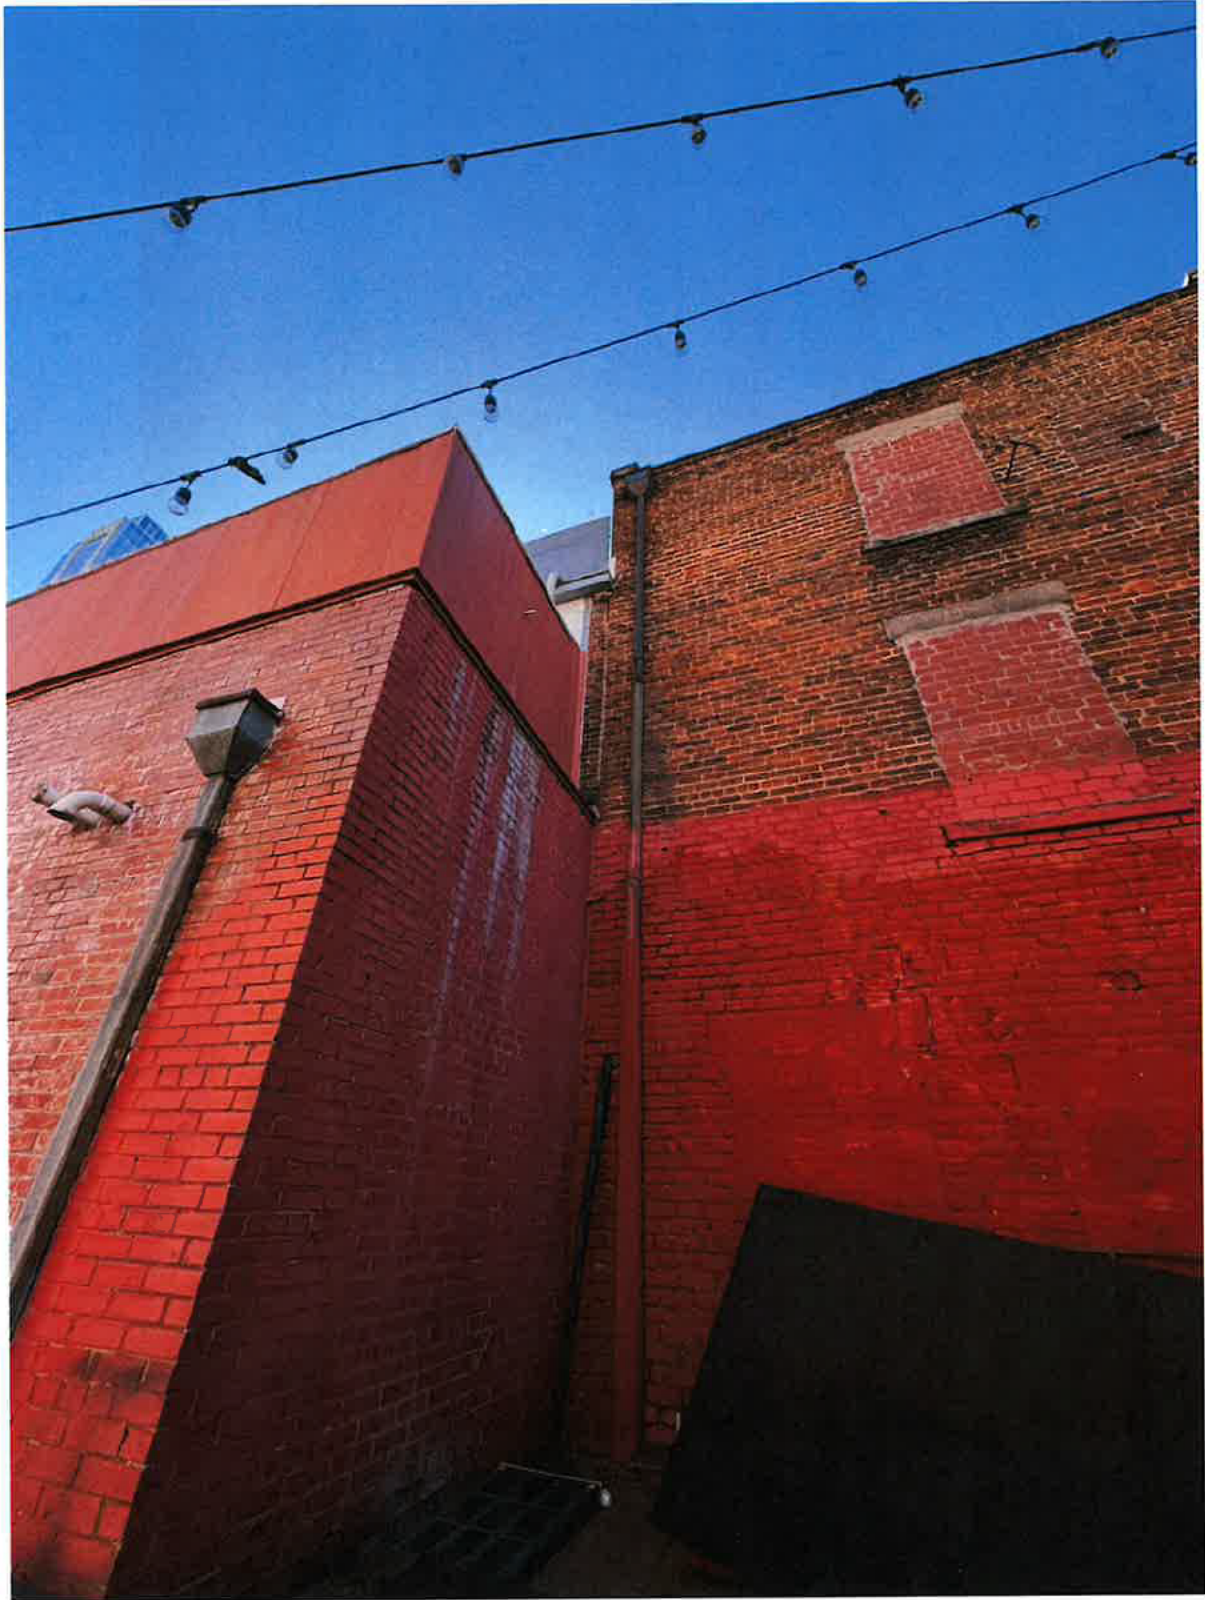
Photo 25: 209 S. Wilmington St. Raleigh, NC (03/19/2026) 209 S. Wilmington south wall, independent of 211 S. Wilmington St.

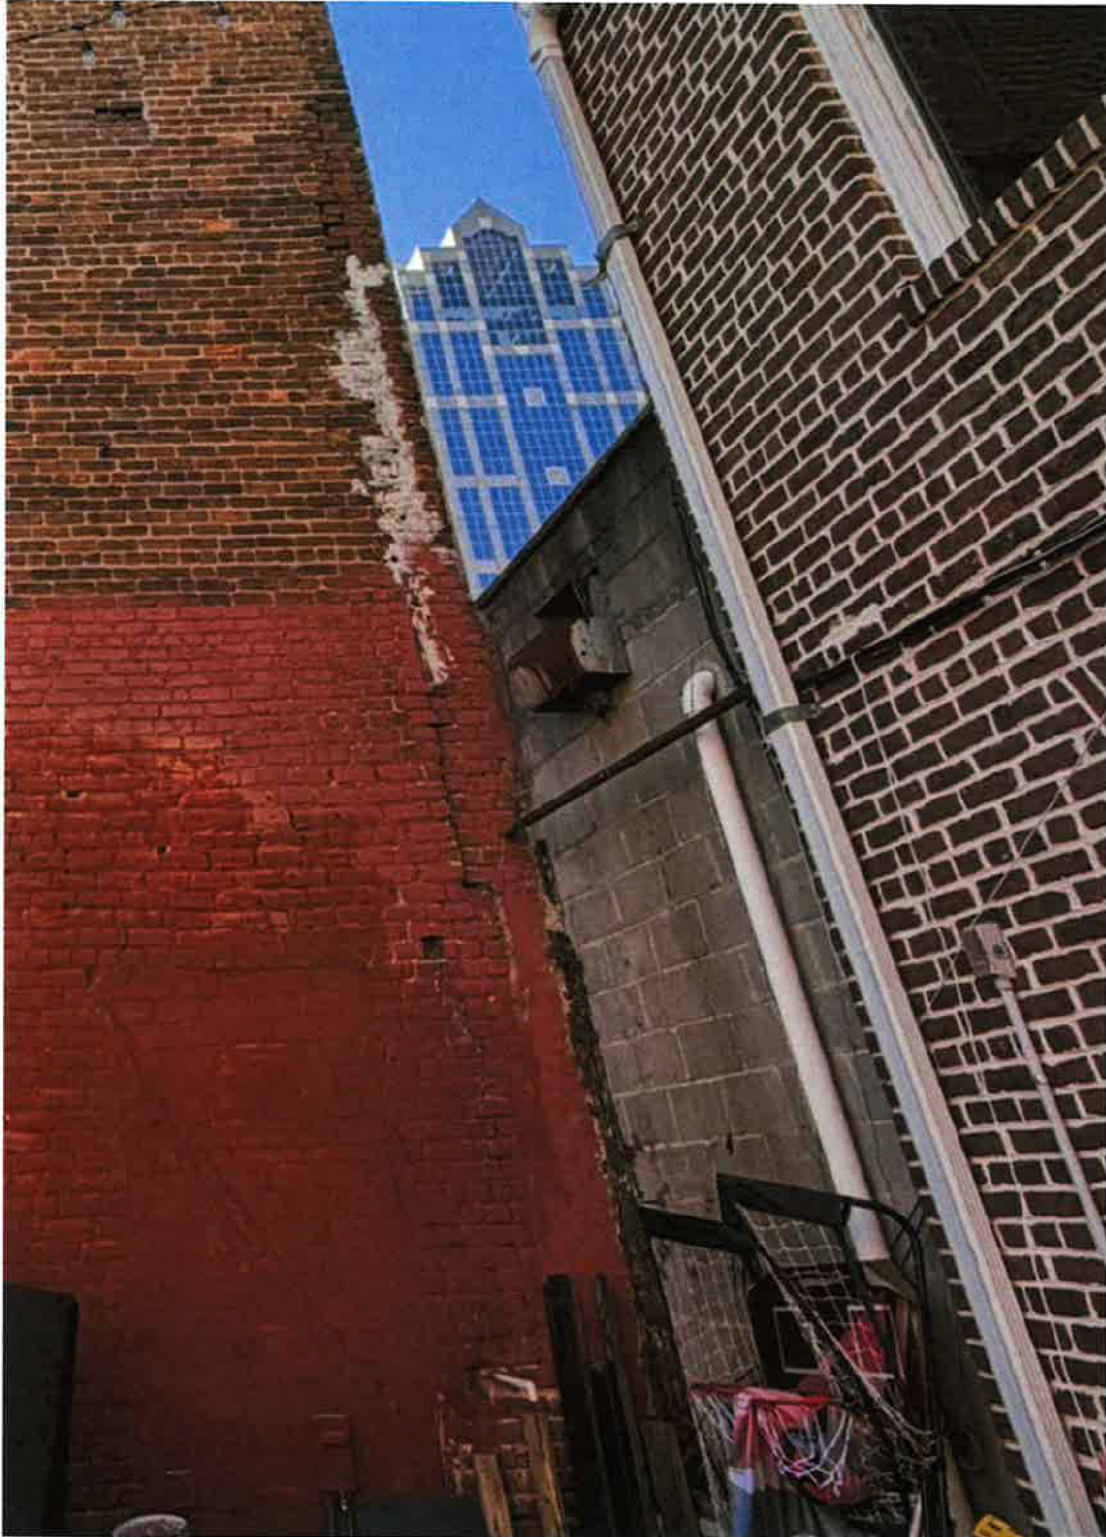
Photo 26: 209 S. Wilmington St Raleigh, NC (03/19/2026) Rear Façade, 209 and 205 separate walls
