COA Application - 415 E Edenton St - Tree Removal

Tree Removal Project Description

The proposed project involves the removal of four trees located on the property at **415 East Edenton Street, Raleigh, NC**, as recommended in the certified arborist report dated **March 4, 2026**, and the replacement of the 18" DBH Elm. The removal is necessary due to documented structural risks, property damage, and public safety concerns associated with the existing trees.

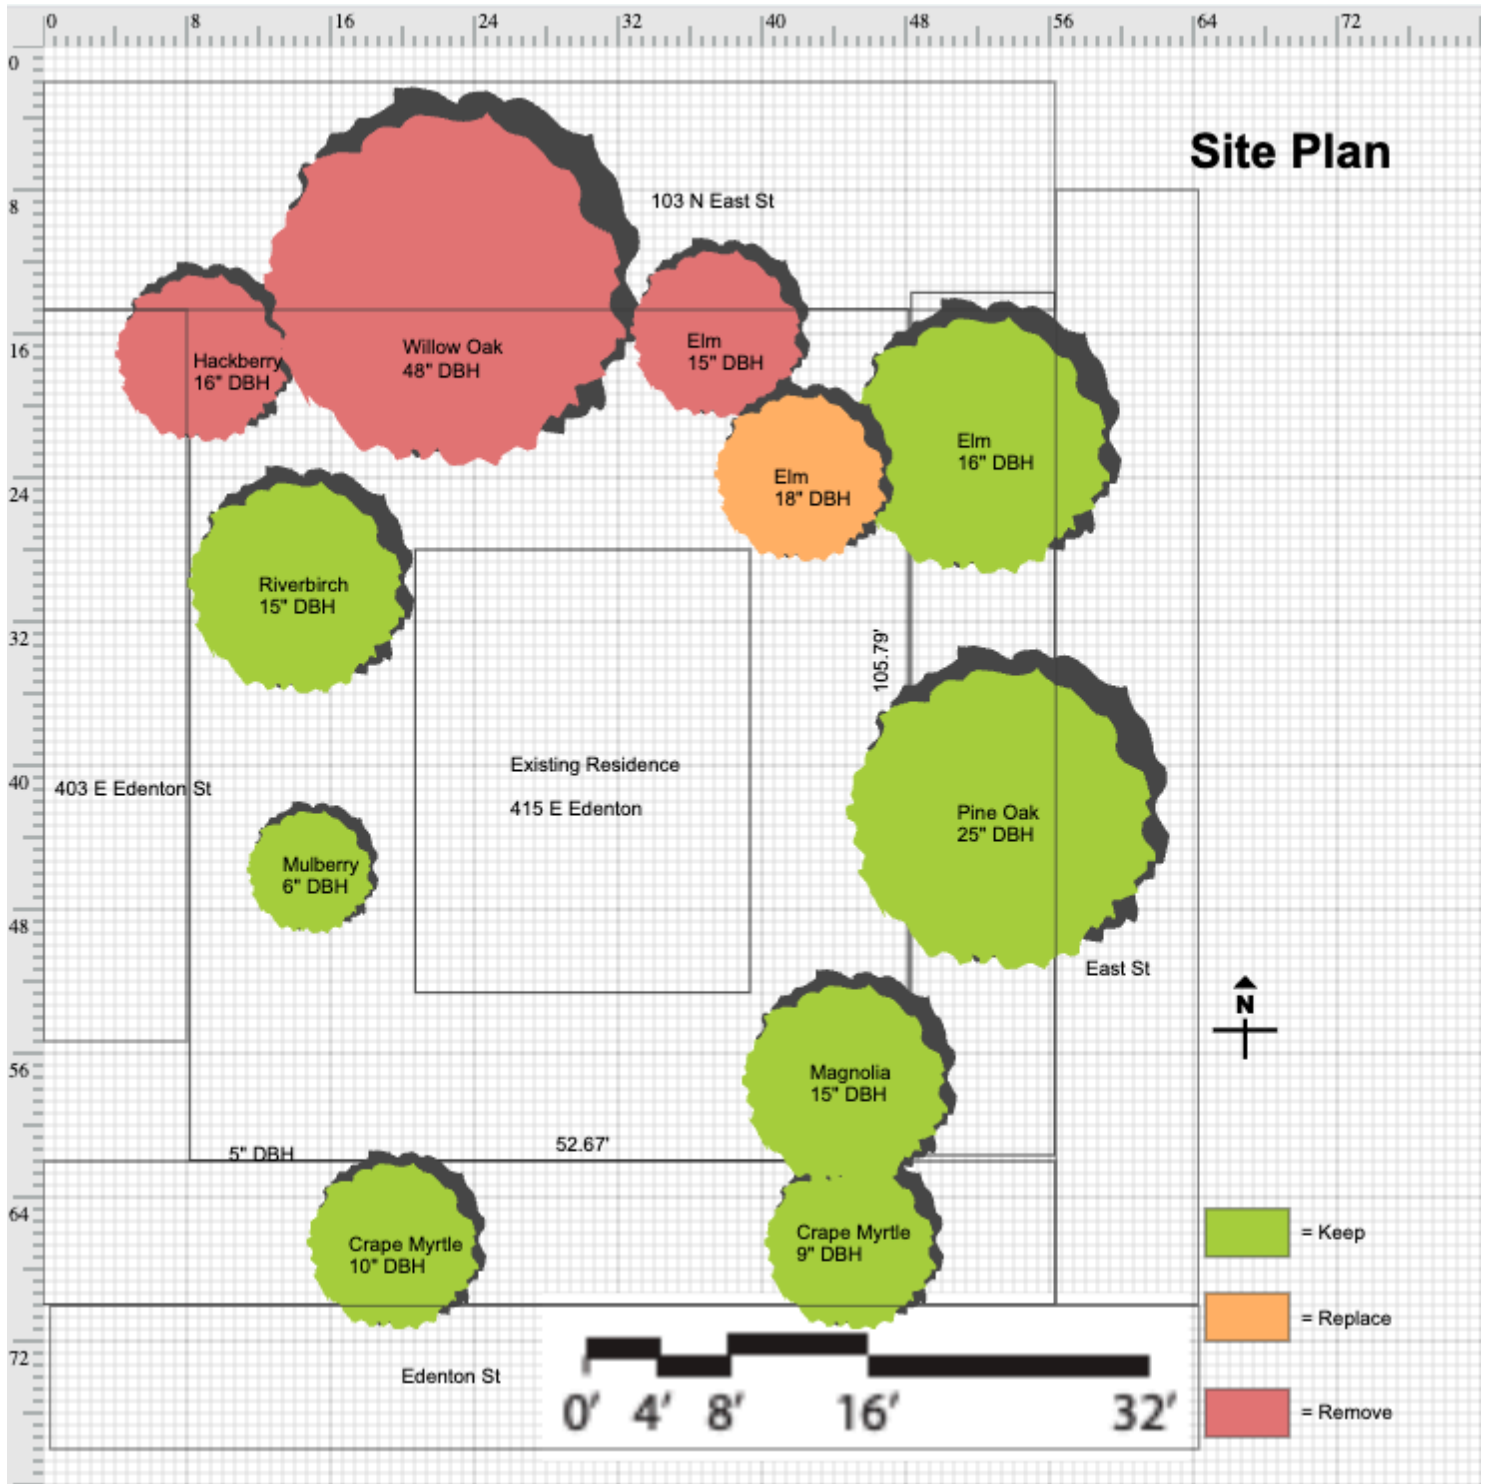
Site Plan

This elm tree exhibits **included bark**, a structural defect that significantly increases the likelihood of trunk splitting or major limb failure. The tree also shows evidence of broken branches in the upper canopy. Remediation through pruning is not feasible because approximately **50% of the canopy would need to be removed**, which would compromise the survival of the tree. Due to the high risk of structural failure and falling limbs, the tree presents a safety hazard to nearby structures, pedestrians, and **vehicles parked on adjacent streets and properties**. This tree is to be replaced in the corner of the lot - see site plan for more information.

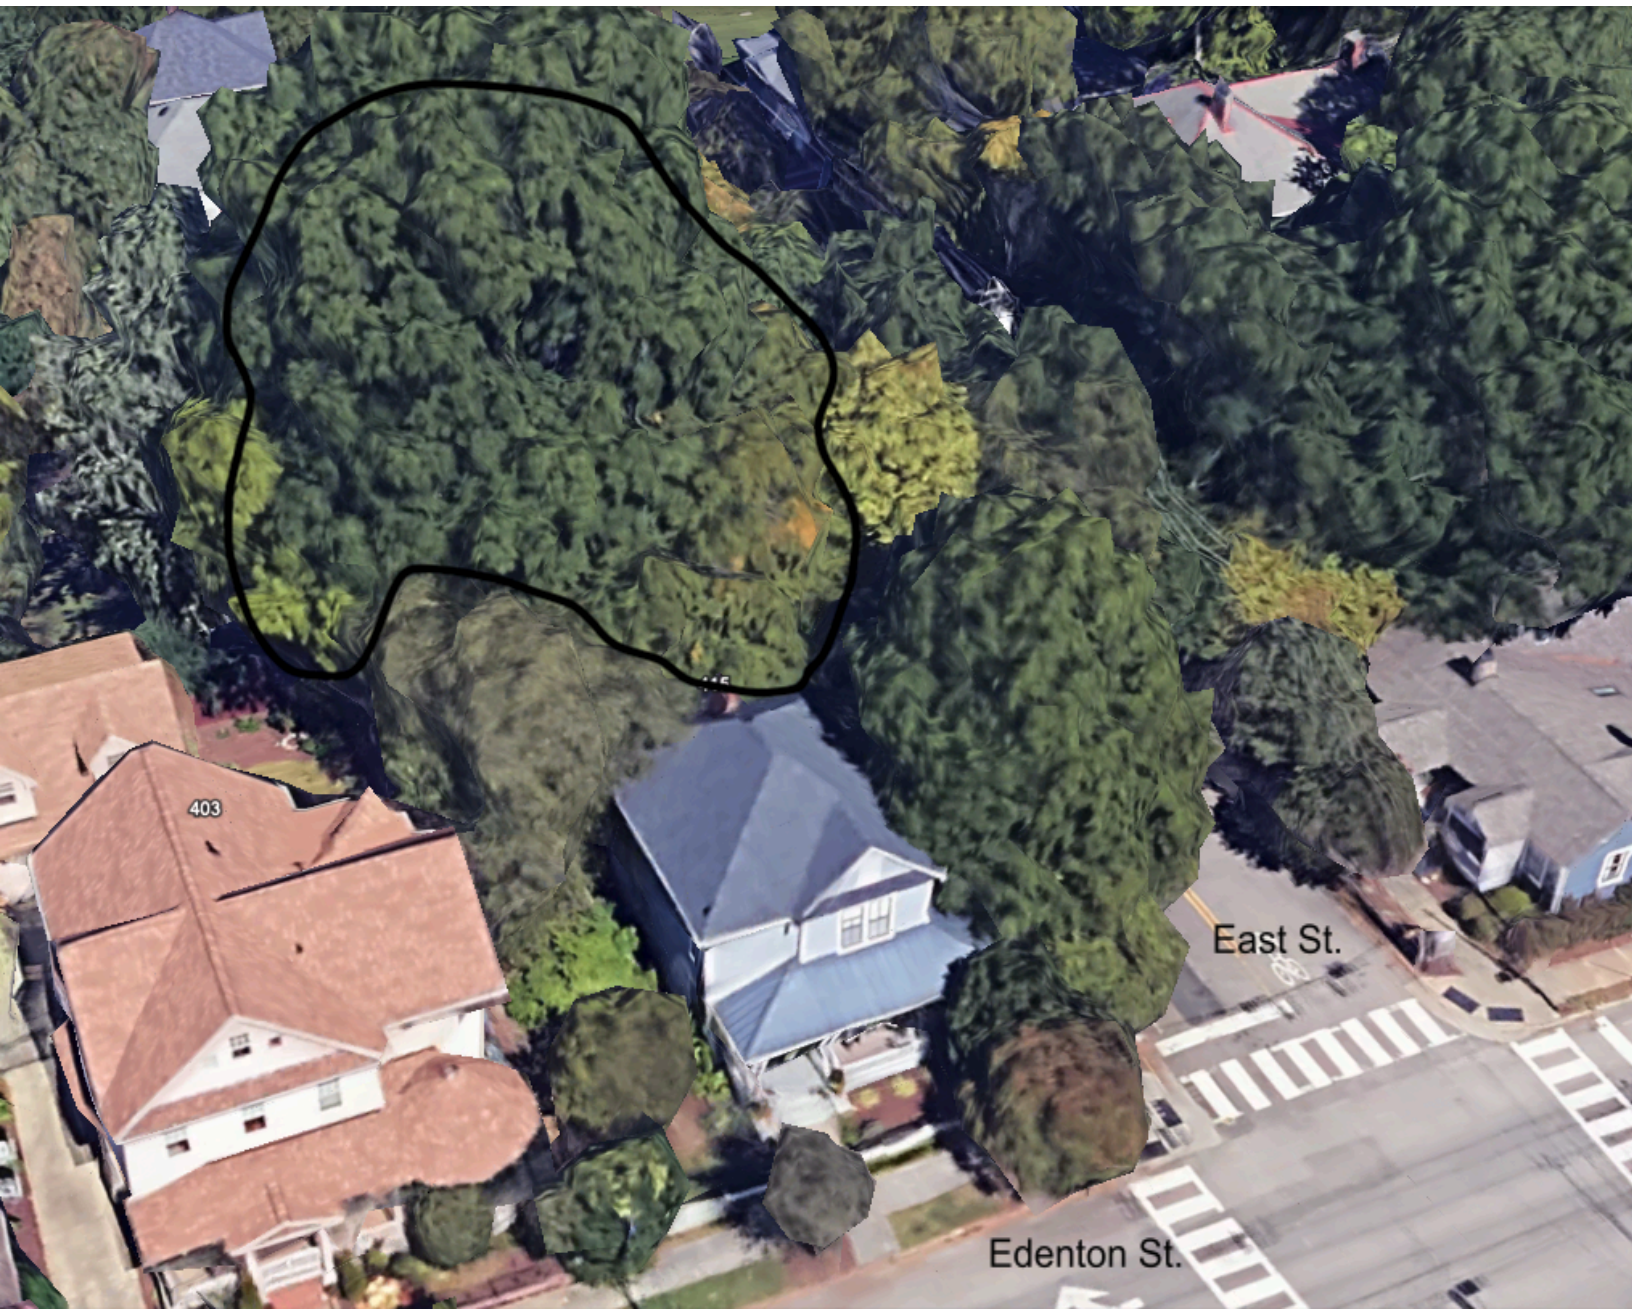
Aerial Photos of Canopy to be Removed

Several of the trees identified in the arborist report present conditions that increase the likelihood of structural failure or property damage. These risks include:

- Root intrusion into building foundations
- Structural defects such as included bark
- Severe leaning and instability
- Broken limbs and canopy damage

Based on the certified arborist's professional assessment, removal of the identified trees is recommended as the safest and most practical course of action to prevent further **structural damage, liability risks, and safety hazards**. The proposed work will eliminate the current risks associated with root intrusion, structural defects, and unstable tree growth while protecting both the subject property and adjacent properties.
